Preliminary Advice

Insured Vehicle No : YN2584Z	Accident Date : 04/07/2019
TP Vehicle No : SLR9828H	Assignment Date : 05/07/2019
Make : TOYOTA COROLLA ALTIS	Est. Duration of Repair : 6
Date of Inspection : 5/7/2019	
Inspection At : HIAP HONG MOTOR REPAIR

Point of Impact / General Description of Damages

VEHICLE DAMAGE INSPECTION REPORT

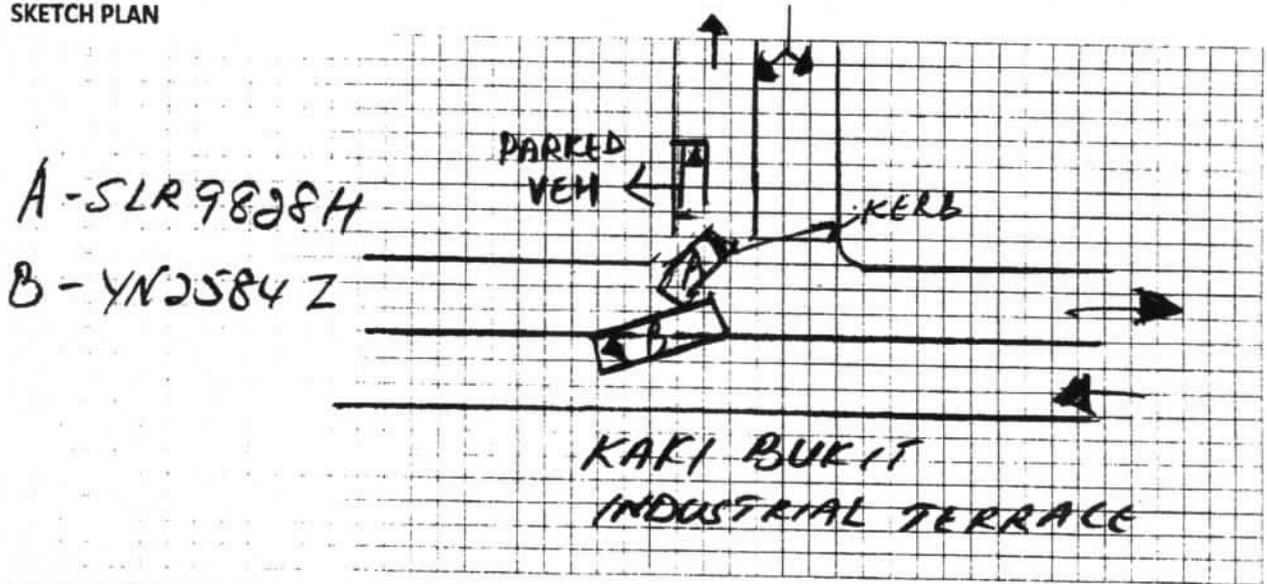
SKETCH PLAN

Type Of Accident SIDE SWIPE
 Weather Conditions CLEAR
 Road Surface DRY

I WAS TRAVELLING FROM KAKI BUKIT INDUSTRIAL TERRACE TWDS LOYANG. WHEN I WANTED TO MAKE A LEFT TURN AHEAD THERE WAS VEH PARKED SO I HAVE TO STOP AT THE JUNC TO GIVE WAY FOR THE VEH B. WHILE VEH B MAKING A RIGHT TURN HIS LEFT SIDE PORTION OF HIS VEH HIT ONTO MY REAR RIGHT SIDE PORTION OF MY VEH. I TRY TO BREAK FREE MY VEH AND MY FRT RIGHT SIDE PORTION HIT ONTO THE KERB.
