To Inspect Vehicle No: XE 8913 Insured: XD 7699H

Make: *SCANIA P400 LA4X2M32 c.c 12742*  
 Colour: *WHITE* A/C: Insured / Std / NI / NA  
 Sp. Reading: *157464* T/Radio: Insured / Std / NI / NA

**RE : ESTIMATE COST FOR SCANIA P400 - XE891J**  
**ACCIDENT INVOLVING XE891J & GXD7699H ON 02/07/2019**

## VEHICLE DAMAGE INSPECTION REPORT

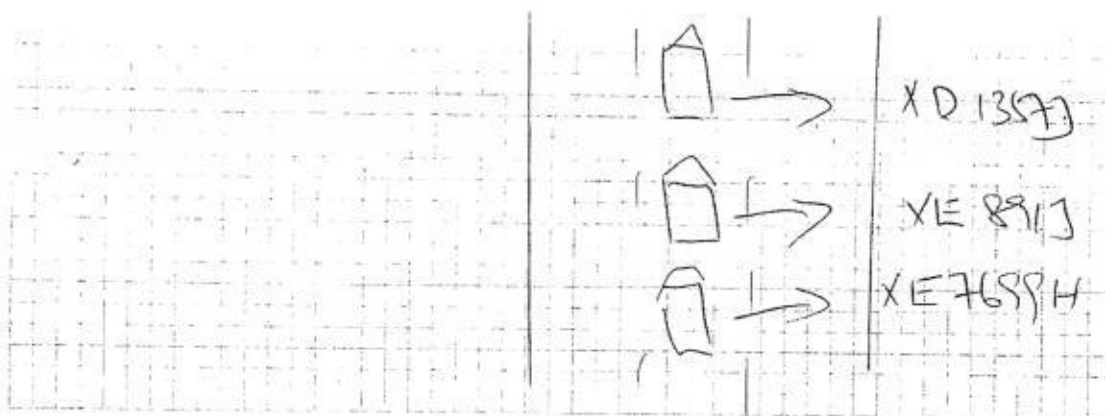
CH PLAN

On 02/7/19, @ about 10:55 hours, my vehicle was stationary along AYE towards Tuas (Before Exit 22) when suddenly, I was hit by behind vehicle, XD 7699H, which caused my vehicle to move forward and hit into the vehicle in front, XD 1357J.
