PRI

TP CLAIM AGAINST SMH5896C, TP: CB6801U

VEHICLE DAMAGE INSPECTION REPORT

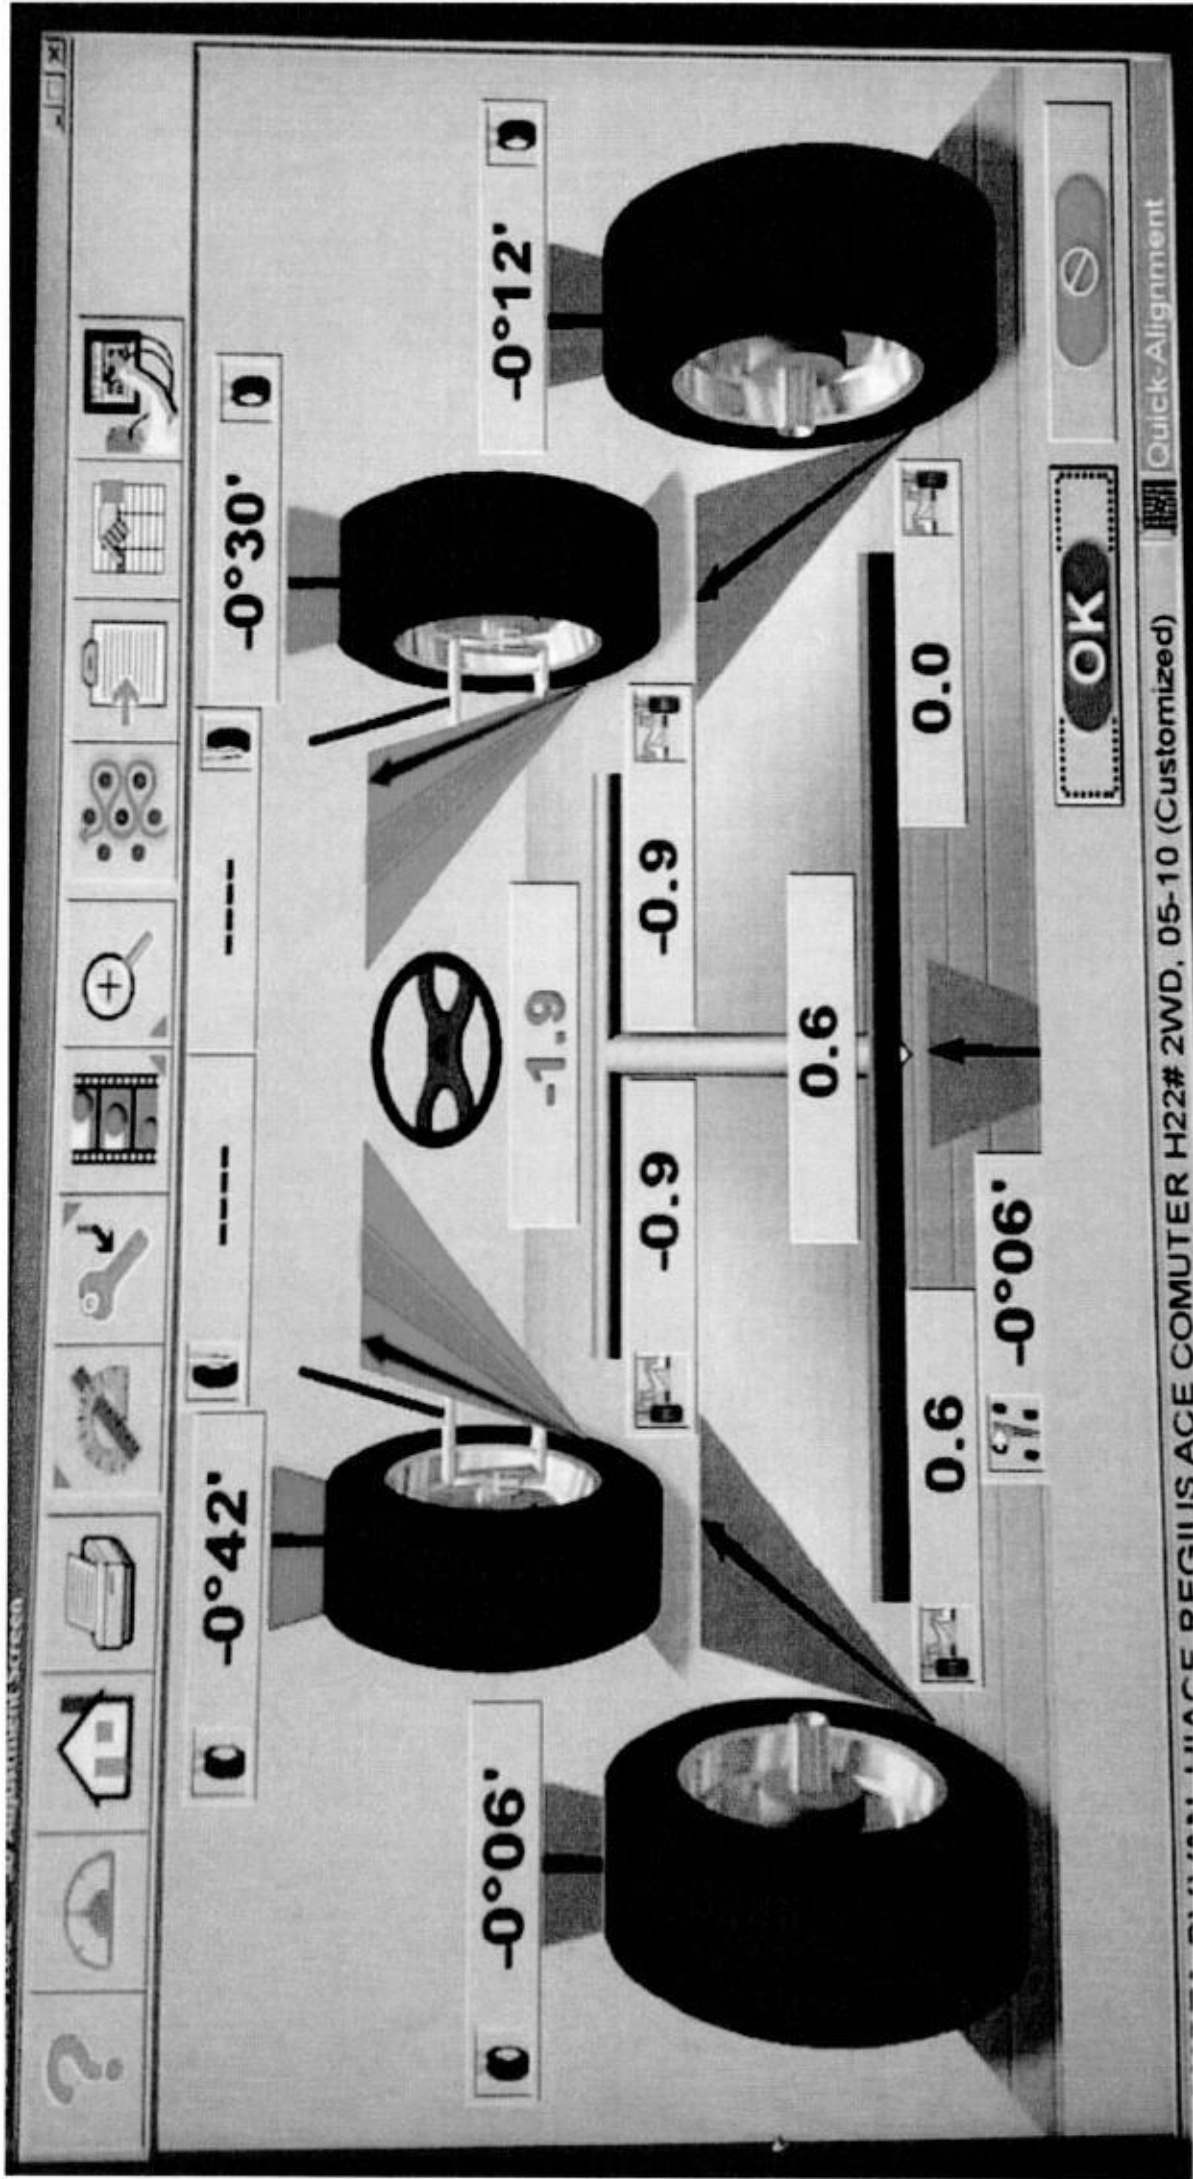
TOYOTA-RV,VAN, HIACE REGIUS ACE COMPUTER H22# 2WD, 05-10 (Customized)

Front Setback
-4mm

Wheel Base Difference
2mm

Rear Setback
-6mm

Track Width Difference
6mm

Axle Offset
-10mm

Left Wheel Offset
-7mm

Right Wheel Offset
13mm
