VEHICLE DAMAGE INSPECTION REPORT

Our File No: CS/TMI19012547/K1TF3E2

Handling Insurer: Tokio Marine Insurance Singapore Ltd Policy No: MK000582
Claimant Vehicle No : SHD4241D **Insured Vehicle No :** SLE6728B
 Date of Loss: 14/07/2019 Nature of Claim: TP Claim No: M1905341

Reg No: **SHD4241D**
 Make & Model: HYUNDAI IONIQ HYBRID, 1.6 GLS DCT (A) Engine No: G4LEGU329722
 Reg. Date: 17/03/2017 (Man. Year: 2017) Chassis No: KMHC851CVHU022835
 Colour: Blue Odometer: 150682 km
 Engine Capacity: 1580 cc
 Market Value/New Car Price: N/A
 Sum Insured (S\$): **Market Value/New Car Price**

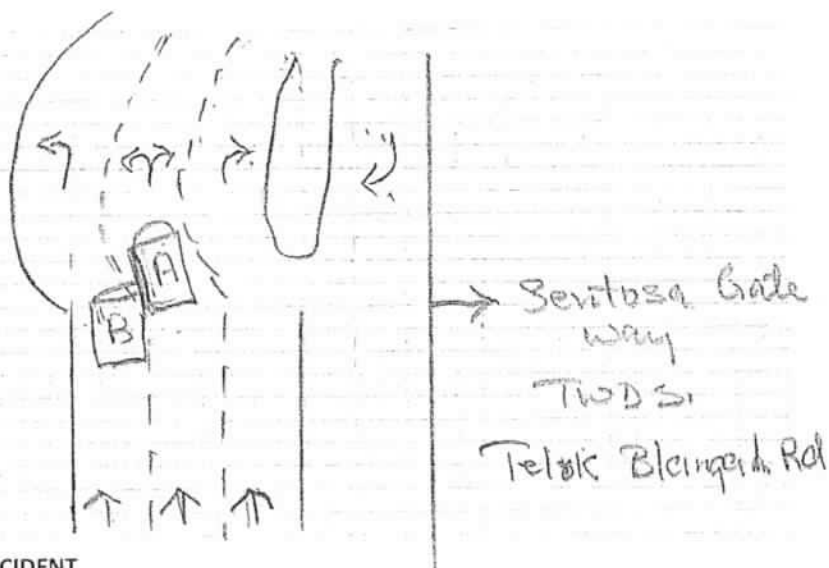
SKETCH PLAN

(A) SHD 4241D
(B) SLE 6728B

On 14/7/2019 at about 1625 hrs, I vehicle A was driving my taxi along Sentosa gate way toward telok blangah Rd. While I was in the middle at the bend, Vehicle B was on my left hit vehicle A at bend Caused the damage. NO one was injured at that time.

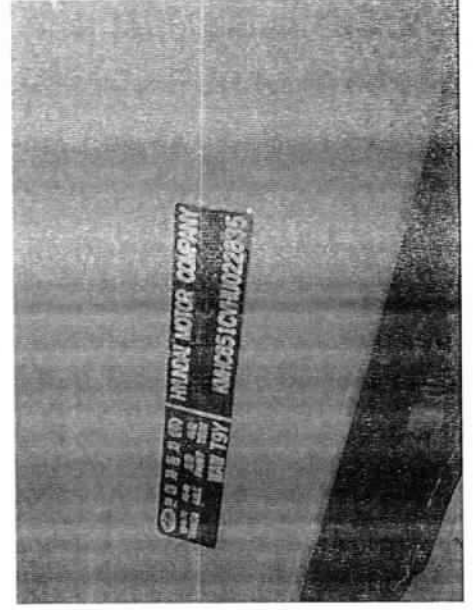
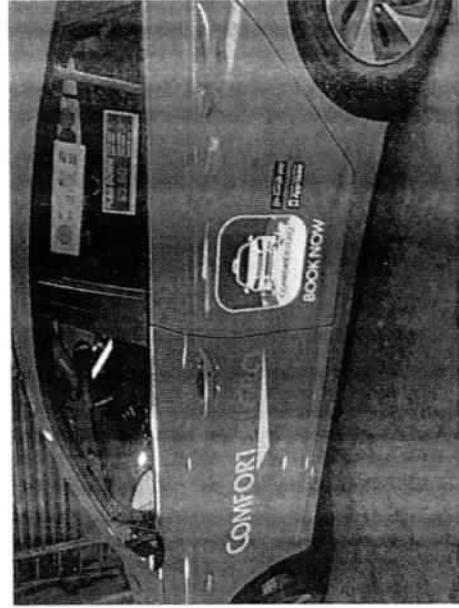
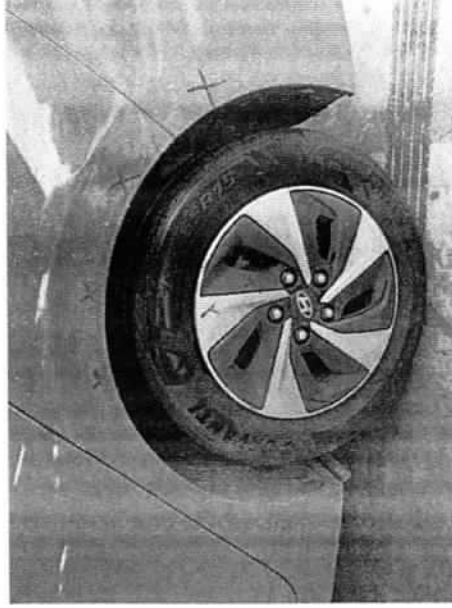
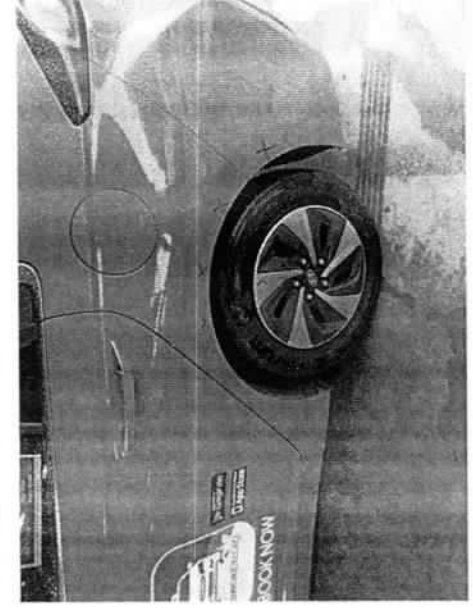
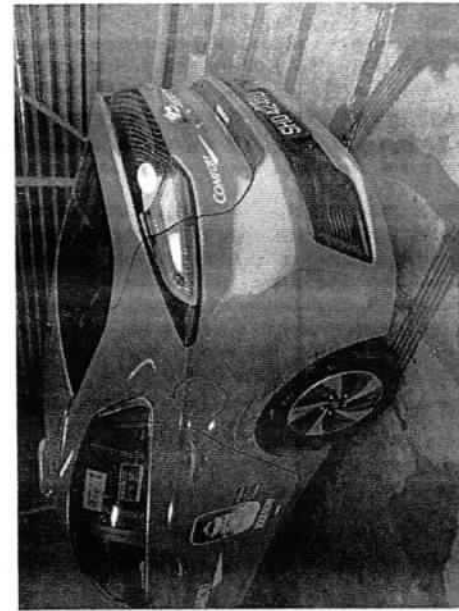
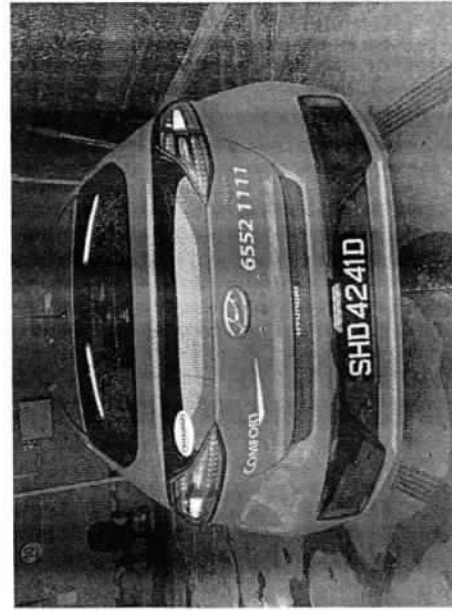
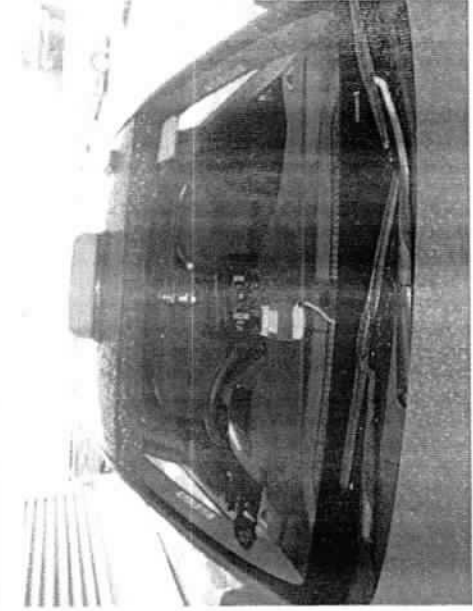
Remark: The veh had commenced its
repair at the time of inspection.

The U/C / Chassis frame / Body Structure affected due to collision.

No.	Qty	Part No.	Particulars	Condition	Repairer's	Amount
1	1		*REAR WHEEL HUB CAP LH	Grazed	346.40 FL	*346.40 FL
2	1		*REAR BUMPER RUBBER MAT	Not Necessary	50.00 F	*- F
3	1		*REAR DOOR COMFORT & APPS STICKER LH	Necessary	80.00 F	*80.00 F
4	1		*REAR DOOR (LH) (NPA)	Repair	-	*- FL
5	1		*REAR FENDER (LH) (NPA)	Repair	-	*- FL
6	1		*REAR BUMPER (NPA)	Repair	-	*- FL
					Sub Total (S\$)	476.40 426.40
					- List Item Discount on L Items 20.00/20.00% (S\$)	69.28 69.28
					Total Parts (S\$)	407.12 357.12

No	Particulars	Lab.Type	Repairer's	Amount
Labour Items				
1	PANEL BEATING - Rear Bumper & Rear Fender Lh	New	500.00	200.00
2	SPRAY PAINTING CHARGE	New	750.00	600.00
3	TUFF KOTE	New	50.00	0.00
4	REAR WHEEL ALIGNMENT	New	120.00	0.00
Gross Labour Cost (\$)			1,420.00	800.00
