To Inspect Vehicle No: GBG 896X Insured: GRT 37242

Nissan Cabstar 30 C.C. 2953

Des. of Damages: ☒ Frt / ☒ Rear / O/S / N/S / U/C / Rooftop or

VEHICLE DAMAGE INSPECTION REPORT

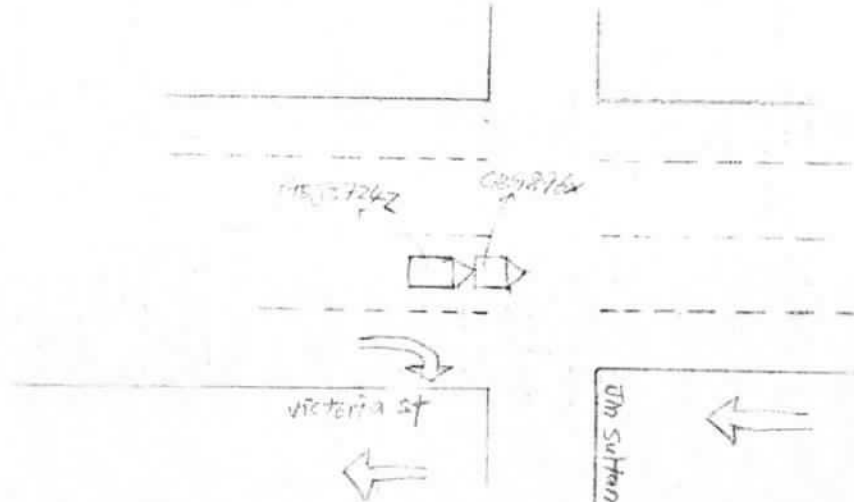
SKETCH PLAN

DESCRIBE CIRCUMSTANCES OF THE ACCIDENT

While GBG896X slowly stop at victoria st traffic junction, that's toward Kallang Road. Suddenly behind one of the van GBJ3724Z very strong hit to GBG896X, the impact force is very large, till GBG896X sliding out, so I'm try my best to brake for stop GBG896X, that's all.
