To Inspect Vehicle No: SKP 8625E

CMTD1903507

Volkswagen Touran

## VEHICLE DAMAGE INSPECTION REPORT

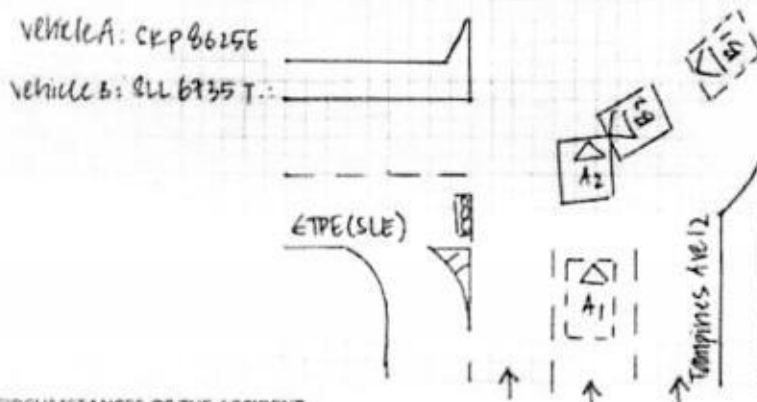
## SKETCH PLAN

on the stated date & time, I, vehicle 'A', CKP8625E, was travelling straight along the stated venue. As it was green light in my favour, I proceeded straight. Vehicle 'B', CLL6735T, turned out from the opposite direction on my right despite me having honk at her and her vehicle then collided onto my vehicles front right portion.
