To Inspect Vehicle No: SDQ 9928C

Claim No: SNM19D203078

Make: MERCEDES BENZ C180 Komp c.c 1597

VEHICLE DAMAGE INSPECTION REPORT

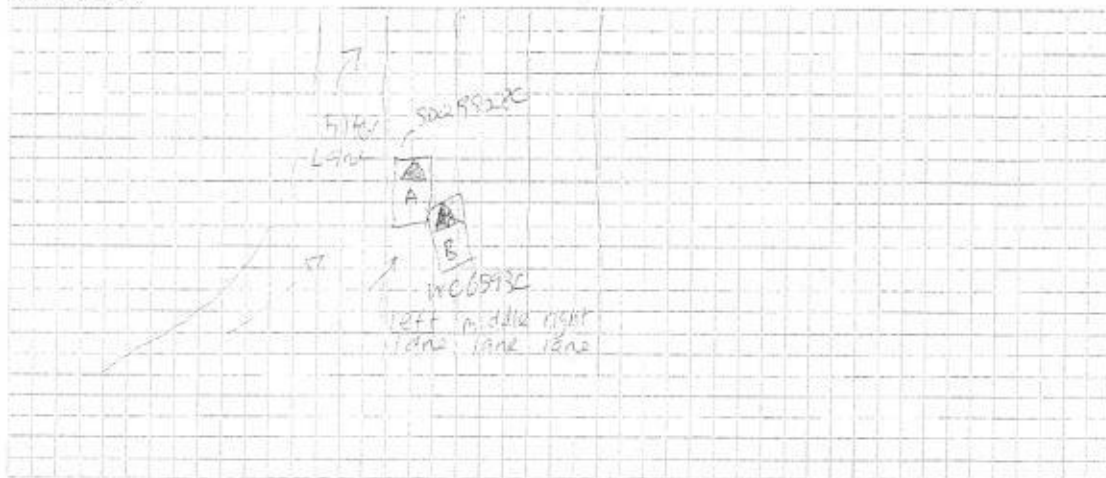
SKETCH PLAN

I was driving along Kallang Road/Sing Avenue where I then turned left to go to Sims Way. When there was no traffic, I filtered to the right successfully and then drive straight. A lorry, WC 6593C in the middle lane filtered to the left and hit my right-rear part of my car. The driver of WC 6593C is a foreign worker (Indian) and don't speak English properly.
