CS/CT/19013107/UT32

SMK 9960H

From: Elaine Cheong <elaine.cheong@sg.cntaiping.com>
Sent: Wednesday, 24 July 2019 3:51 PM
To: Hamzah; assignments
Cc: elmer@tanchong.com; mavis@tanchong.com
Subject: FW: OUR REF: SNM19D203418-CHEONGML - & YR REF: SMK9960H -Accident involving SMK9960H and GBE6275J on 20-7-2019. -PRS
Attachments: SMK9960H GIA REPORT 20.07.2019.pdf; smk9960h-estimate 200719.pdf

VEHICLE DAMAGE INSPECTION REPORT

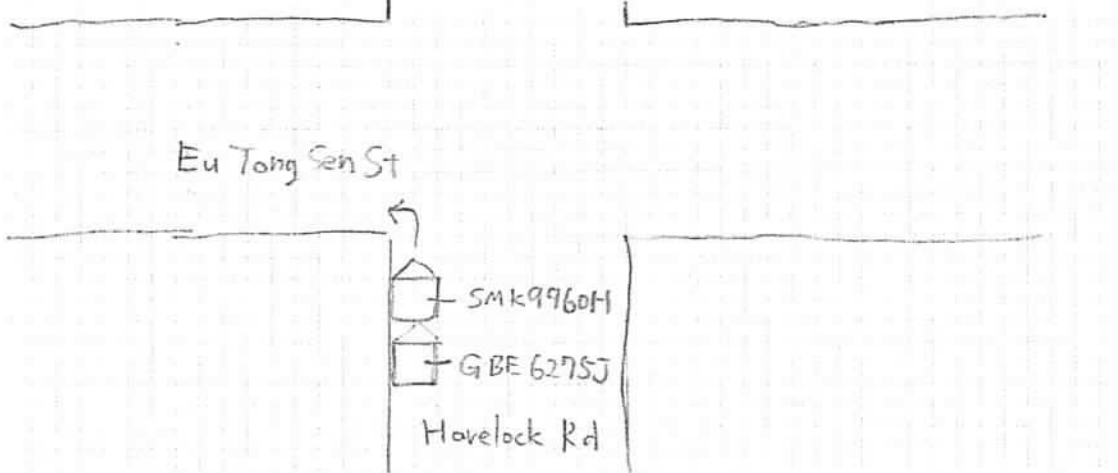
SKETCH PLAN

DESCRIBE CIRCUMSTANCES OF THE ACCIDENT

On 20 July 2019 at about 12.10pm, as my vehicle was about to turn into Eu Tong Sen Street, a vehicle GBE6275J suddenly hit onto the back of my vehicle causing damage to the back of my vehicle.
