ACCIDENT STATEMENT

ACCIDENT VEHICLE SURVEY REPORT

Vehicle Reg No.:	SJB4303X	Odometer:	240160km
Make & Model:	Honda Civic 1.8L A	Colour:	Black
Chassis number:	JHMFD16308S212221	Date of accident:	09/10/2017
Year of Regn.:	11/01/2008	Date inspected:	16/10/2017
Repairer at:	N-51 Automotive Pte Ltd 2 Kaki Bukit Ave 2 #01-18 Kaki Bukit Auto Hub Singapore 417921	Date inspected (After Repair):	20/10/2017

VEHICLE DAMAGE INSPECTION REPORT

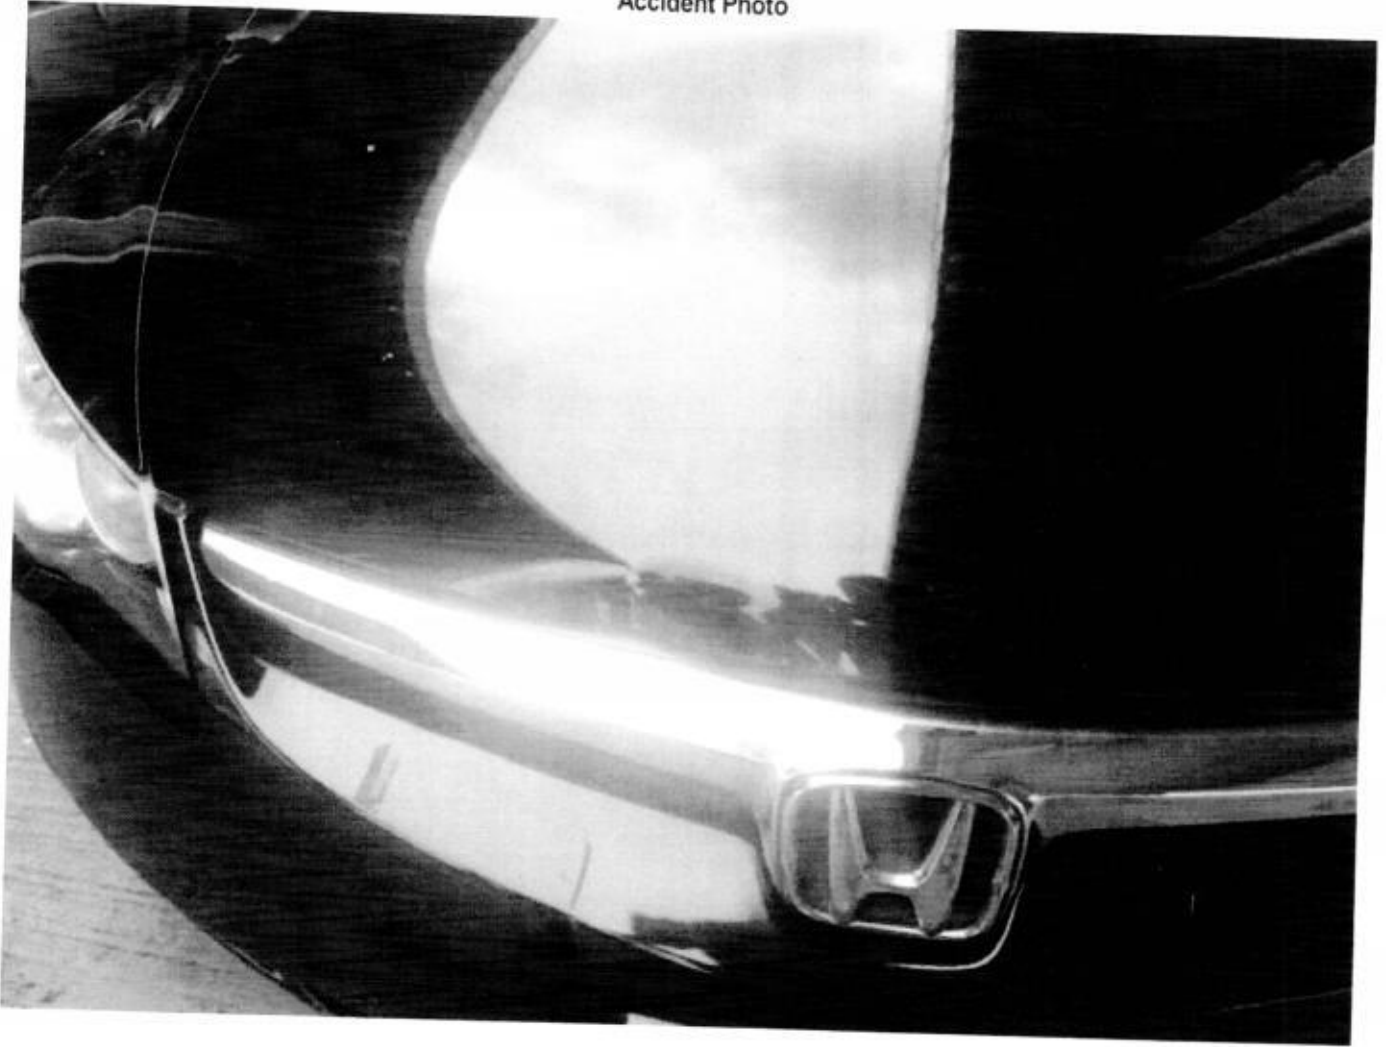
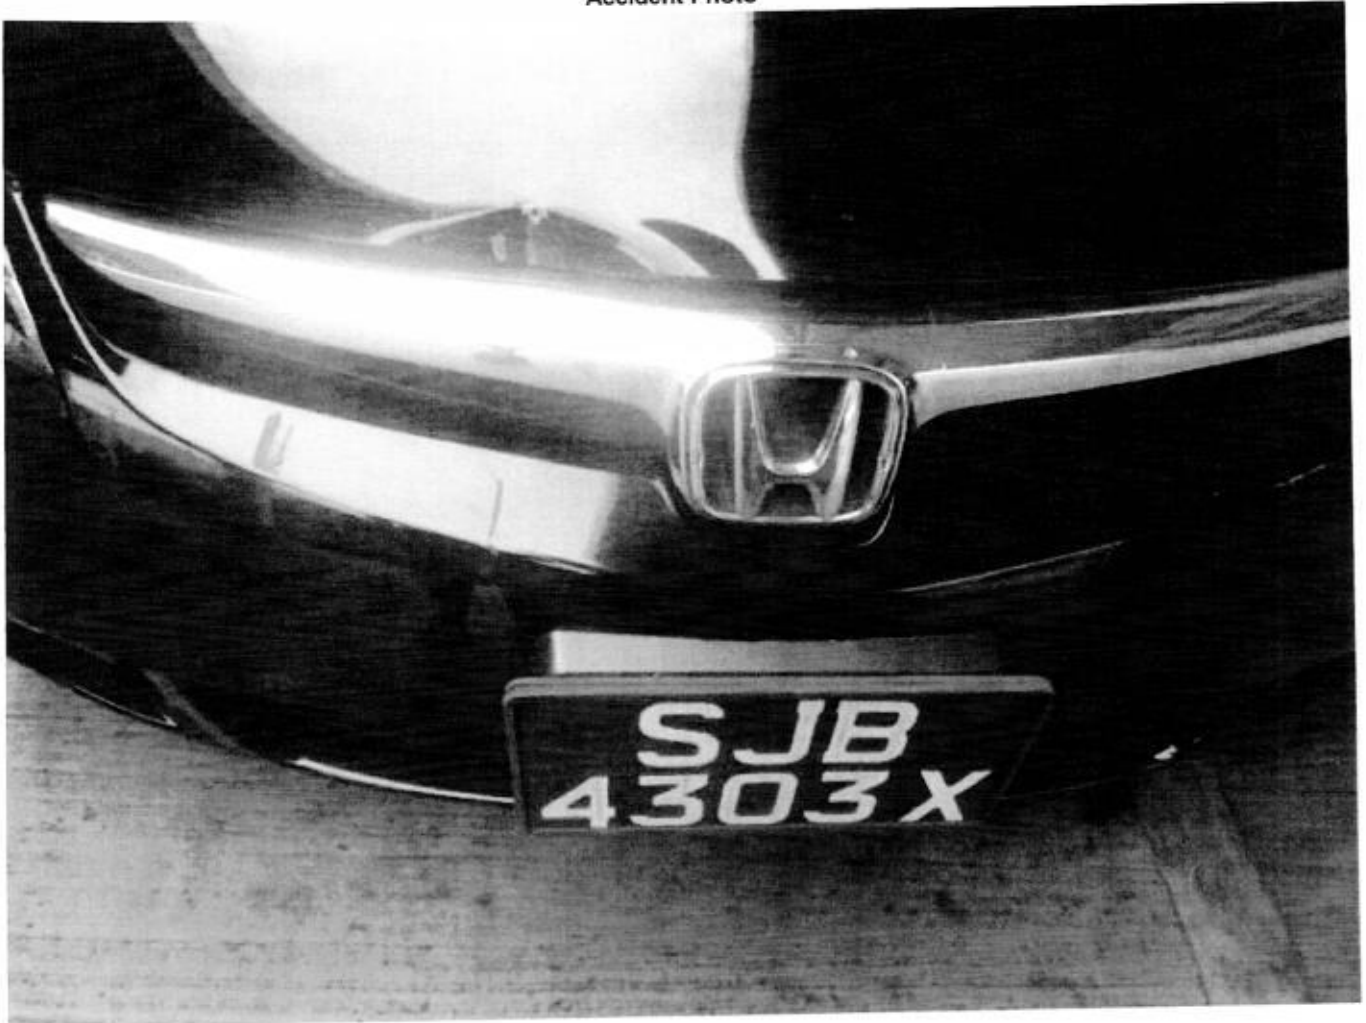
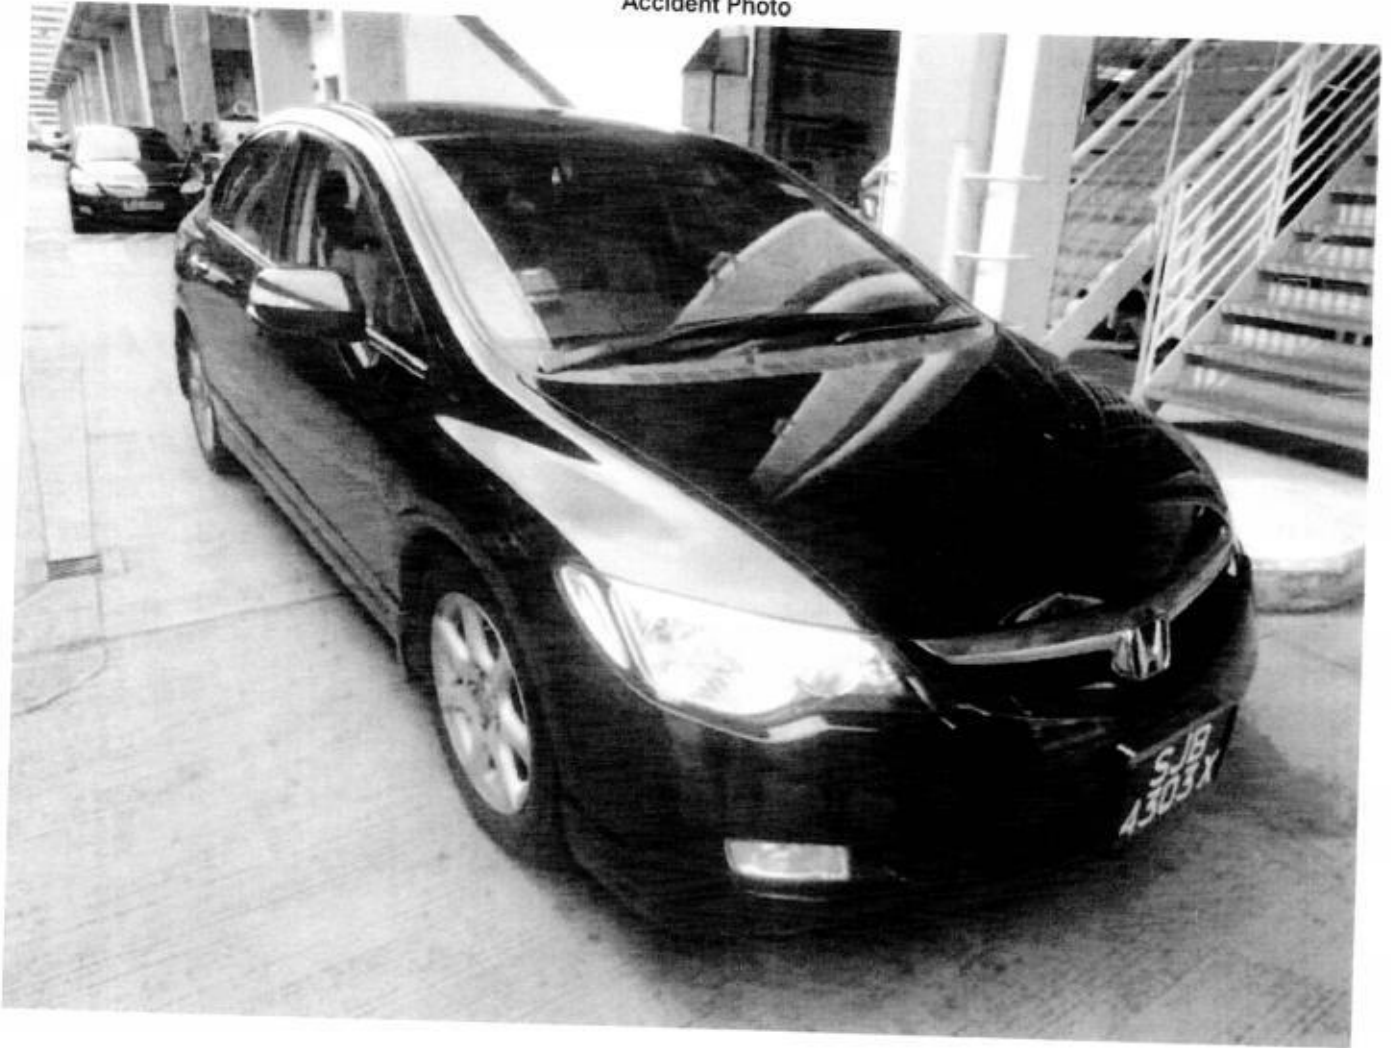
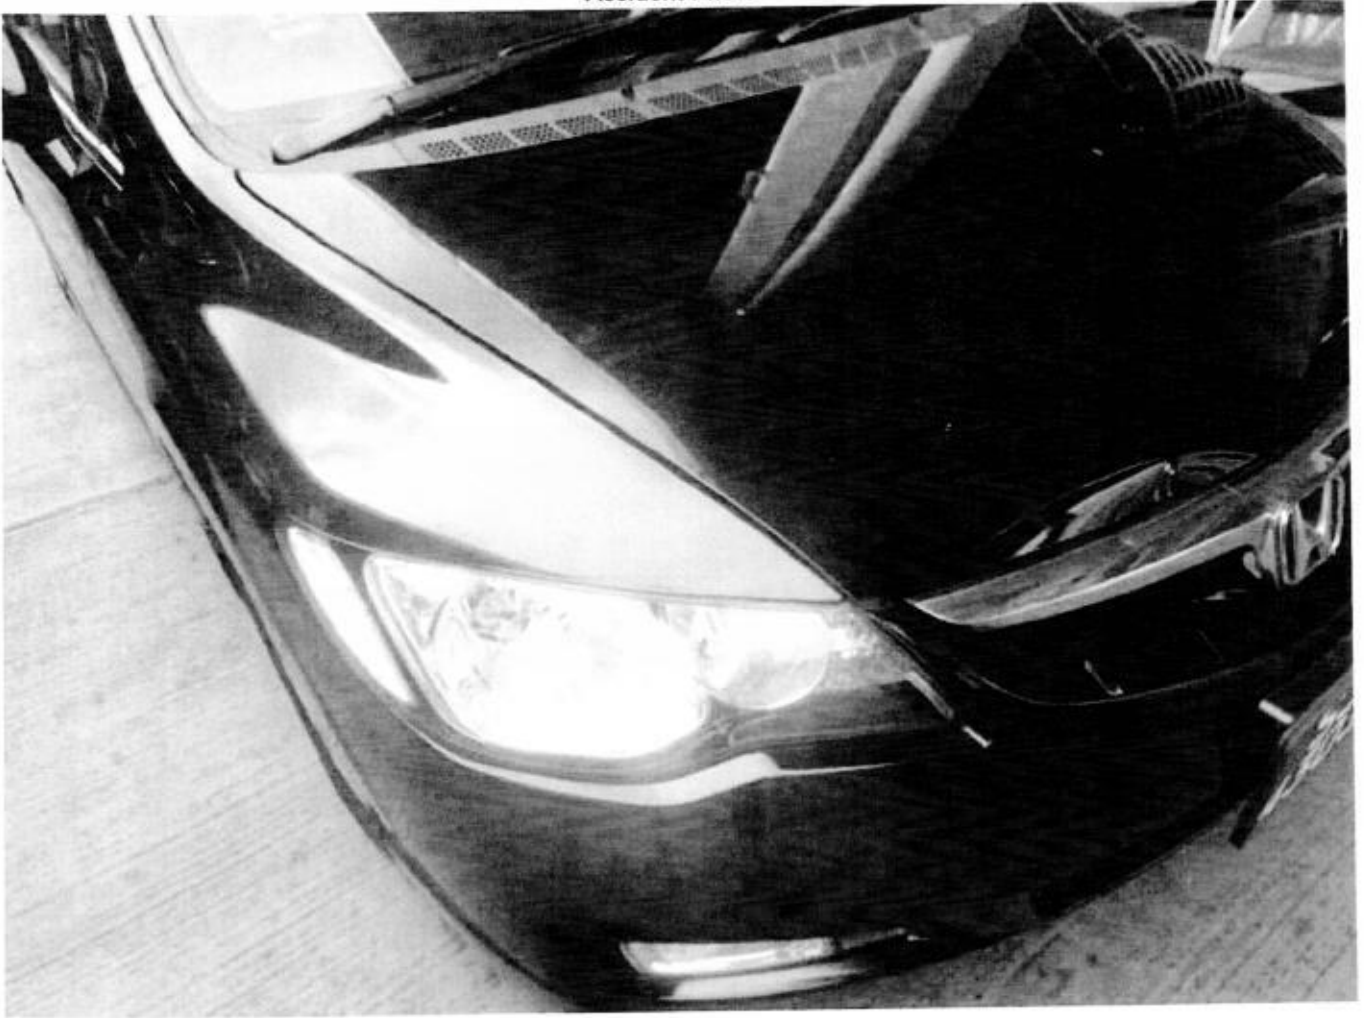
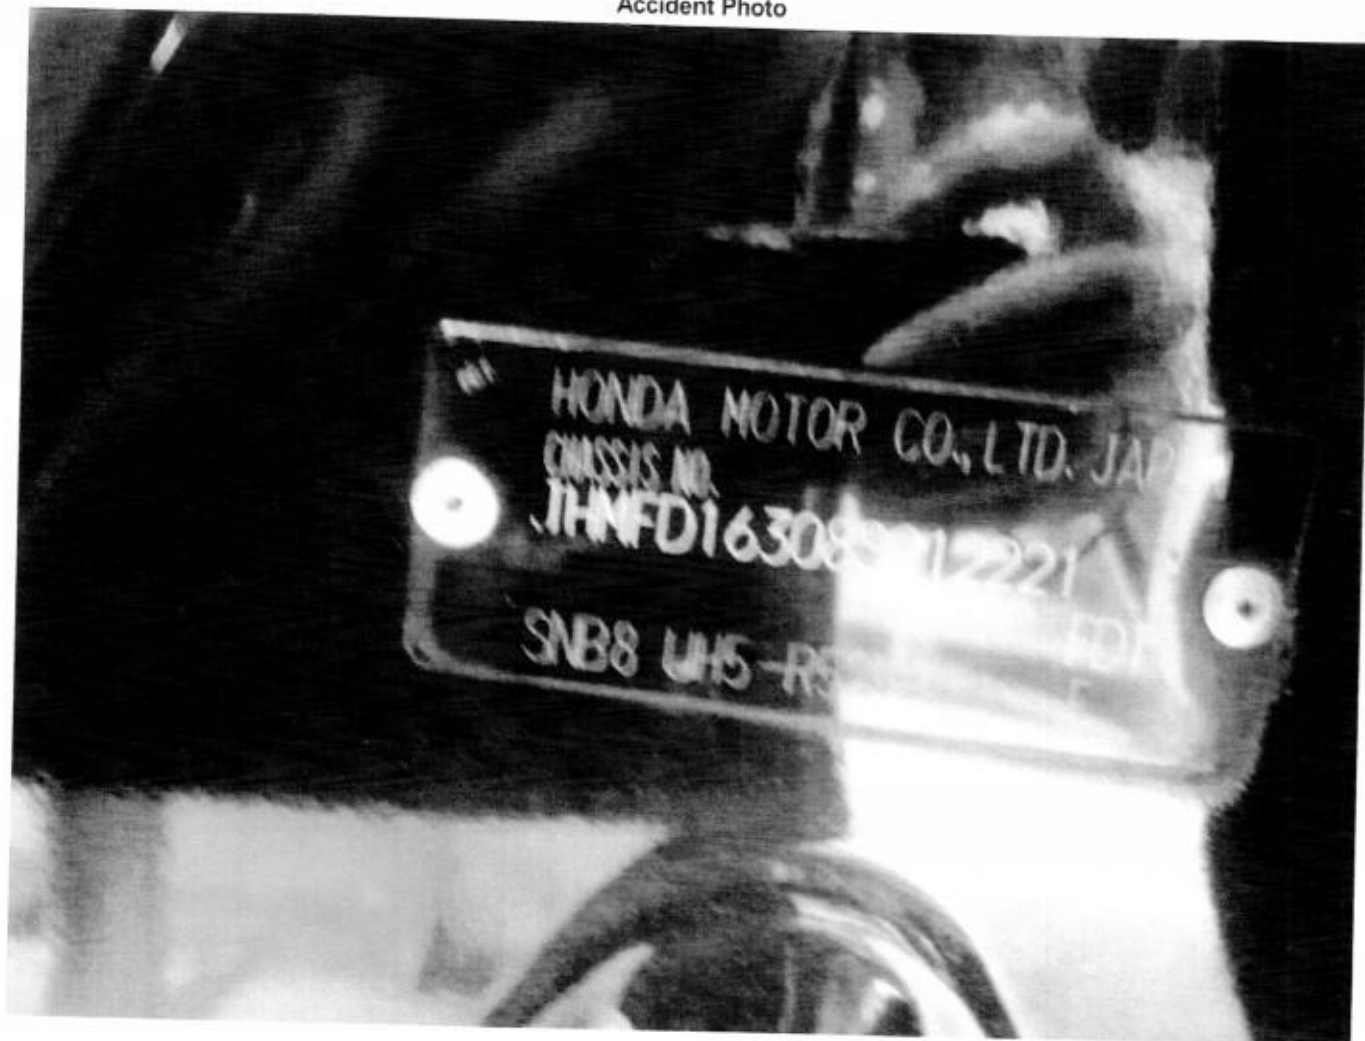
WHEN I WAS REVERSING MY VEHICLE AT WOODLANDS BLK 880. I ACCIDENTALLY HIT ONTO THE FRONT PORTION OF A PARKED VEHICLE. ATTENDED BY LYNDIA

Impact on the front portion.
Please see details as described in the Annex for parts and labour.

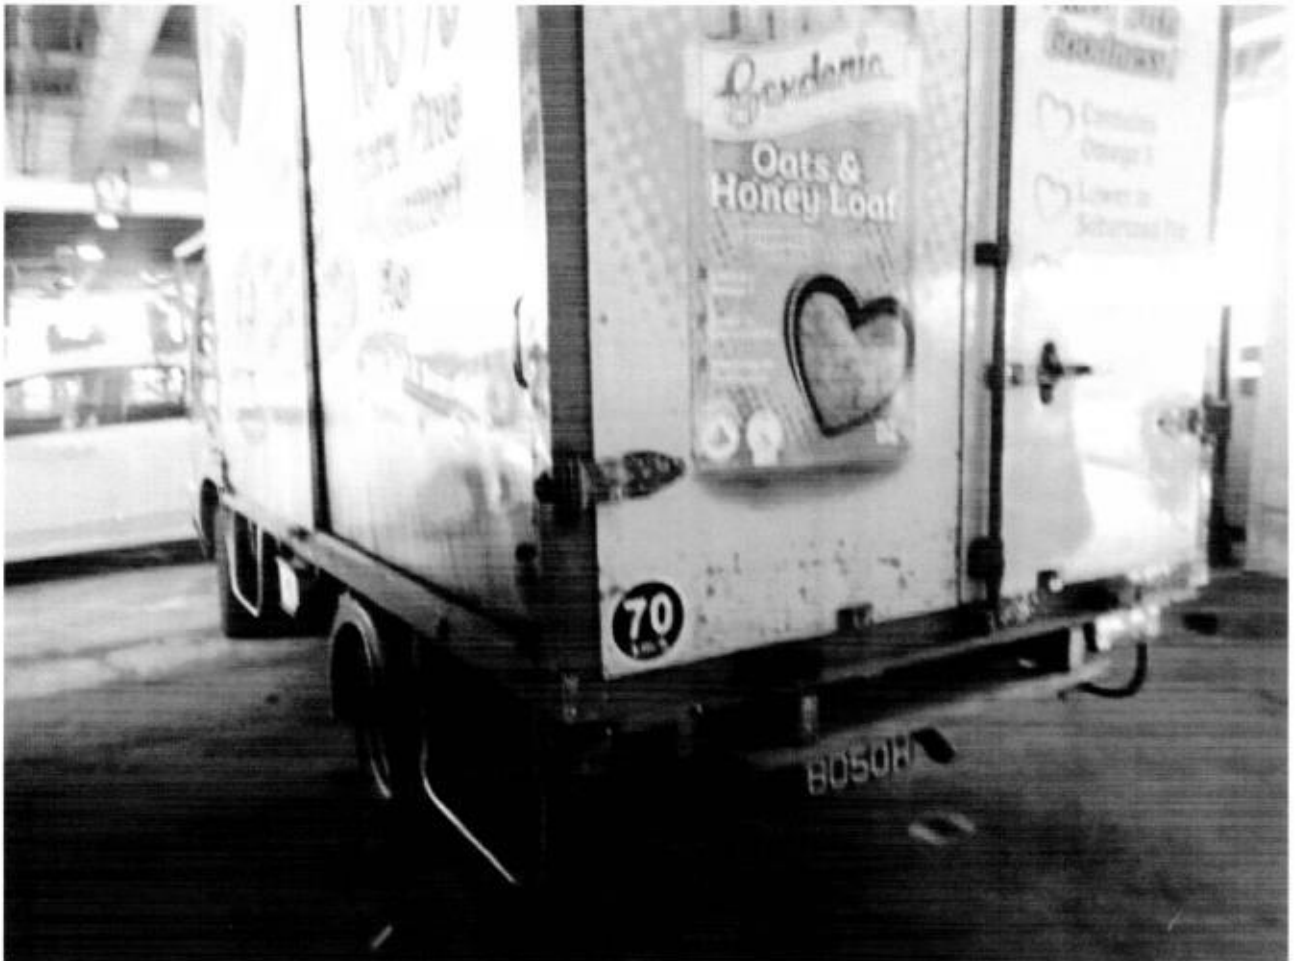
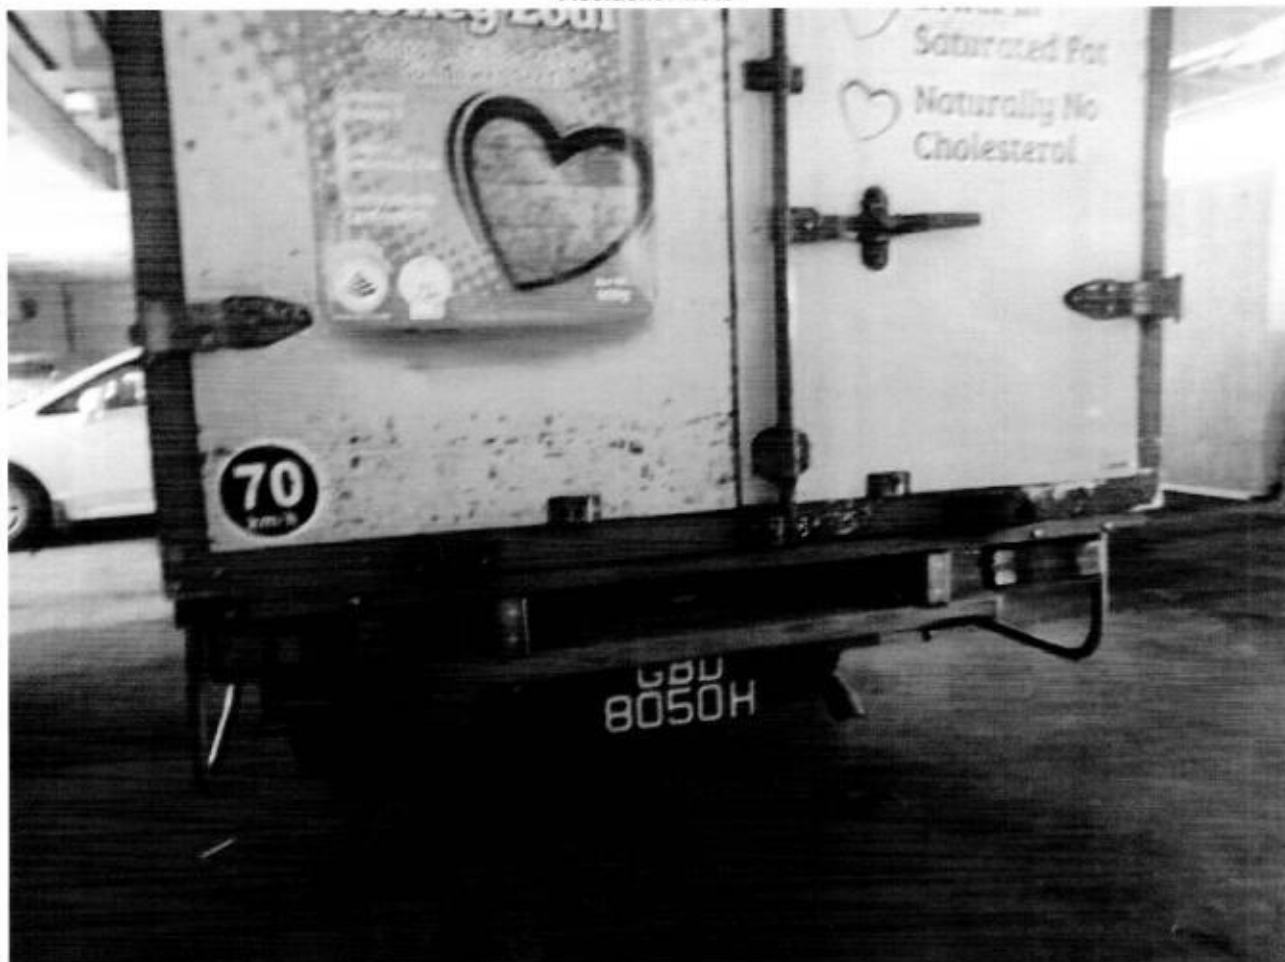
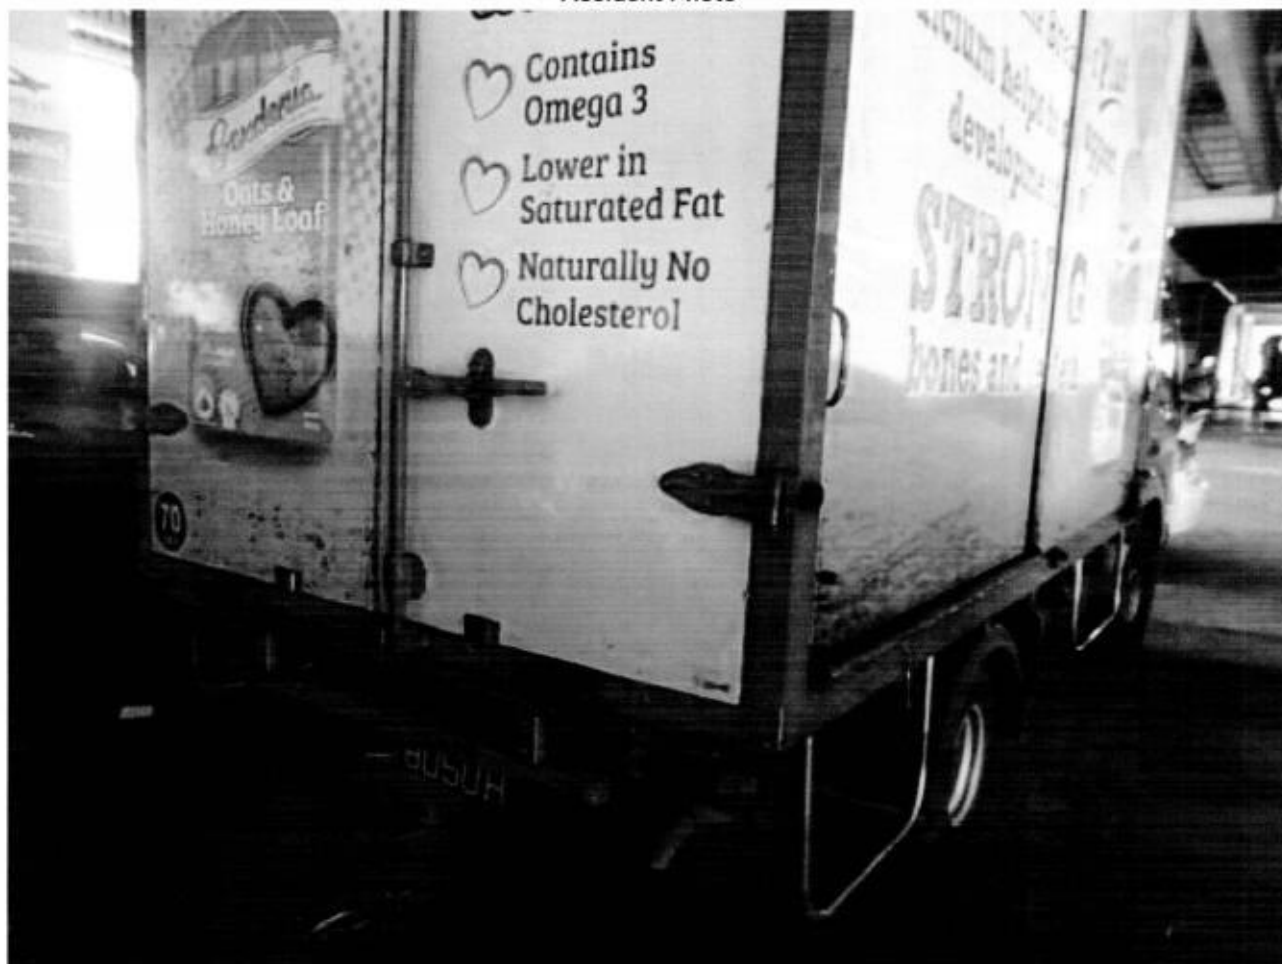
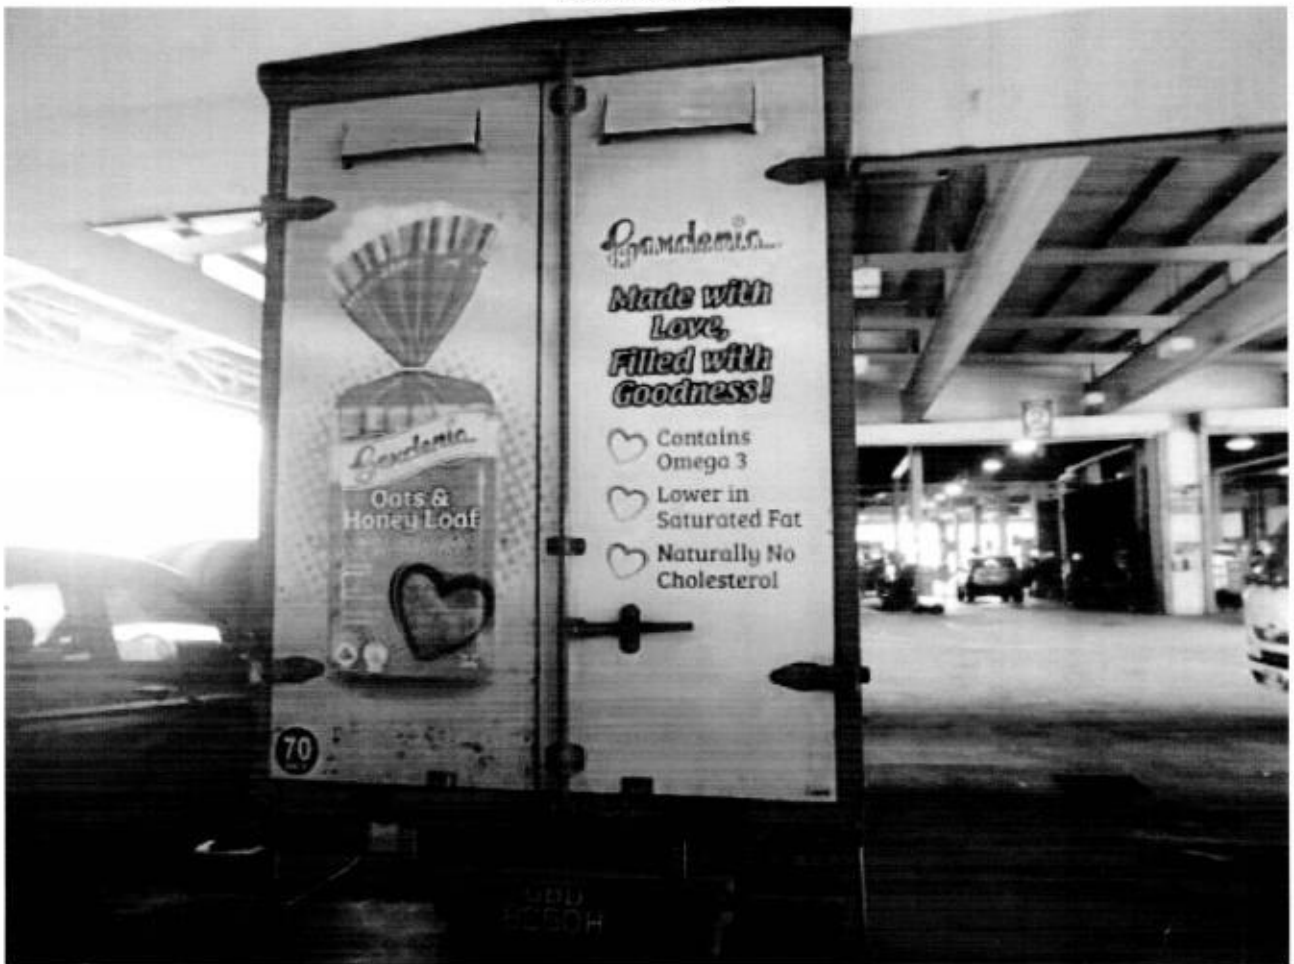
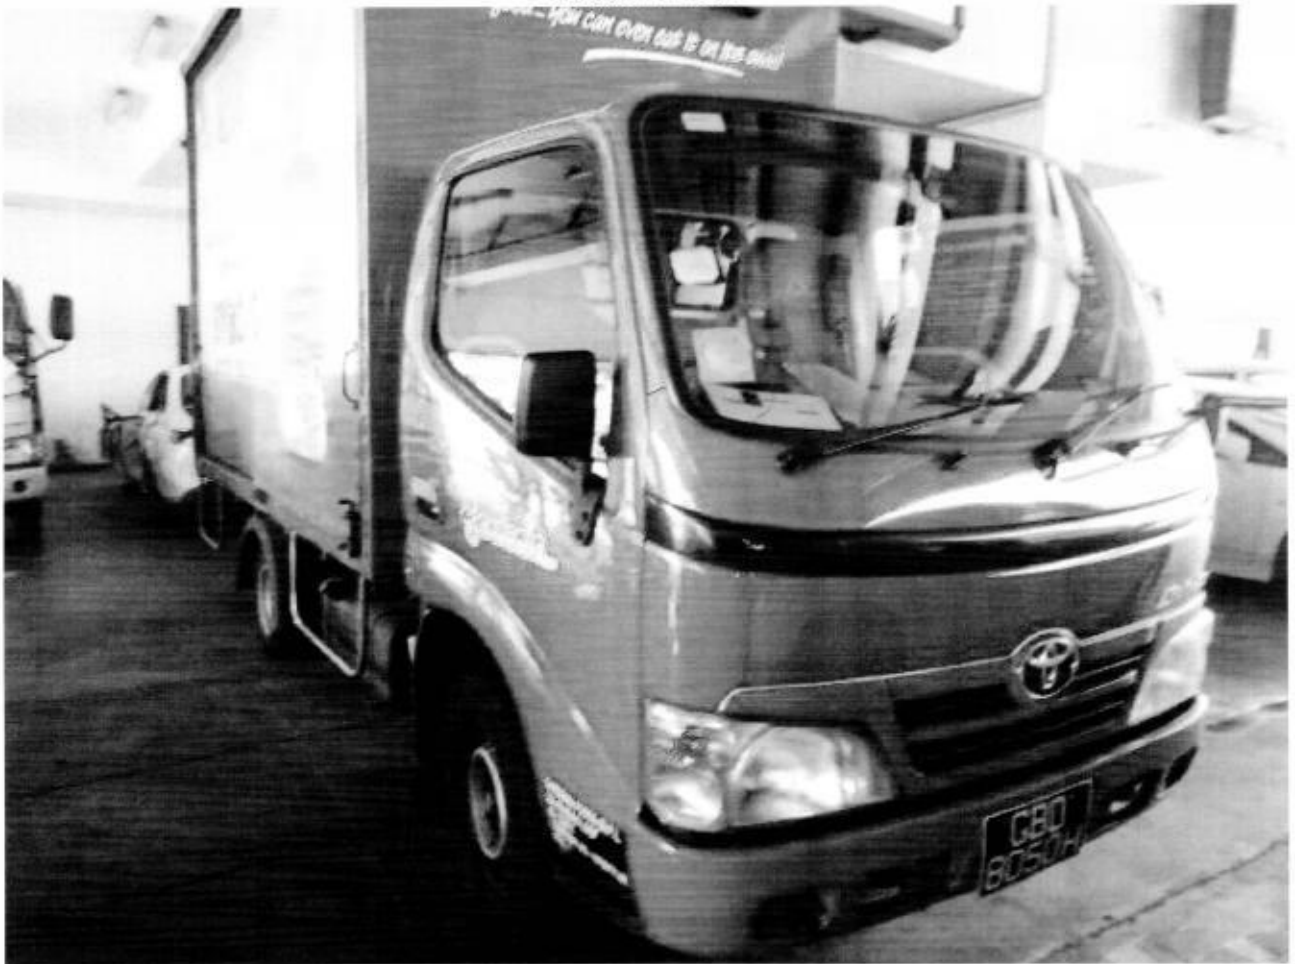
We had carried out re-inspection during works in progress and post repair inspection on the above vehicle. Attached in Annex B are the re-inspection photos, showing the work in progress and our re-inspection to the hidden part that were damaged.
