Veh No: SLF3224C Yr Regn: 2016 AugustType: M.Car / M.Cycle / Bus / Van / Lorry / Taxi / Prime Mover /

Make: Honda Vezel c.c 1496Colour: Black A/C: Insured / Std / NI / NASp.Reading: 168185 T/Radio: Insured / Std / NI / NA

The U/C / Chassis frame / Body Structure affected due to collision.

## VEHICLE DAMAGE INSPECTION REPORT

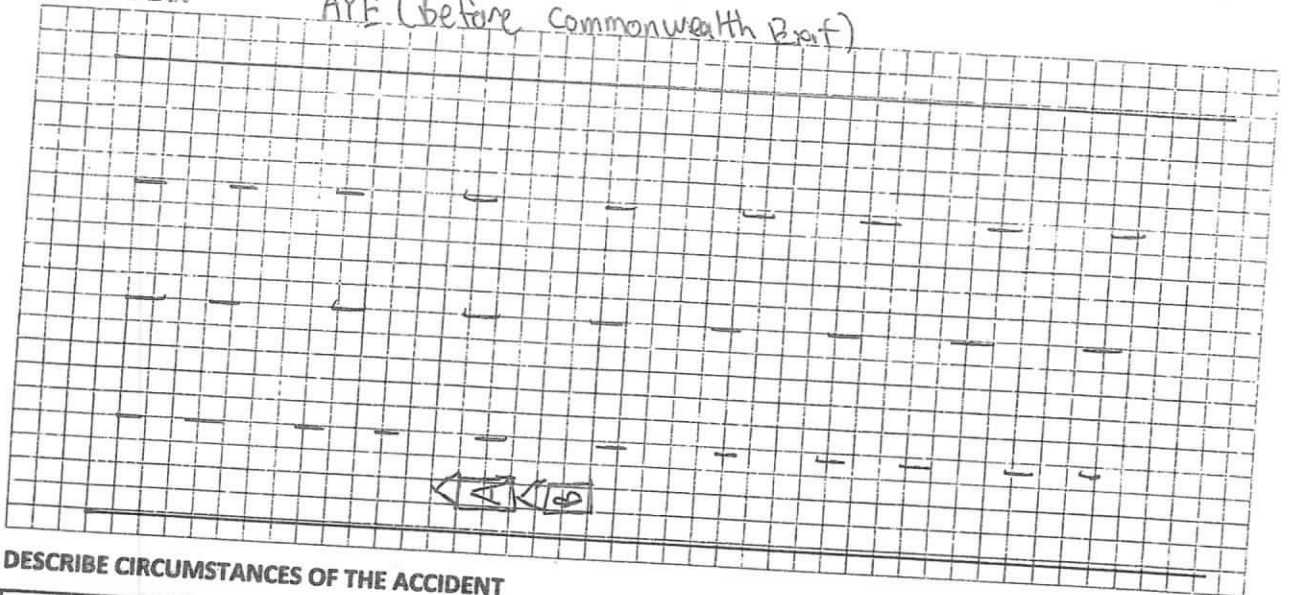
**SKETCH PLAN**

AYE (before Commonwealth Bort)

On the above mention date, time and location I was travelling on the extreme left lane, there was a heavy traffic during the point of time. when the car in front slowed down and came to a complete stop hence I followed suit. Suddenly I heard a loud bang, when I alighted from my vehicle 'A' I realised it was vehicle 'B' that had collided onto the rear portion of my vehicle 'A' causing damages to my vehicle 'B'.

Vehicle 'A' - SLF 3244G

Vehicle 'B' - GV2323G
