Date Of Report	01/08/2019 15:30
Date Of Accident	01/08/2019 13:25
Exact Location Of Accident	YISHUN AVE 1 X YISHUN ST 81
Country/State of Loss	SINGAPORE

1. Policy Particulars :- THIRD PARTY CLAIM			
Insured Veh.	GZ 1311B	Veh. Inspected	SHA 532G
Policy No.		Coverage (\$)	0.00
Claim No.	MT/1056277-002	Excess (\$)	0.00
Assign From		Assign Date	02/08/2019

4. Description of Damages			
THE VEHICLE SUSTAINED DAMAGES AT THE REAR PORTION. DAMAGES SEE DETAILS.			
5. General Information			
Accident Date	01/08/2019	Inspection Date	02/08/2019
Survey held at	COMFORTDELGRO ENGINEERING PTE LTD 59 LOYANG DRIVE SINGAPORE 508969		
5a. Remarks			
A)THE INSPECTION WAS CONDUCTED ON A"WITHOUT PREJUDICE" BASIS. B)IN ACCORDANCE TO YOUR INSTRUCTIONS, WE HAVE NOT AUTHORISED REPAIRS.			
5b. Estimate Days of Repair			
ESTIMATED NORMAL PERIOD FOR REPAIR:		3 Working Days

ADJUSTMENT ON REPAIR COST FOR VEHICLE NO. SHA 532G

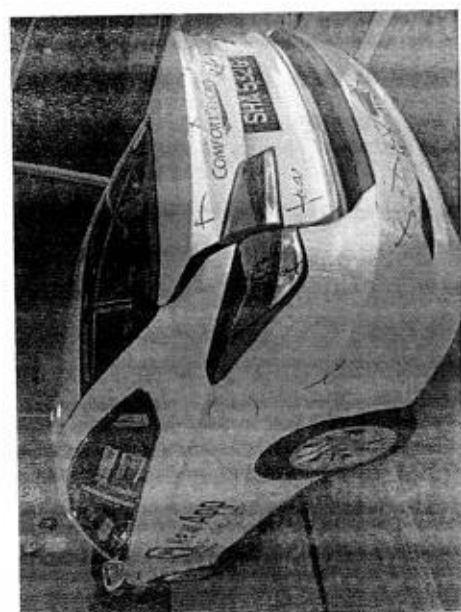
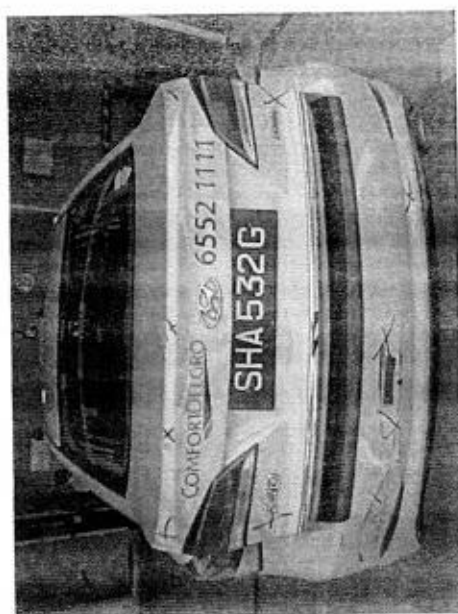
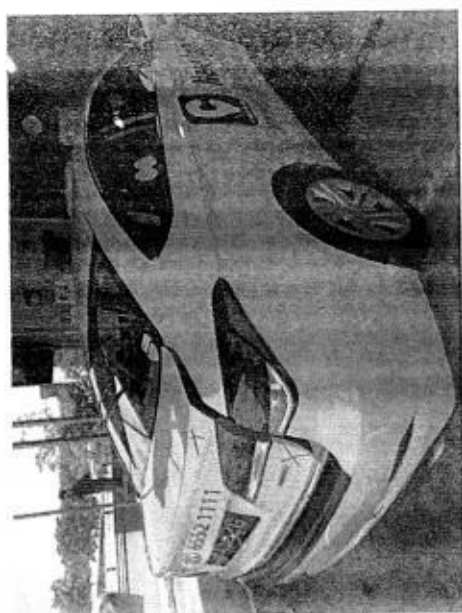
The U/C / Chassis frame / Body Structure affected due to collision.

Qty	Description of Parts	Condition	Estimate By Workshop (\$)	Our Adjusted (\$)
	<u>REPLACEMENT OF PARTS</u>			
1	BOOT LID	BUCKLED	2,174.90	2,174.90
1	BOOT LID LOCK UPPER	SERVICEABLE	102.60	-
1	BOOT LID LOCK LOWER	SERVICEABLE	31.70	-
1	BOOT LID "H" EMBLEM	NECESSARY	28.70	28.70
1	BOOT LID CRDI PLATE	NECESSARY	27.90	27.90
1	BOOT LID LAMP (LH)	SERVICEABLE	565.60	-
1	BOOT LID TRIMBOARD	SERVICEABLE	116.40	-
10	BOOT LID TRIMBOARD CLIPS	NOT NECESSARY	11.00	-
1	BOOTLID MOULDING	SERVICEABLE	85.00	-
1	BOOTLID I40 EMBLEM	NECESSARY	27.90	27.90
1	BOOTLID LOWER GARNISH	TO REPAIR SEE LABOUR	227.90	-
1	REAR BUMPER	DEFORMED	553.00	553.00
1	REAR BUMPER REINFORCEMENT	SERVICEABLE	428.40	-
2	REAR BUMPER REINFORCEMENT BRACKET (LH/RH) @\$80.30	SERVICEABLE	160.60	-
10	REAR BUMPER CLIP	NECESSARY	22.00	22.00
2	REAR BUMPER BRACKET @\$35.60	SERVICEABLE	71.20	-
1	REAR BUMPER SPONGE	SERVICEABLE	103.50	-
1	REAR BUMPER UNDER COVER	CUT	228.00	228.00

1	REAR BUMPER REFLECTOR LAMP (LH)	SERVICEABLE	30.60	-
1	TAIL LAMP (LH)	TO REPAIR SEE LABOUR	697.80	-
1	REAR PANEL	TO REPAIR SEE LABOUR	526.70	-
1	REAR PANEL GARNISH	NOT NECESSARY	57.70	-
1	REAR PANEL LOWER PANEL	TO REPAIR SEE LABOUR	89.40	-
1	EXHAUST PIPE INSULATOR,LH	SERVICEABLE	58.55	-
1	EXHAUST SILENCER,LH	BENT	967.70	967.70
1	EXHAUST PIPE HANGER,LH	SERVICEABLE	58.55	-
1	EXHAUST PIPE CENTRE	BENT	730.10	730.10

Qty	Description of Parts	Condition	Estimate By Workshop (\$)	Our Adjusted (\$)
	LESS 20% DISCOUNT		-1,636.68	-952.04
			6,546.72	3,808.16
	<u>SPECIAL NETT ITEMS</u>			
1	BOOT LID COMFORT LOGO & TEL NO STICKER (SN)	NECESSARY	30.00	30.00
1	REAR BUMPER REVERSE SENSOR (SN)	SHORTED	135.70	135.70
1	REAR BUMPER RUBBER MAT (SN)	NECESSARY	50.00	50.00
			215.70	215.70
	<u>LABOUR</u>			
	PANEL BEATING.INCLUSIVE OF THE REPAIR OF BOOTLID LOWER GARNISH,TAIL LAMP (LH),REAR PANEL AND REAR PANEL LOWER PANEL.		800.00	400.00
	SPRAY PAINTING CHARGE.		900.00	600.00
	WIRING CHARGE.		50.00	20.00
	TUFF KOTE.		50.00	20.00
	REMOVE/REFIX REVERSE SENSOR.		80.00	30.00
			1,880.00	1,070.00
	GRAND TOTAL		8,642.42	5,093.86
	RECOMMENDED COST OF LUMP SUM REPAIRS (TO ITS PRE-ACCIDENT CONDITION) (CONFIRMED)			4,050.00
