1. Policy Particulars :- THIRD PARTY CLAIM

4. Description of Damages

THE VEHICLE SUSTAINED DAMAGES AT THE O/S FRONT PORTION.
DAMAGES SEE DETAILS.

ADJUSTMENT ON REPAIR COST FOR VEHICLE NO. SHC 8595L

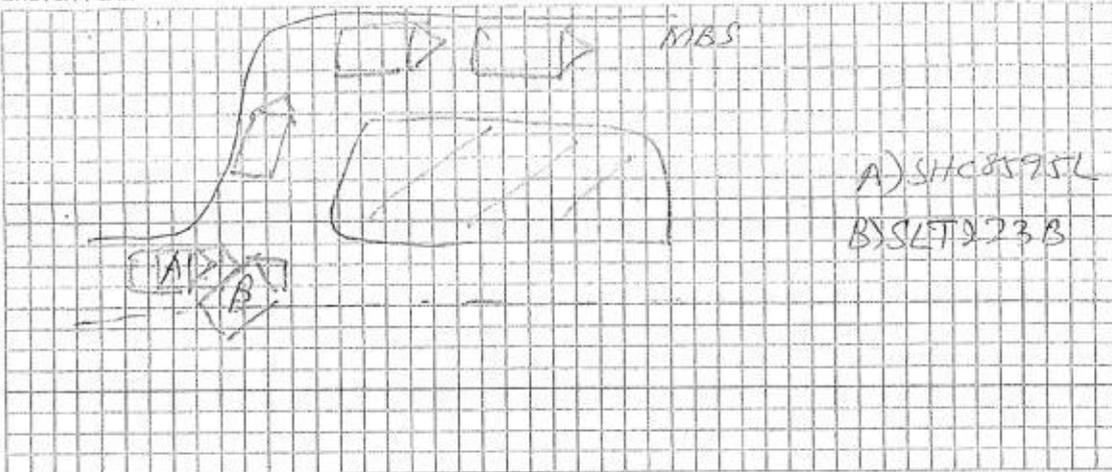
SKETCH PLAN

On 3/8/19 at about 2305hr when I Veh A just moved forward after picking up a passenger, Veh B suddenly overtook my vehicle to enter the convention hall (MBS) and collided on to the right front portion of my vehicle. Veh B sustained damage on the ~~door~~ left ^{rear} door portion.
