Insured Veh.	XD 6365C	Veh. Inspected	SH 9647H
Policy No.	5094305615-01	Coverage (\$)	0.00
Claim No.	MT/1056824-002	Excess (\$)	0.00
Assign From		Assign Date	07/08/2019

Make & Model	HYUNDAI IONIQ	c.c	1580
Engine No.	HIDDEN	Year of Reg.	2018
Chassis No.	KMHC851CVKU115143	Colour	BLUE
Odometer	106770	Steering	IN ORDER
Brakes	IN ORDER	Modification	STANDARD ALLOY RIM
General	FAIR

THE VEHICLE SUSTAINED DAMAGES AT THE O/S FRONT PORTION AND O/S BODY.
DAMAGES SEE DETAILS.

ADJUSTMENT ON REPAIR COST FOR VEHICLE NO. SH 9647H

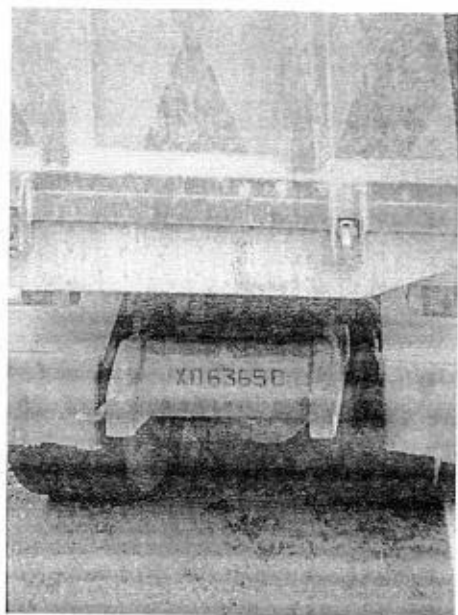
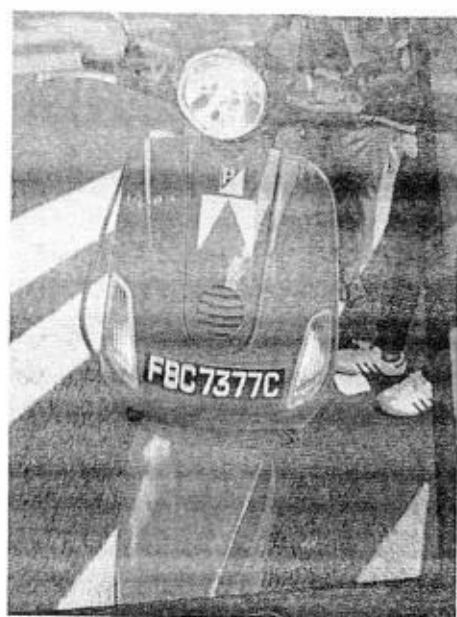
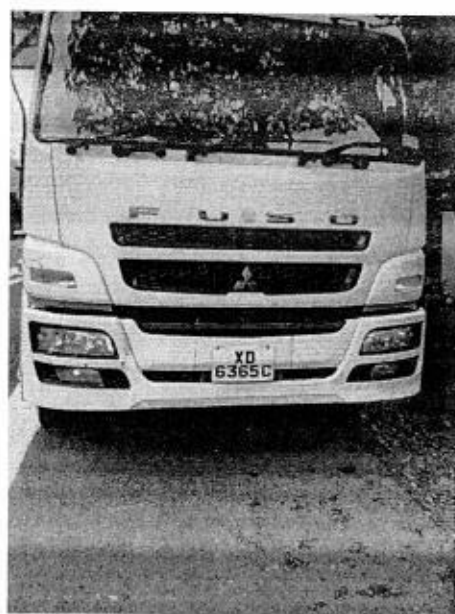
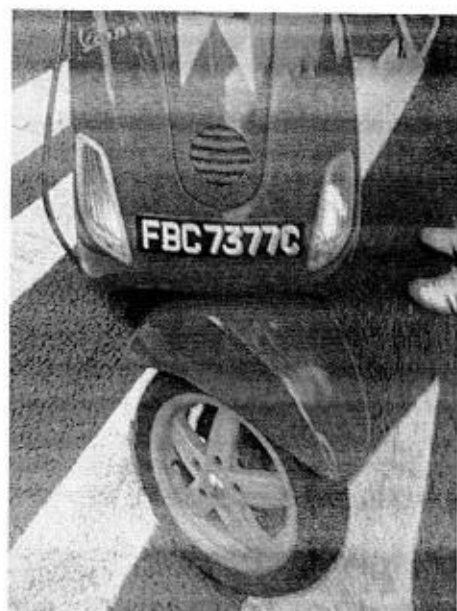
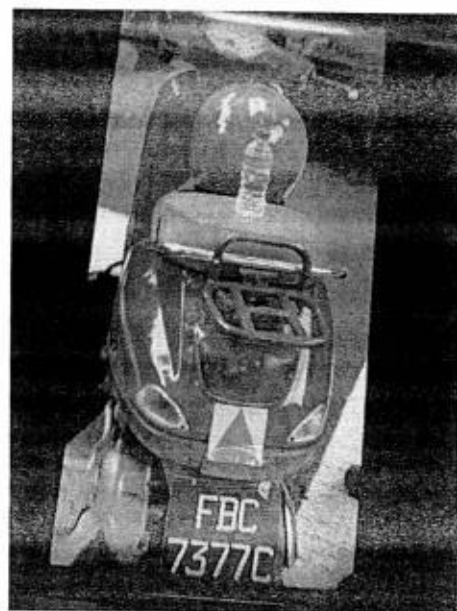
Remark: The veh had commenced its
repair at the time of inspection.

On 6/8/19 at about 1300hrs while I Veh A was travelling along lane 2 noticed Veh C colliding with Veh D. I immediately swayed left to avoid a frontal contact and collision. However, Veh B fell onto the side and contacted the right front portion of my vehicle. Shortly after, Veh B collided onto the left whole side of my vehicle. My vehicle ^{also} sustained damage on the right front.

REPAIR - whole Left, Right Front
LRR/K-dm

1. The repair job shall bill to: NTUC XD6365C
2. The finalized amount shall be:
 - (a) Spare Parts after List discount \$3,375.88
 - (b) Labour Charges \$1,540.00
 - Total for Part-By-Part Repair Cost** \$4,915.88
 - (c) Lumpsum Repair (if applicable)
Total for Lumpsum repair cost after Less: _____
Final Lumpsum Repair cost _____
