NTUC INCOME INSURANCE CO-OPERATIVE LTD Ref: NS/INC19013957/K1sf3n2

1. Policy Particulars :- THIRD PARTY CLAIM

THE VEHICLE SUSTAINED DAMAGES AT THE FRONT PORTION. DAMAGES SEE DETAILS.

ADJUSTMENT ON REPAIR COST FOR VEHICLE NO. SHC 3085A

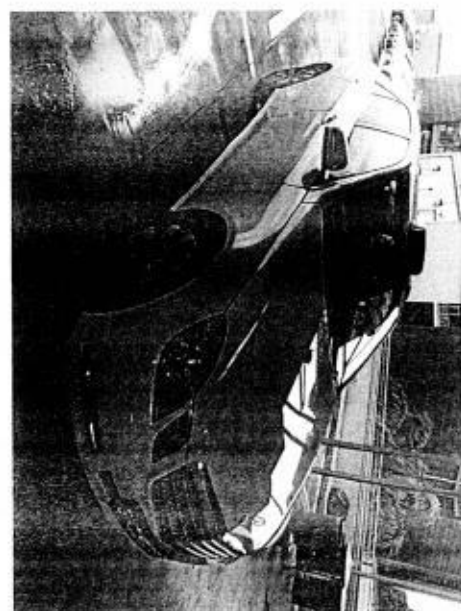
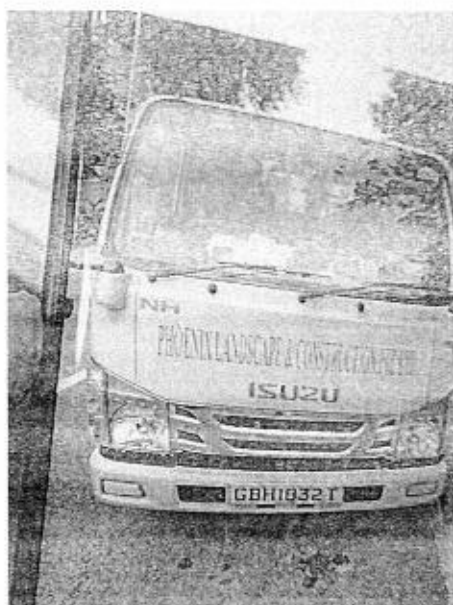
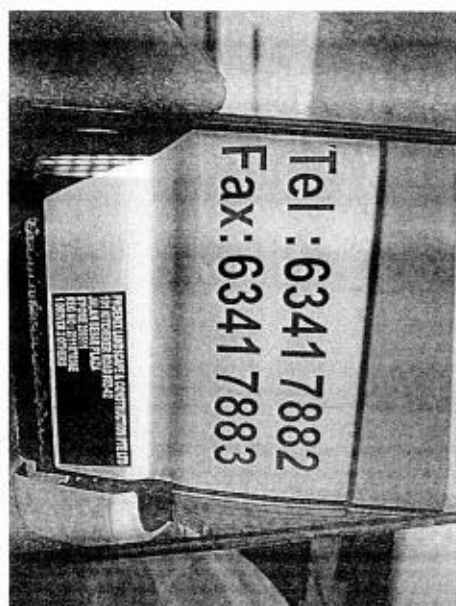
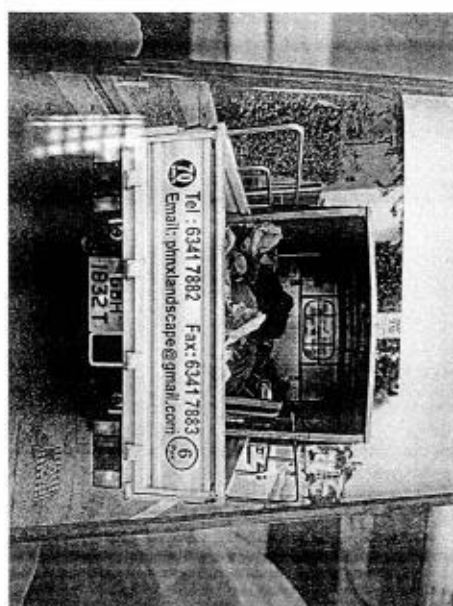
The UIC / Chassis frame / Body Structure affected due to collision.

Qty	Description of Parts	Condition	Estimate By Workshop (\$)	Our Adjusted (\$)
	<u>REPLACEMENT OF PARTS</u>			
1	BUMPER ASSY,FRT	CRACKED	1,890.50	1,890.50
1	RADIATOR GRILLE (E6)	CRACKED	1,220.00	1,220.00
1	RADIATOR GRILLE STAR LOGO	NOT NECESSARY	170.00	-
1	RADIATOR GRILLE ADJUSTER BRACKET	SERVICEABLE	685.70	-
1	BONNET ASSY	BUCKLED	2,850.60	2,850.60
1	BONNET MERCEDES STAR LOGO	NECESSARY	112.00	112.00
2	BONNET STOPPER SPRING (LH/RH) @\$385.00	SERVICEABLE	770.00	-
2	BONNET LOCK SENSOR (LH/RH) @\$285.50	SERVICEABLE	571.00	-
1	BONNET CENTRE LOCK	SERVICEABLE	95.00	-
1	BONNET LOCK, TOP	SERVICEABLE	94.00	-
2	BONNET LOCK LOWER @\$92.00	SERVICEABLE	184.00	-
1	BONNET CATCH HANDLE	SERVICEABLE	29.50	-
	LESS 10% DISCOUNT		-867.23	-607.31
			7,805.07	5,465.79
	<u>LABOUR</u>			
	PANEL BEATING.		800.00	300.00
	SPRAY PAINTING CHARGE.		600.00	400.00
	WIRING CHARGE.	NOT NECESSARY	50.00	-
	TOWING CHARGES.		50.00	-
	TUFF KOTE.		50.00	20.00

REMOVE/REFIX RADIATOR.	NOT NECESSARY	90.00	-
	REMOVE/REFIX AIRCON & REFILL GAS.	NOT NECESSARY	150.00	-
	-		-	-
	-		-	-
			1,790.00	720.00
	GRAND TOTAL		9,595.07	6,185.79
	RECOMMENDED COST OF LUMP SUM REPAIRS (TO ITS PRE-ACCIDENT CONDITION) (CONFIRMED)			4,450.00
