REF: NS/NC 19014105/klvf352

### 1. Policy Particulars :- THIRD PARTY CLAIM

### 4. Description of Damages

## ADJUSTMENT ON REPAIR COST FOR VEHICLE NO. SHC 8949A

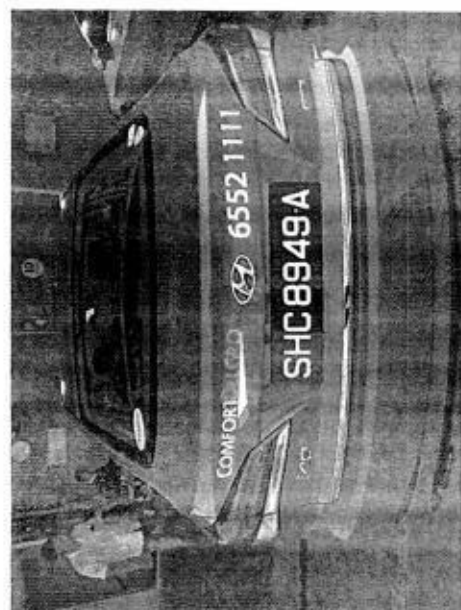
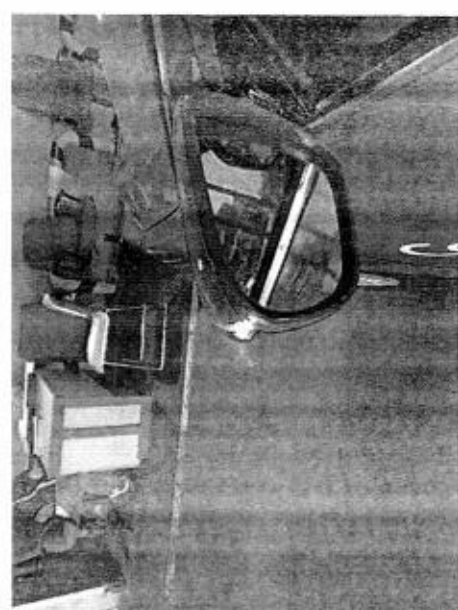
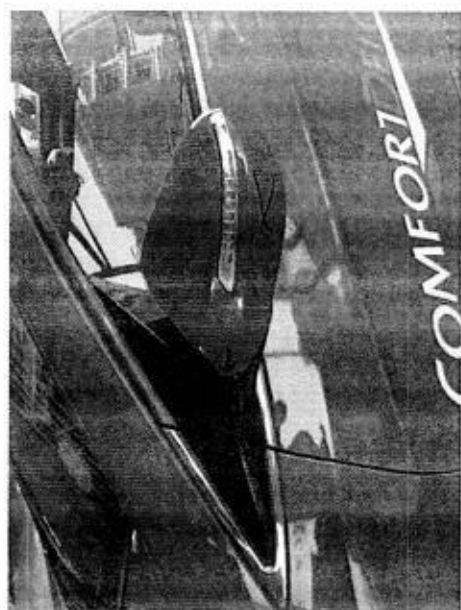
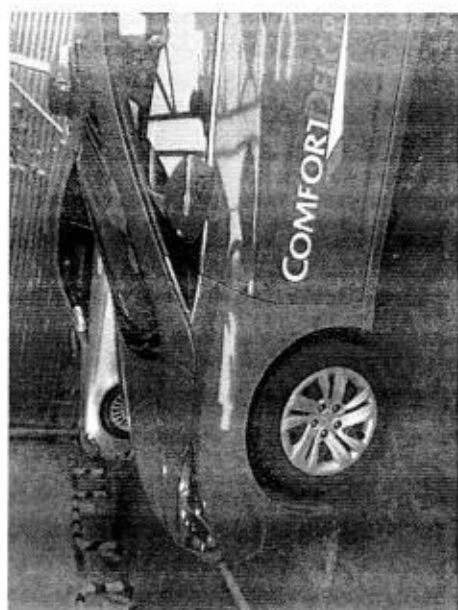
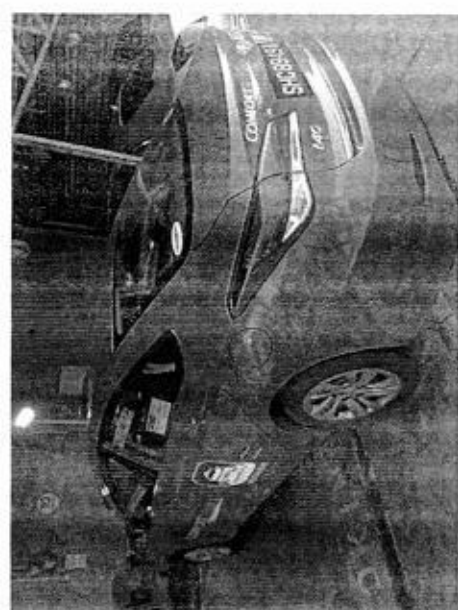
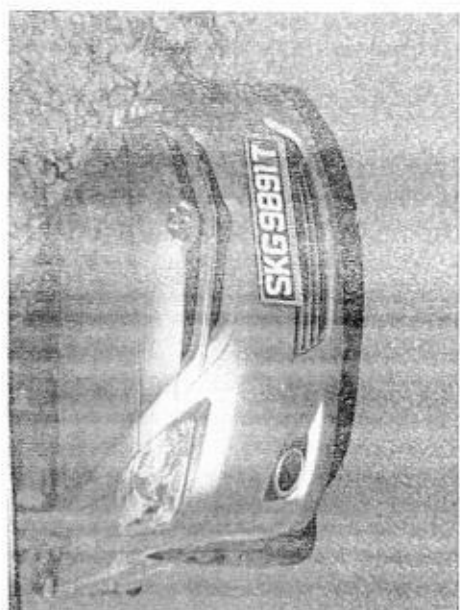
Vehicle Registration Number	SKG9891T
Vehicle Make/Model/Colour	
Details Of Properties	
Vehicle Category	PRIVATE CAR
Name of Driver	
NRIC/Passport Number	
Contact Number	
Address	
Postcode	
Insurance Company Name	
Nature Of Damage	RHT WING MIRROR

As I was driving suddenly a vehicle of SKG9891T encroached onto my lane and hit onto my left wing mirror.

THE VEHICLE SUSTAINED DAMAGES AT THE N/S WING MIRROR. DAMAGES SEE DETAILS.
---

Qty	Description of Parts	Condition	Estimate By Workshop (\$)	Our Adjusted (\$)
1	<b>REPLACEMENT OF PARTS</b>	CUT		
	I40VC MIRROR ASSY-O/S REA		670.00	670.00
	LESS 20% DISCOUNT		-134.00	-134.00
			536.00	536.00
	<b>LABOUR</b>			
	PANEL BEATING.		100.00	50.00
	SPRAYPAINT CHARGE.		100.00	50.00
			200.00	100.00
<b>GRAND TOTAL</b>			<b>736.00</b>	<b>636.00</b>
<b>RECOMMENDED COST OF LUMP SUM REPAIRS (TO ITS PRE-ACCIDENT CONDITION) (CONFIRMED)</b>				<b>500.00</b>
