TP Claims against NTUC Income: Follow-Through Survey

1. Policy Particulars :- THIRD PARTY CLAIM

ADJUSTMENT ON REPAIR COST FOR VEHICLE NO. SH 9008C

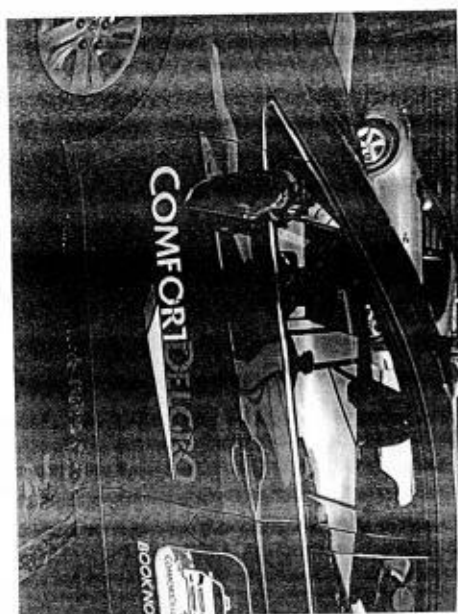
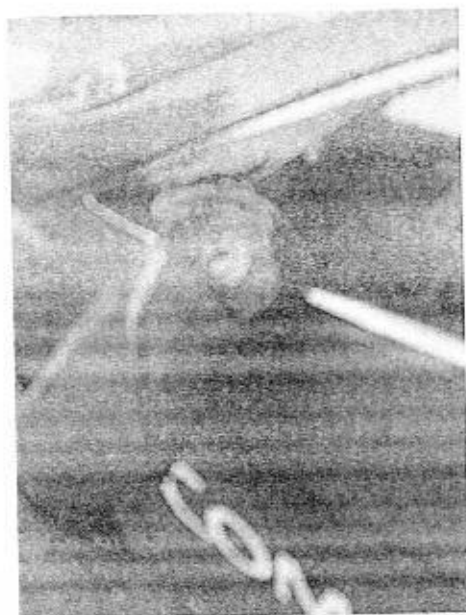
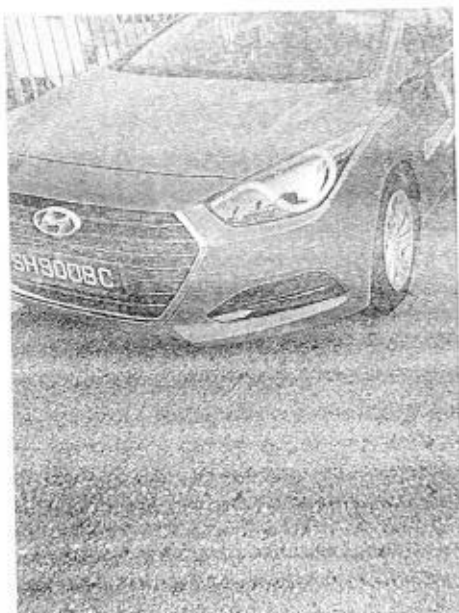
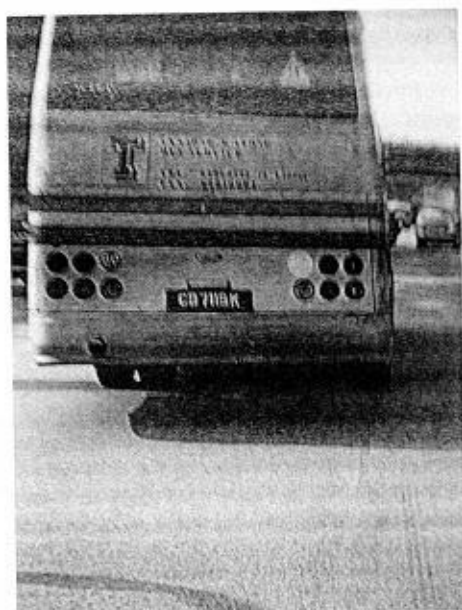
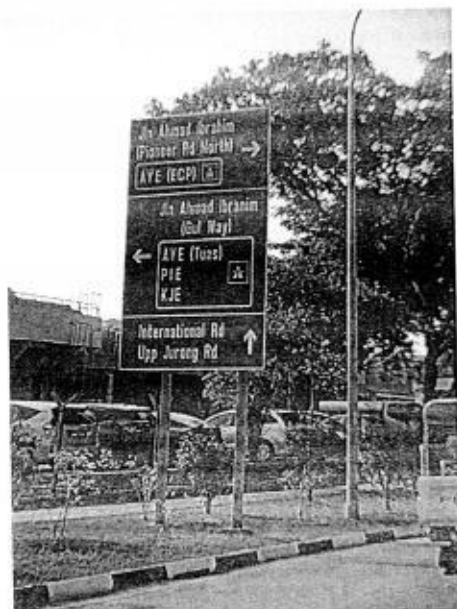
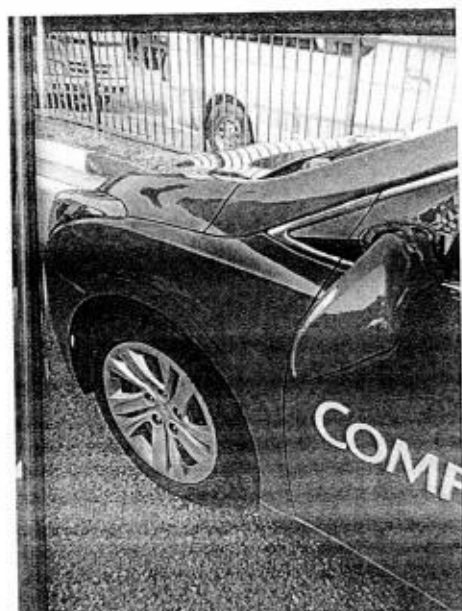
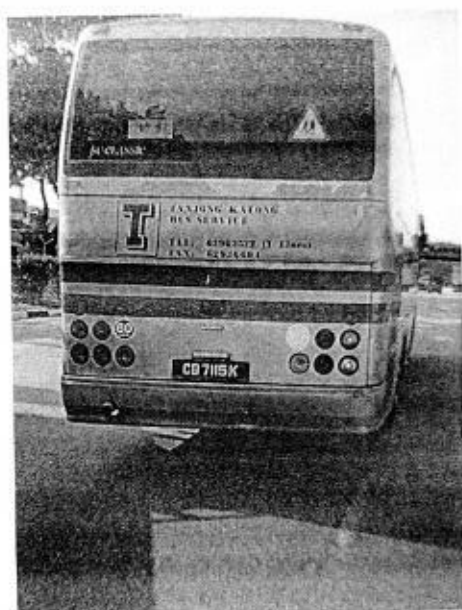
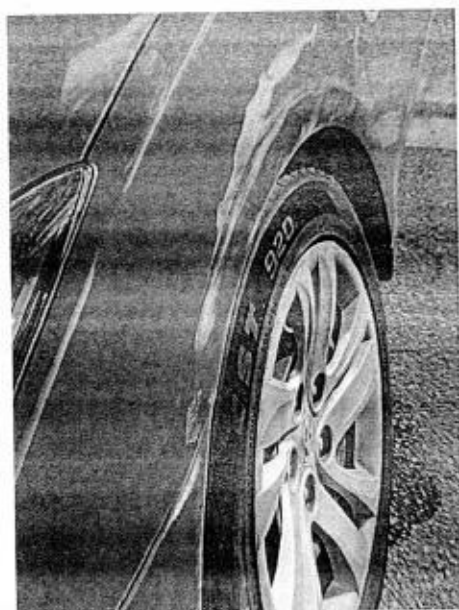
THE VEHICLE SUSTAINED DAMAGES AT THE N/S BODY. DAMAGES SEE DETAILS.
--

Qty	Description of Parts	Condition	Estimate By Workshop (\$)	Our Adjusted (\$)
<u>REPLACEMENT OF PARTS</u>				
1	FRONT BUMPER COVER	TO REPAIR SEE LABOUR	1,052.20	-
1	FRONT BUMPER SIDE BRACKET-LH	SERVICEABLE	24.60	-
1	FRONT BUMPER TOP BRACKET-LH	SERVICEABLE	22.40	-
10	FRONT BUMPER CLIPS @\$2.20	NOT NECESSARY	22.00	-
1	SIDE MIRROR-LH	BROKEN	670.00	670.00
1	FRONT FENDER-LH	TO REPAIR SEE LABOUR	566.30	-
1	FRONT FENDER SHIELD-LH	SERVICEABLE	174.90	-
1	FRONT WHEEL COVER-LH	SERVICEABLE	107.10	-
1	FRONT DOOR (LH)(NPA)	TO REPAIR SEE LABOUR	-	-
1	REAR DOOR (LH)(NPA)	TO REPAIR SEE LABOUR	-	-
	LESS 20% DISCOUNT		-527.90	-134.00
			2,111.60	536.00
<u>SPECIAL NETT ITEMS</u>				
1	FRONT DOOR COMFORTDELGRO STICKER-LH (SN)	NECESSARY	75.00	75.00
1	REAR DOOR COMFORTDELGRO STICKER-LH (SN)	NECESSARY	80.00	80.00

155.00	155.00
<u>LABOUR</u>				
	PANEL BEATING.INCLUSIVE OF THE REPAIR OF FRONT BUMPER COVER,FRONT FENDER-LH,FRONT DOOR (LH) AND REAR DOOR (LH).		600.00	200.00
	SPRAY PAINTING (BUMPER,FENDER,MIRROR,DOOR).		750.00	650.00
	TUFF KOTE.	NOT NECESSARY	50.00	-
	WIRING CHARGE.		50.00	30.00
			1,450.00	880.00
GRAND TOTAL			3,716.60	1,571.00

RECOMMENDED COST OF LUMP SUM REPAIRS (TO ITS PRE-ACCIDENT CONDITION) (CONFIRMED)			1,250.00
--	--	--	----------
