## VEHICLE DAMAGE INSPECTION REPORT

Our File No: CS/TMI19014600/K1TF3E2

Claimant Vehicle No : SHC8801S

Make &amp; Model: HYUNDAI I40, 1.7 D CRDi (A)

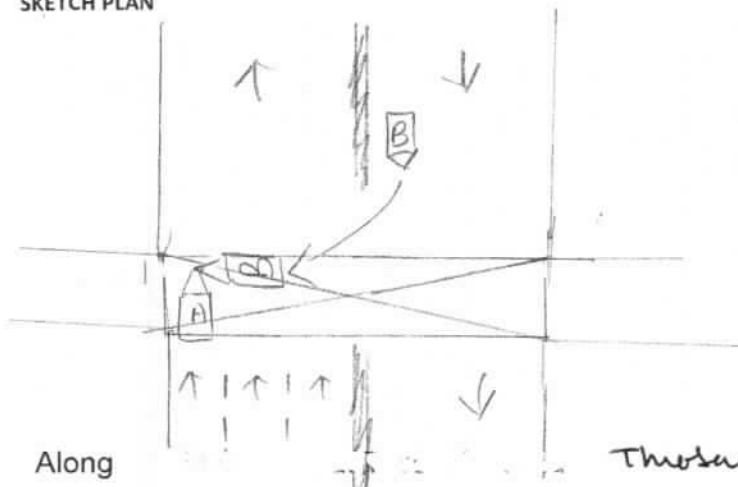
## SKETCH PLAN

A - SHC 8801S  
B - SGG 9386H

On 19.08.2019 at about 15:05 hours I was travelling along <u>Thoson Rd Towards</u>
<u>Moulmein Rd</u> with no passenger onboard .
While travelling straight on the extreme left lane , suddenly veh B ( SGG 9386H )
made a u-turn and collided into my taxi A - <u>Right Portion</u> .
As it took place too fast I could not take evasive action to prevent the accident .
I have company and photos and video at scene to support my claims .
No injury in this accident .
Veh B ( SGG 9386H ) - Mr Mohamed Azhar Bin Mohamed Yusoff H/P : 9856 3356

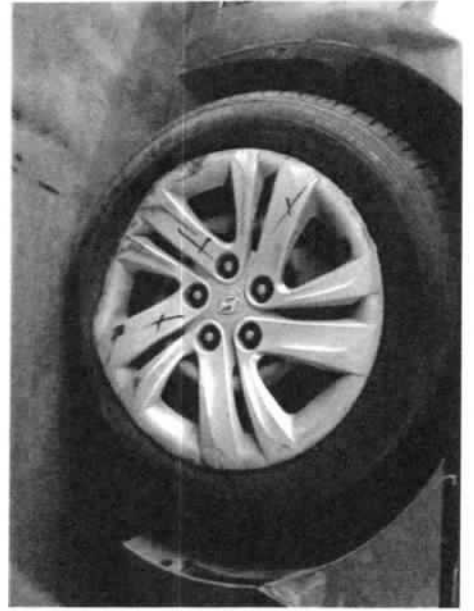
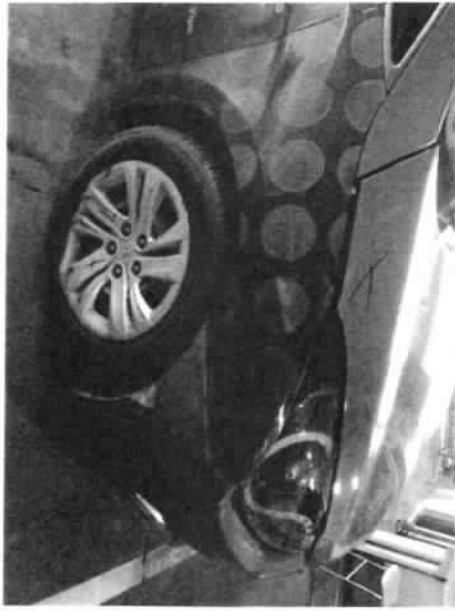
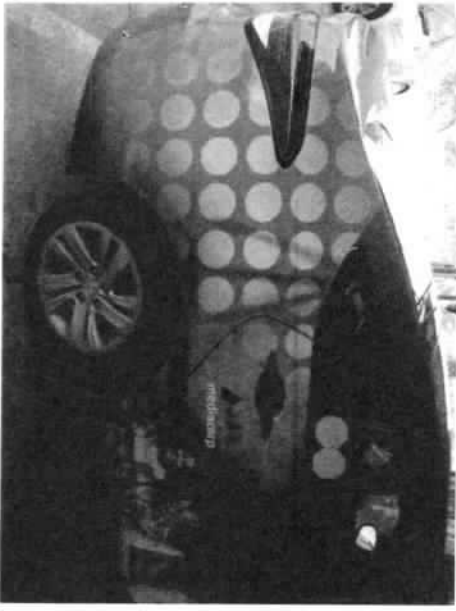
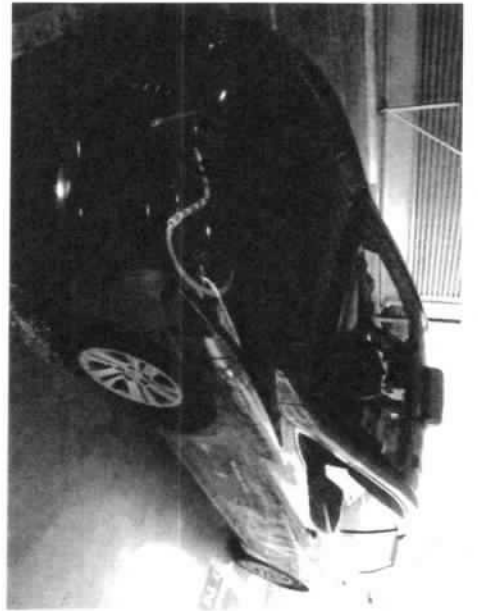
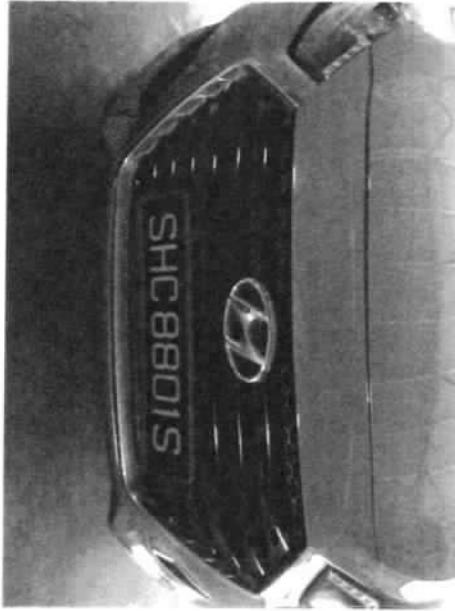
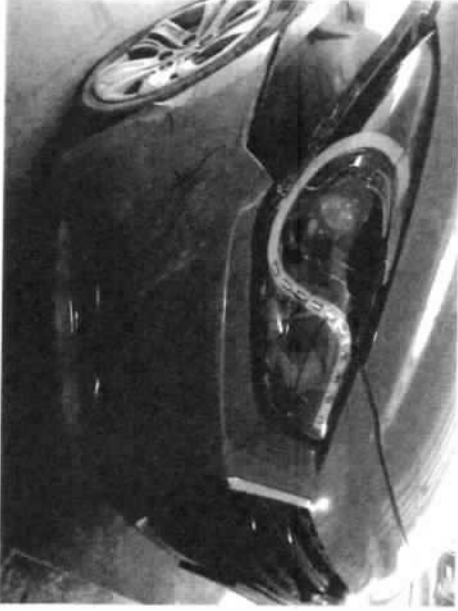
Des. of Damages: Frt / Rear / O/S / N/S / U/C / Rooftop or

O/S Front

The U/C / Chassis frame / Body Structure affected due to collision.

No.	Qty	Part No.	Particulars	Condition	Repairer's	Amount
1	1		*FRT BUMPER ASSY	Cracked	1,052.20 FL	*1,052.20 FL
2	1		*FRT BUMPER GRILLE RH	Cut	41.60 FL	*41.60 FL
3	1		*FRT BUMPER BRACKET TOP RH	Serviceable	22.40 FL	*- FL
4	1		*FRT BUMPER BRACKET RH	Cracked	24.60 FL	*24.60 FL
5	1		*HEADLAMP ASSY RH	Cracked	1,388.00 FL	*1,388.00 FL
6	1		*FRT FENDER RH	Buckled	566.30 FL	*566.30 FL
7	1		*FRT FENDER SHIELD RH	Serviceable	175.90 FL	*- FL
8	1		*FRT FENDER RETAINER RH	Serviceable	24.60 FL	*- FL
9	1		*FRT WHEEL RIM RH	Serviceable	325.30 FL	*- FL
10	1		*FRT WHEEL RIM CAP RH	Cracked	107.10 FL	*107.10 FL
11	1		*FRT FENDER ADVERTISEMENT STICKER RH	Necessary	100.00 F	*100.00 FS
					<b>Sub Total (S\$)</b>	<b>3,828.00 3,279.80</b>
					<b>- List Item Discount on L Items 20.00/20.00% (S\$)</b>	<b>745.60 635.96</b>
					<b>Total Parts (S\$)</b>	<b>3,082.40 2,643.84</b>

No	Particulars	Lab.Type	Repairer's	Amount
<b>Labour Items</b>				
1	PANEL BEATING	New	400.00	300.00
2	SPRAYPAINT	New	600.00	400.00
3	WIRING	New	50.00	20.00
4	TUFF KOTE	New	50.00	20.00
5	FRT WHEEL ALIGNMENT	New	80.00	0.00
<b>Gross Labour Cost (S\$)</b>			<b>1,180.00</b>	<b>740.00</b>
