REF: NS/INC 19614638 / K1s f 3m2

NTUC INCOME INSURANCE CO-OPERATIVE LTD		Ref: NS/INC19014638/K1sf3n2	
73 BRAS BASAH ROAD

4. Description of Damages			
THE VEHICLE SUSTAINED DAMAGES AT THE O/S FRONT PORTION. DAMAGES SEE DETAILS.			
5. General Information			
Accident Date	19/08/2019	Inspection Date	20/08/2019
Survey held at	COMFORTDELGRO ENGINEERING PTE LTD 59 LOYANG DRIVE SINGAPORE 508969		
5a. Remarks			
A)THE INSPECTION WAS CONDUCTED ON A"WITHOUT PREJUDICE" BASIS. B)IN ACCORDANCE TO YOUR INSTRUCTIONS, WE HAVE NOT AUTHORISED REPAIRS.			
5b. Estimate Days of Repair			
ESTIMATED NORMAL PERIOD FOR REPAIR:		3 Working Days

ADJUSTMENT ON REPAIR COST FOR VEHICLE NO. SHA 7895M

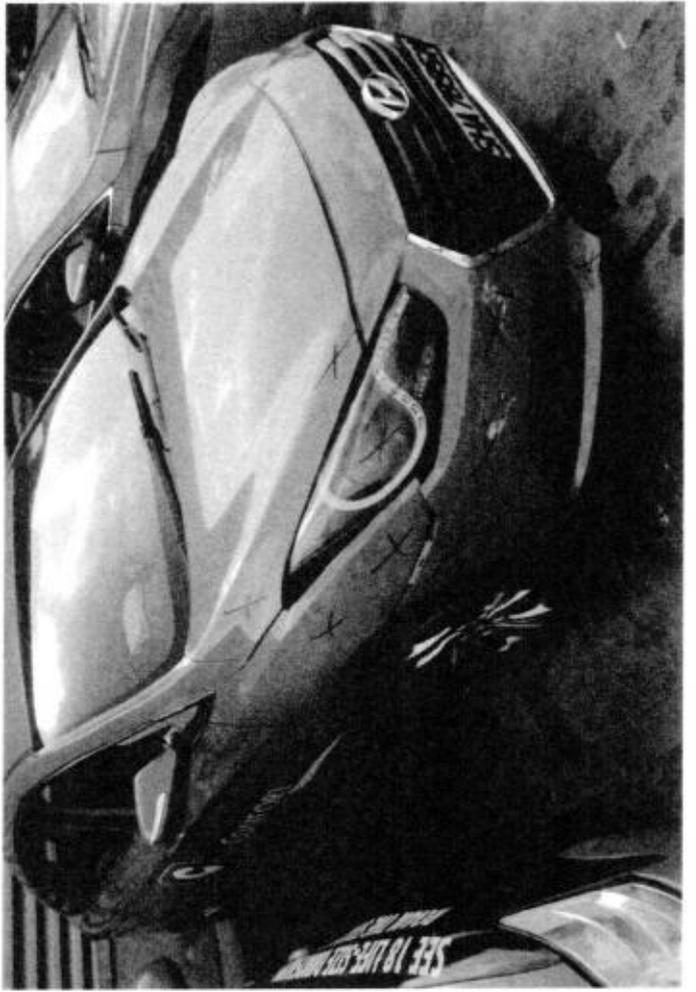
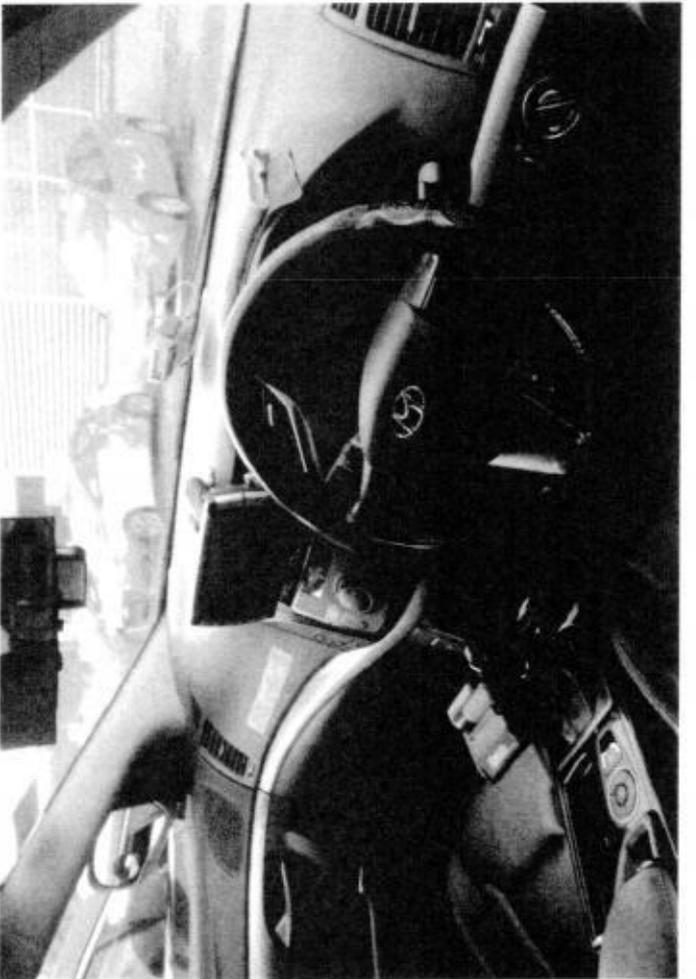
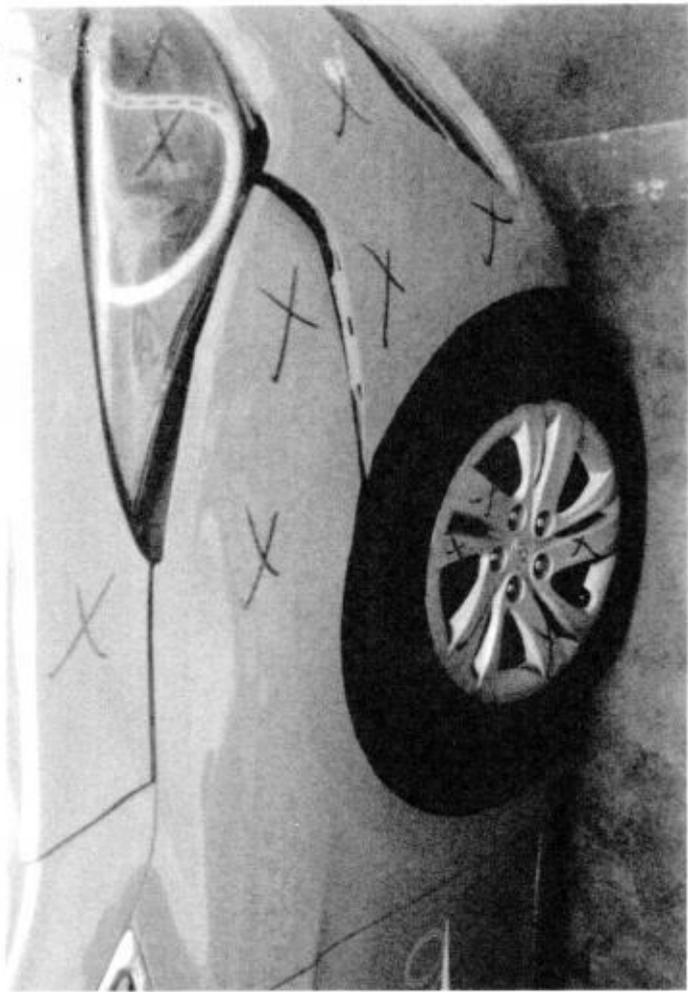
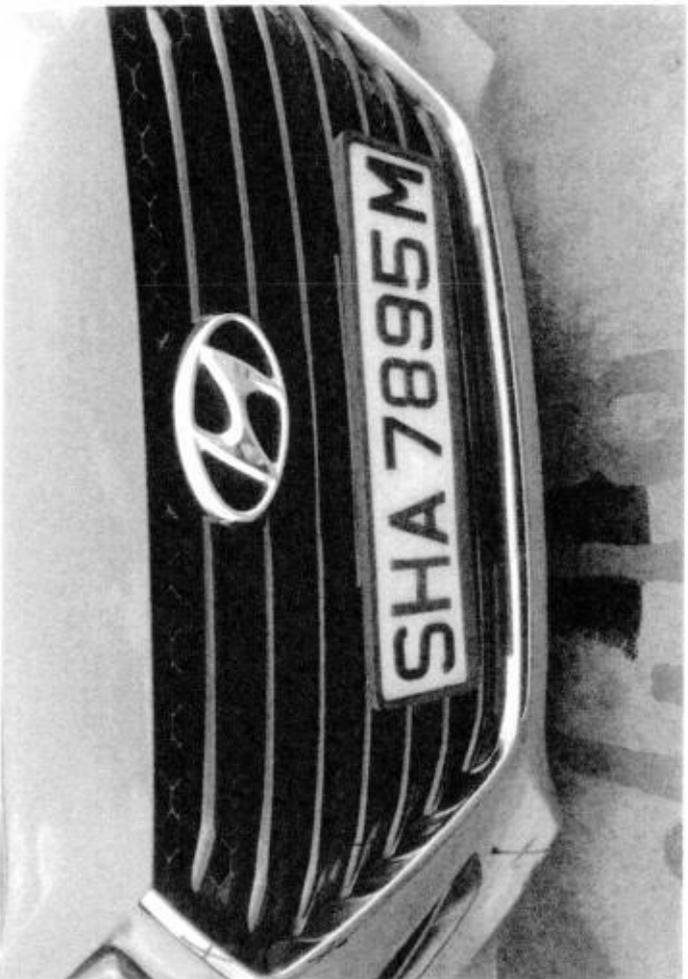
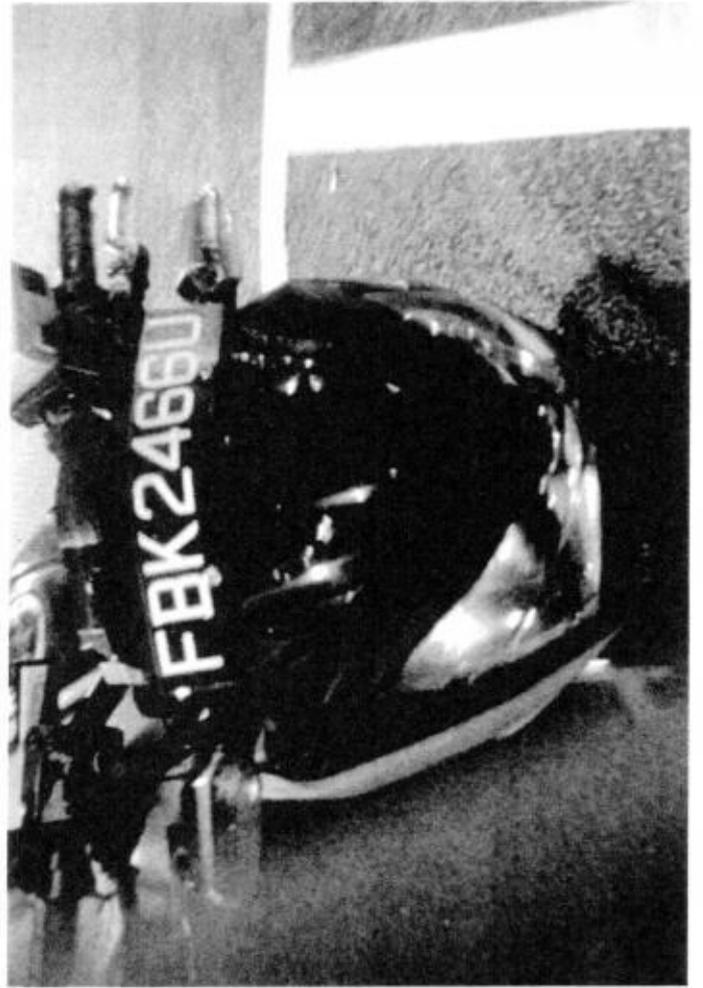
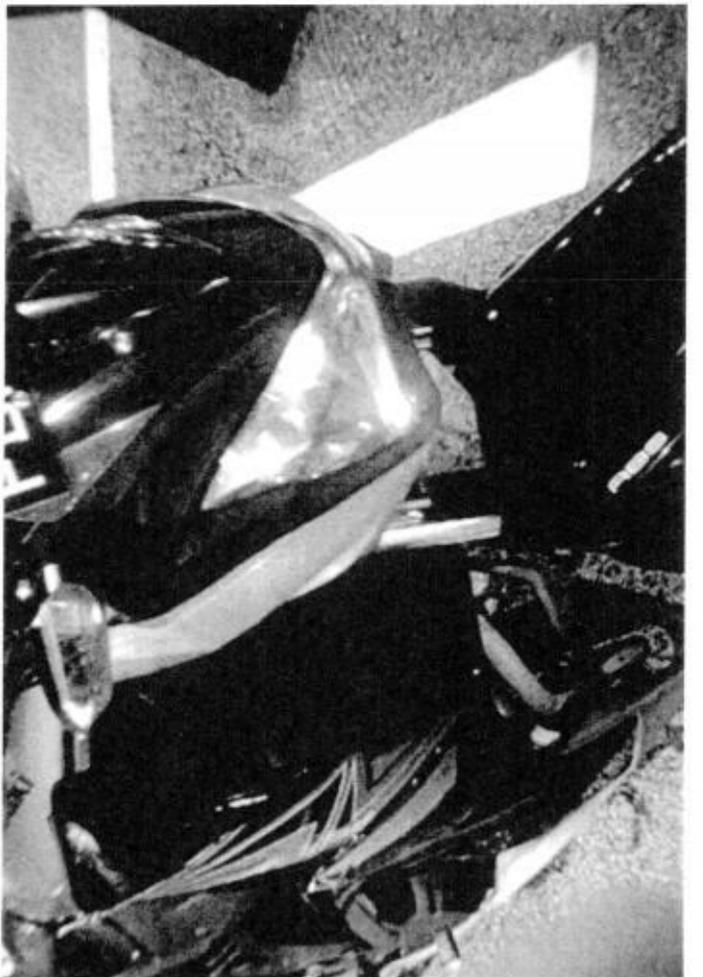
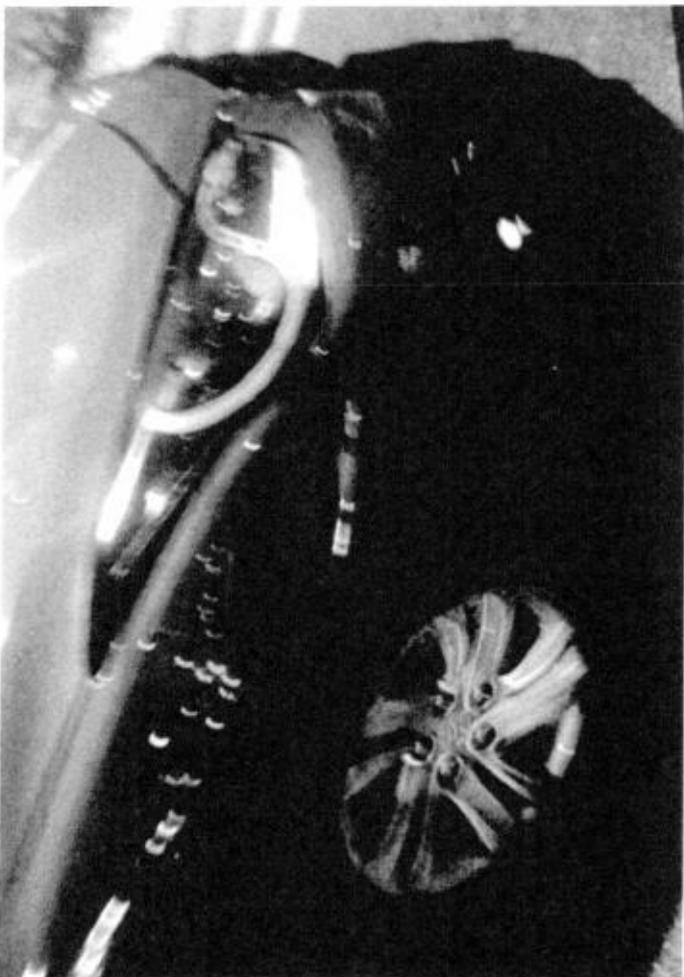
Due to the accident, my taxi's right front tyre was punctured, the front right portion of my taxi was dented and alignment was out. The front right bumper also slightly came out. My taxi and the motorcycle was towed away. Due to the accident, I did not sustain any injuries. My passenger did not complain of any injury.

Qty	Description of Parts	Condition	Estimate By Workshop (\$)	Our Adjusted (\$)
<u>REPLACEMENT OF PARTS</u>				
1	RADIATOR GRILLE	CUT	1,110.10	1,110.10
1	FRONT BUMPER COVER	CUT	1,052.20	1,052.20
1	FRONT BUMPER BRACKET TOP (RH)	SERVICEABLE	22.40	-
1	FRONT BUMPER BRACKET (RH)	CRACKED	24.60	24.60
1	HEADLAMP (RH)	CRACKED	1,388.00	1,388.00
1	FRONT FENDER (RH)	BUCKLED	566.30	566.30
1	FRONT FENDER SHIELD (RH)	SERVICEABLE	175.90	-
1	FRONT FENDER RETAINER	SERVICEABLE	24.60	-
1	FRONT WHEEL RIM (RH)	SERVICEABLE	325.30	-
1	FRONT WHEEL HUB CAP (RH)	GRAZED	107.10	107.10
1	FRONT WHEEL BEARING	SERVICEABLE	540.50	-
1	FRONT SHOCK ABSORBER (ASSY)(RH)	SERVICEABLE	342.20	-
1	FRONT SHOCK ABSORBER MOUNTING (RH)	SERVICEABLE	108.80	-
1	FRONT DRIVE SHAFT RH	SERVICEABLE	1,030.80	-
1	FRONT SUSPENSION LOWER ARM (RH)	SERVICEABLE	529.30	-
1	KNUCKLE ARM (RH)	SERVICEABLE	552.00	-
	LESS 20% DISCOUNT		-1,580.02	-849.66
			6,320.08	3,398.64
<u>SPECIAL NETT ITEMS</u>

1	FRONT TYRE (RH)(50%)(SN)	CUT	216.00	108.00
			216.00	108.00
<u>LABOUR</u>				
	PANEL BEATING.		400.00	300.00
	SPRAY PAINTING CHARGE.		600.00	400.00
	WIRING.		50.00	20.00
	TUFF KOTE.		50.00	20.00
	REMOVE/REFIX UNDERCARRIAGE (FRT).	NOT NECESSARY	400.00	-
	FRT WHEEL ALIGNMENT.	NOT NECESSARY	80.00	-
			1,580.00	740.00

GRAND TOTAL		8,116.08	4,246.64
RECOMMENDED COST OF LUMP SUM REPAIRS (TO ITS PRE-ACCIDENT CONDITION) (CONFIRMED)			3,400.00
