REF: CS/SM019014759 / FvF322

To Inspect Vehicle No: FS 1188P

Yamaha mt 09

VEHICLE DAMAGE INSPECTION REPORT

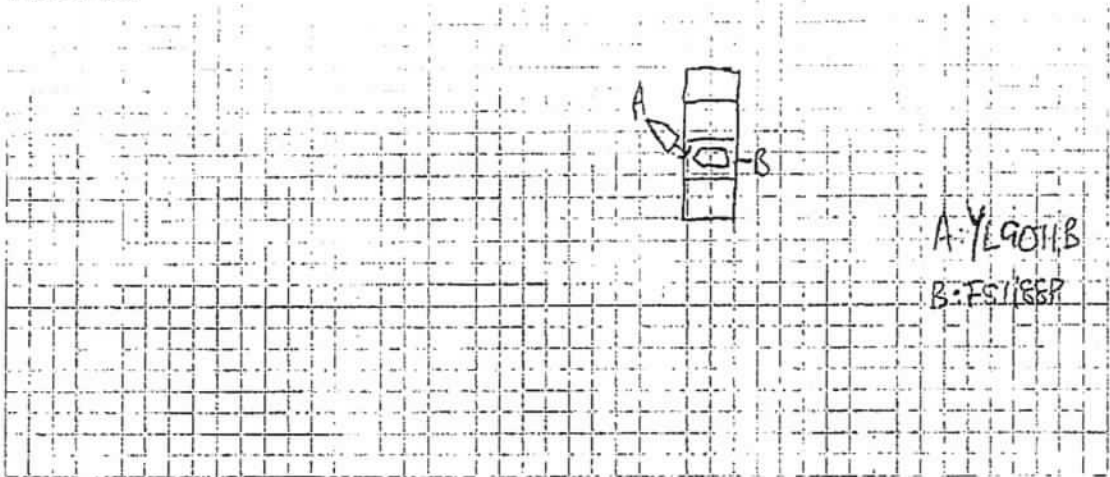
SKETCH PLAN

On 04/01/19 at about 1144 hrs my bike registration number FS1188P was park inside 111 was ave 2 then this Lorry YL9011B reverse and hit my bike at the lot. the accident footage was captured by the building's cctv.
