Remark: The veh had commenced its
repair at the time of inspection.

ADJUSTMENT ON REPAIR COST FOR VEHICLE NO. SHD 3625L

4. Description of Damages

THE VEHICLE SUSTAINED DAMAGES AT THE REAR O/S PORTION. DAMAGES SEE DETAILS.
--

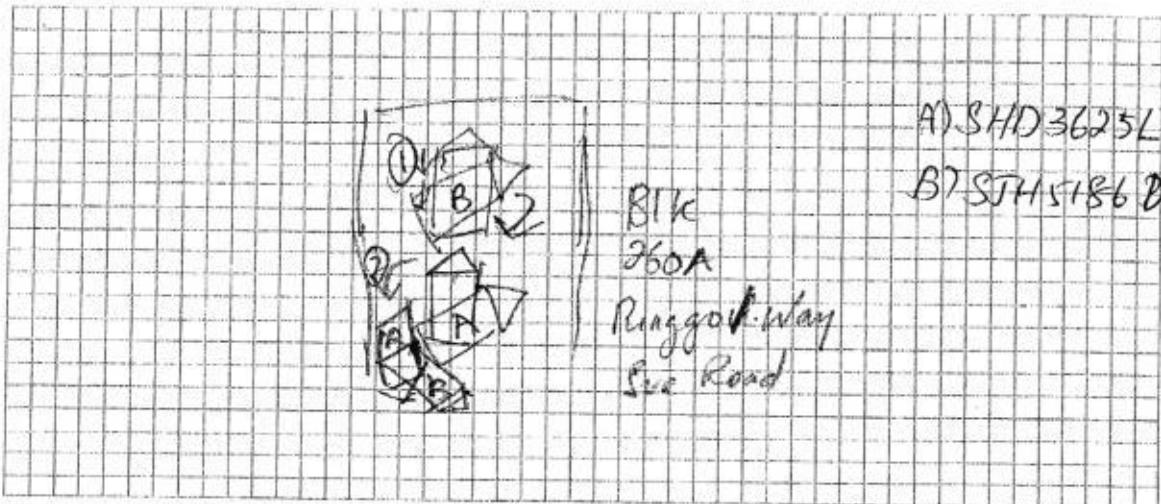
SKETCH PLAN

RTK
260A
Ringgo Way
Sea Road

A) SHD 3625L
B) SJH 5186 D

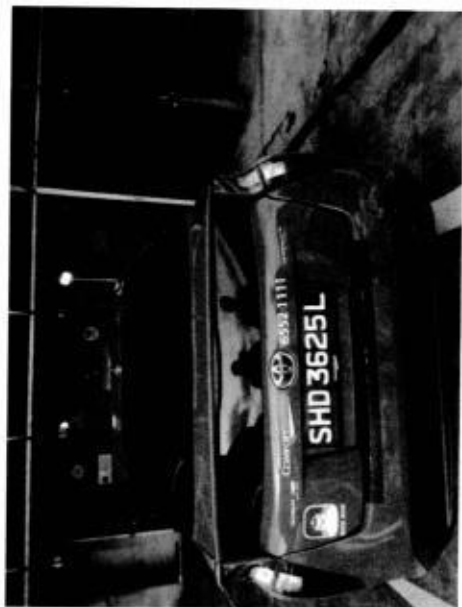
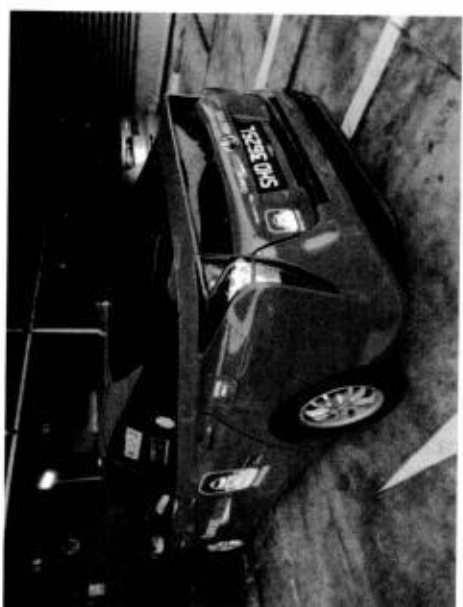
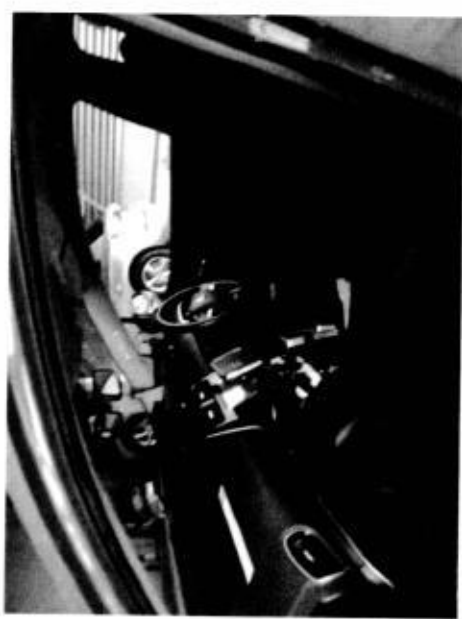
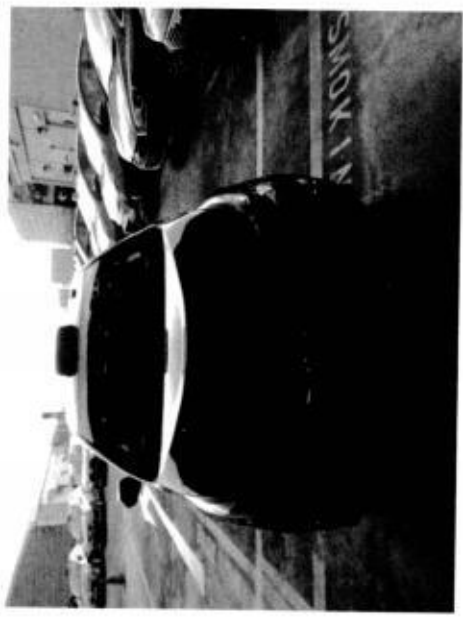
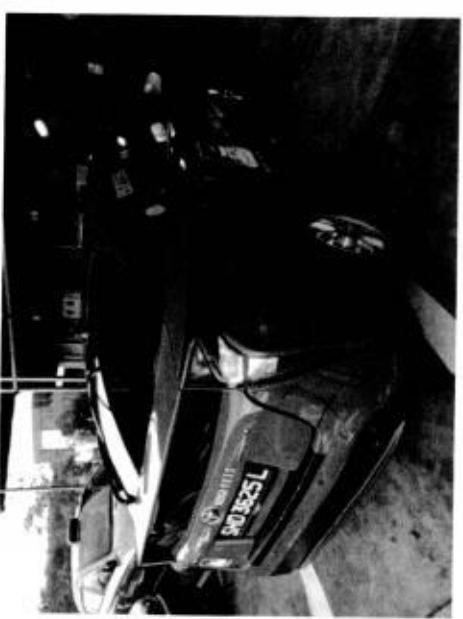
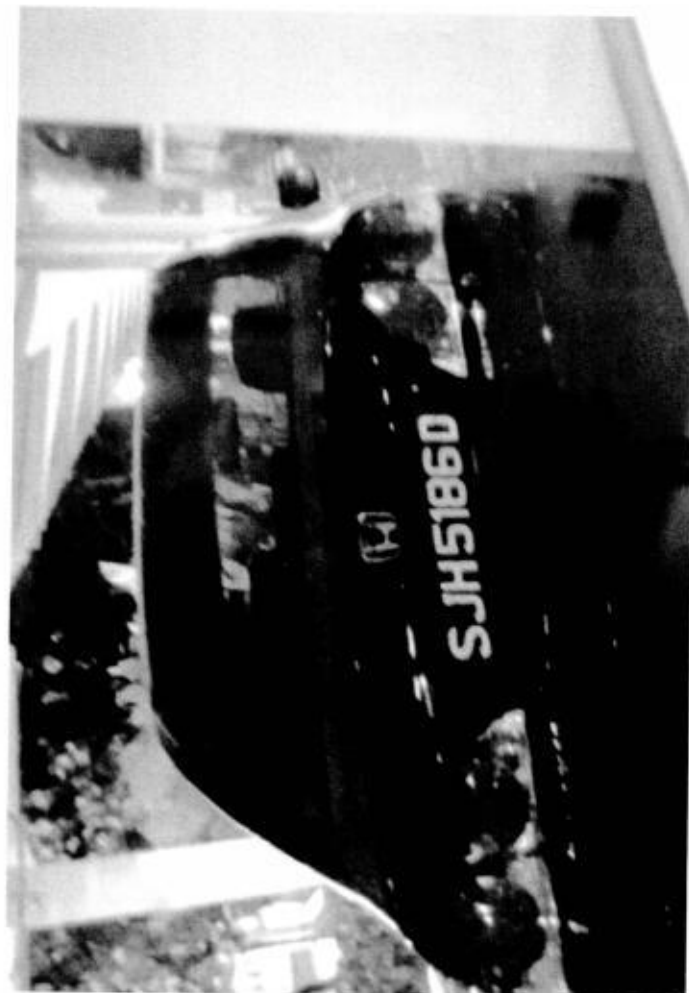
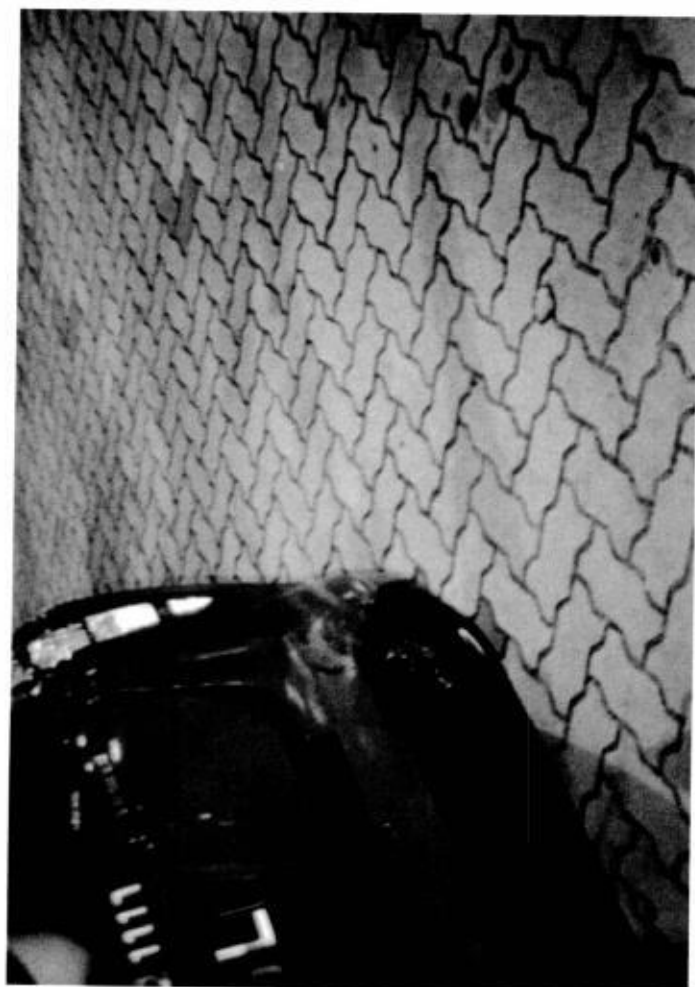
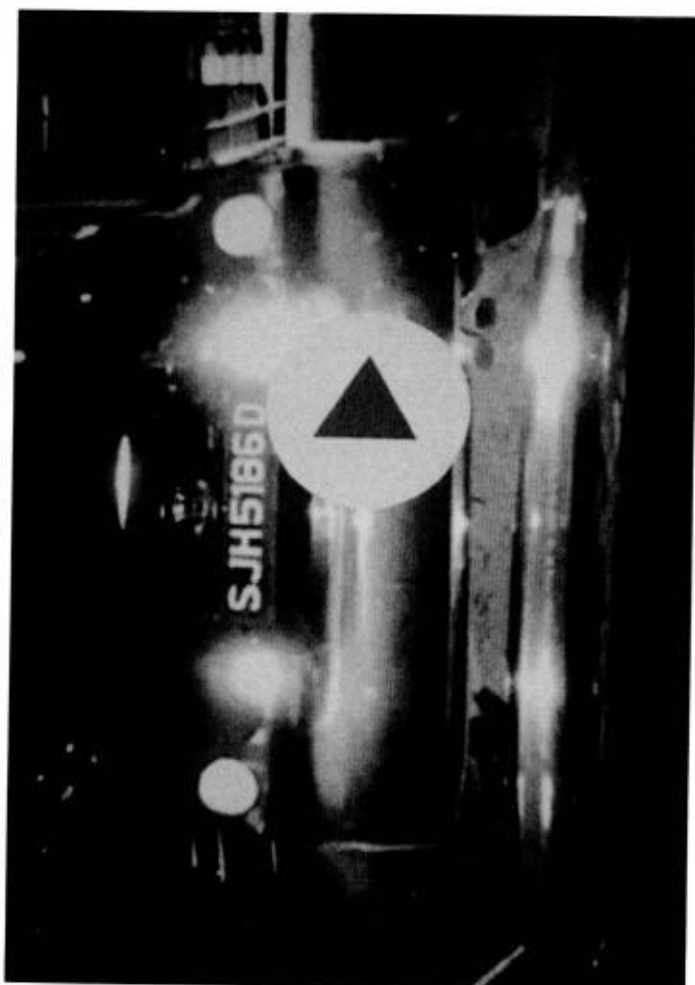
Qty	Description of Parts	Condition	Estimate By Workshop (\$)	Our Adjusted (\$)
	<u>REPLACEMENT OF PARTS</u>			
1	REAR BUMPER	DEFORMED	458.60	458.60
1	REAR BUMPER UNDER COVER	CRACKED	552.60	552.60
1	REAR BUMPER SIDE RETAINER	SERVICEABLE	112.70	-
1	REAR BUMPER TOWING COVER	MISSING	82.70	82.70
10	REAR BUMPER CLIPS	NECESSARY	22.00	22.00
1	RETAINER, REAR BUMPER SIDE, RH	SERVICEABLE	94.80	-
1	SEAL, REAR BUMPER SIDE, RH	TO REPAIR SEE LABOUR	148.40	-
	LESS 25% DISCOUNT		-367.95	-278.97
			1,103.85	836.93
	<u>LABOUR</u>			
	PANEL BEATING, INCLUSIVE OF THE REPAIR OF SEAL, REAR BUMPER SIDE, RH.		400.00	200.00
	SPRAY PAINTING CHARGE.		300.00	200.00
	WIRING CHARGE.	NOT NECESSARY	50.00	-
	REMOVE/REFIX REVERSE SENSOR.		80.00	30.00
			830.00	430.00
	GRAND TOTAL		1,933.85	1,266.93
RECOMMENDED COST OF REPAIRS (CONFIRMED)				1,266.93

1. The repair job shall bill to: NTUC SJH5186D
2. The finalized amount shall be:
 - (a) Spare Parts after List discount \$836.93
 - (b) Labour Charges \$430.00
 - Total for Part-By-Part Repair Cost** \$1266.93
 - (c) Lumpsum Repair (if applicable)
Total for Lumpsum repair cost after Less: 20%
Final Lumpsum Repair cost
