Preliminary Advice

Insured Vehicle No	: SKS6749D	Accident Date	: 18/08/2019
TP Vehicle No	: FU3246G	Assignment Date	: 23/08/2019
Make	: KAWASAKI KRR ZX150 M	Est. Duration of Repair	: 4.00
Date of Inspection	: 23/08/2019		
Inspection At	: SG 98 MOTOR PTE LTD (HQ) BLK 4001 ANG MO KIO INDUSTRIAL PARK 1 #01-21 SINGAPORE 569622

VEHICLE DAMAGE INSPECTION REPORT

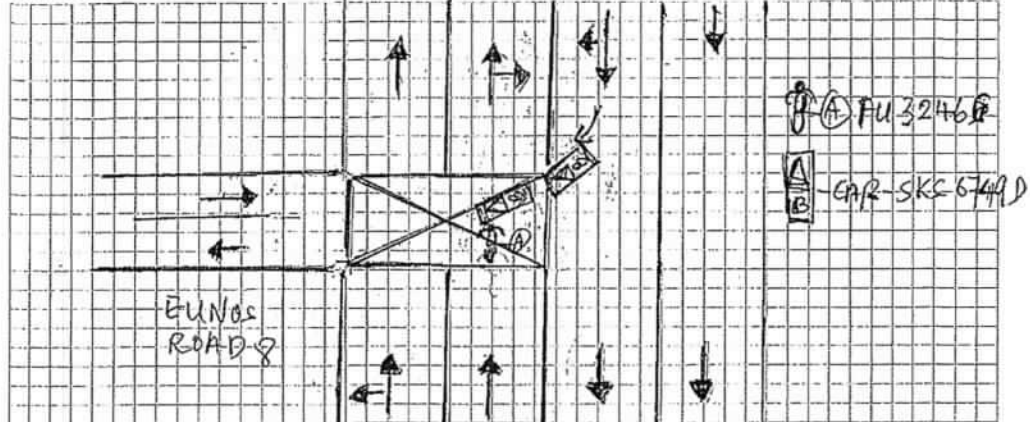
SKETCH PLAN

DESCRIBE CIRCUMSTANCES OF THE ACCIDENT

Refer to police report no: T/20190818/2163

Immediately I applied my emergency break but could not stop in time and due to that accident happened as I hit onto her left front side bumper and I felt on the left side. A few passerby render assistance and I also realized that the driver did come out from the vehicle. I did seek assistance from a passerby to call for Traffic Police and ambulance which they did. Shortly after that the lady driver came out from the vehicle but she did approached about my condition. After which the lady driver husband came to the location and informed that to claim the matter through insurance.
