PRE-REPAIR INSPECTION - ACCIDENT INVOLVING OUR INSURED VEHIC...

**ACCIDENT INVOLVING SJJ 9522 E / SGT 7937 M ON 21st AUGUST 2019 ALONG
SERANGOON CENTRE TOWARDS CTE AT ABOUT 14:30**

Subaru : Impreza (Including WRX/STI, XV) : 2007-11 (GE/GH) : 1.5L, 2.0L Gasoline : 17" Wheel
4-Wheel Total Alignment

VEHICLE DAMAGE INSPECTION REPORT

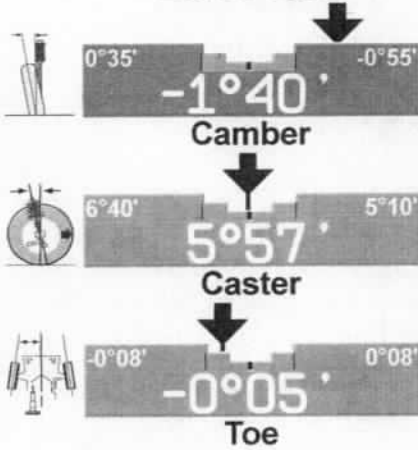
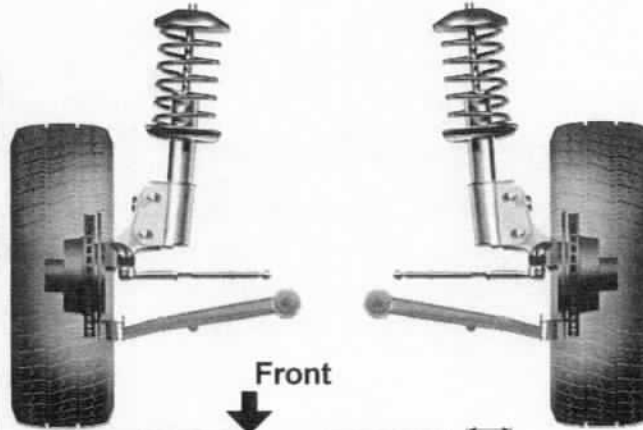
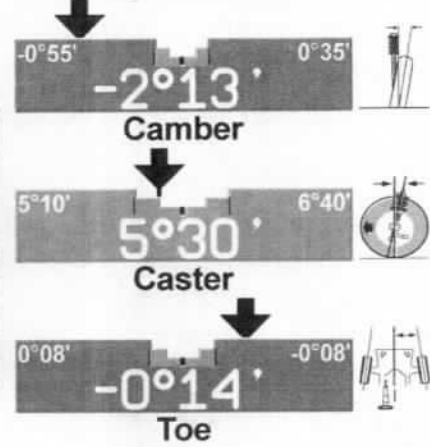
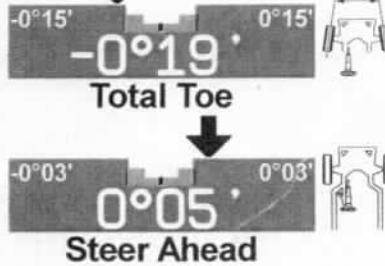
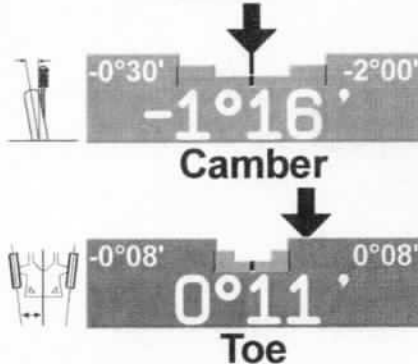
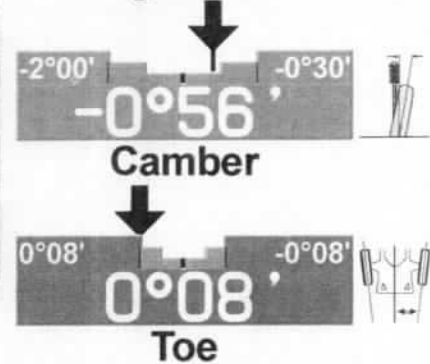
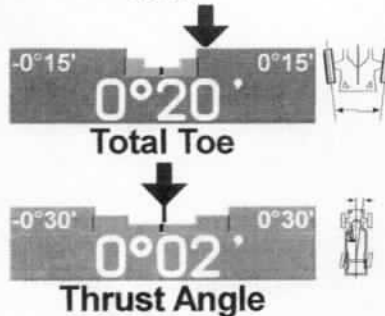
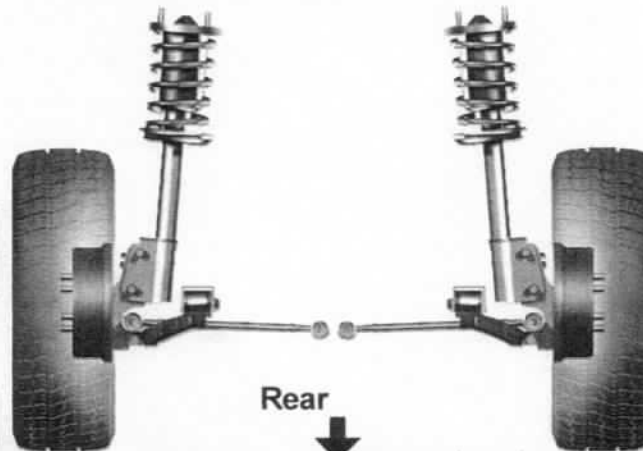
Before Measurements

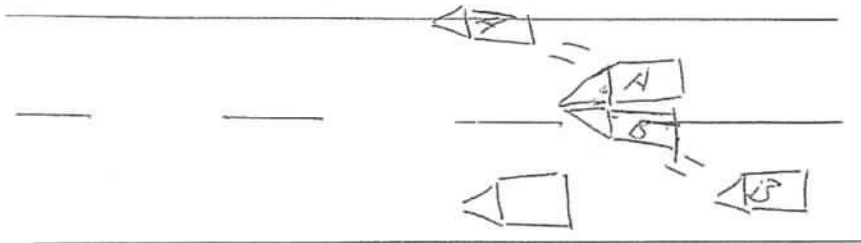
SKETCH PLAN

Serangoon Centre Toward CTE

A SJS 9522E

B SGT 7937M

I was driving along at the Serangoon Centre Toward CTE at the 2 lane traffic and I was driving at the extreme right lane suddenly vehicle B from my left cut into my lane and collided onto my car due to the straight impact my car go onto the kerb after the accident.
