Veh No: SJH7612C Yr Regn: 2008 Augst.Type: M.Car / M.Cycle / Bus / Van / Lorry / Taxi / Prime Mover /

**PRE-REPAIR INSPECTION - ACCIDENT INVOLVING OUR INSURED VEHIC...**

**Subject:** RE: PRE-REPAIR INSPECTION - ACCIDENT INVOLVING OUR INSURED VEHICLE SDG6718P AND SJH7612C ON 17/08/2019

## VEHICLE DAMAGE INSPECTION REPORT

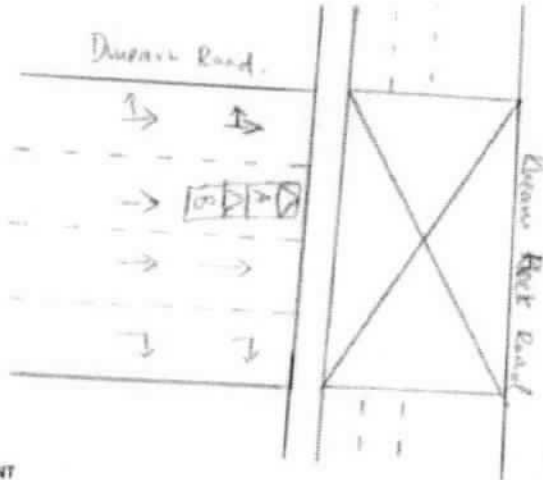
## SKETCH PLAN

Vehicle A: 5JH76126  
Vehicle B: 5D67678P

On 17/08/2019 @ 10:00hrs, I was travelling along Dunearn Road towards city when I stop at the traffic (Red light) light junction of Kearns Road. & Vehicle 'B' 5D67678P collided with my rear.
