To Inspect Vehicle No: SCU 6245K Insured: SKB 173T

VEHICLE APPRAISAL REPORT

Registration No.	: SKU 6295K	Chassis Frame No.	: JHMGK5850GX200050
Make / Model	: Honda Jazz 1.5 VTIR CVT ABS	Engine No. (Logcard)	: L15B31020005
Year of Manufacture/Reg	: 2015	Odometer Reading	: 113,119 KM
Colour	: Red		
Class / Type	: Hatchback

VEHICLE DAMAGE INSPECTION REPORT

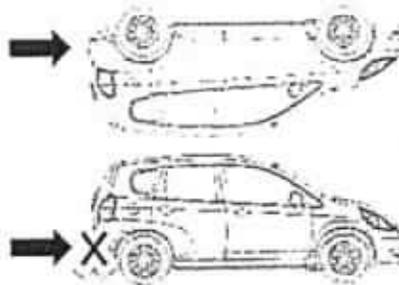
Damages sustained were consistent with the subject vehicle being involved in a collision with another vehicle and the impact was delivered **Squarely to the RH Rear** portion of the vehicle.

The general area of damages is at the **RH Rear portion**
(Please refer to the parts list and photographs as attached for more information)

The estimated repair costs submitted by Messrs **Apex Motoring** is \$ **2,374.80**
We have adjusted the cost to \$ **1,698.32** and the repairer has agreed to undertake the repairs at a
Contract Lump Sum of \$ 1,350.00 to a acceptable quality and standards.
However, we have not given authorization and instruction to the repairer to proceed with the repairs.

The repairs should be completed within a reasonable period of **2** working days.
