VEHICLE DAMAGE INSPECTION REPORT

Our File No: CS3/AIG19014973/ACF3E2

Handling Insurer: AIG Asia Pacific Insurance Pte. Ltd. Policy No: 1800022480
Claimant
Vehicle No : GBA6558P **Insured Vehicle No :** SKJ8666T
Date of Loss: 30/07/2019 **Nature of Claim:** TP **Claim No:** 9143537429SG

Reg No: GBA6558P
Make & Model: RENAULT KANGOO, 1.5 D DCI70 (M) **Engine No:** K9KW714D183235
Reg. Date: 29/09/2007 (Man. Year: 2007) **Chassis No:** VF1FC1EAF38134693
Colour: Green **Odometer:** 166000 km
Engine Capacity: 1461 cc
Market Value/New Car Price: N/A
Sum Insured (S\$): Market Value/New Car Price

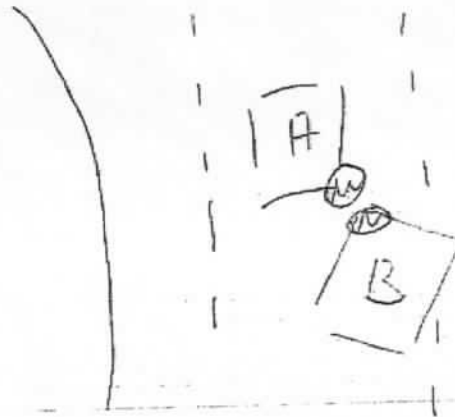
SKETCH PLAN

Type Of Accident	COLLISION - HEAD TO REAR
Weather Conditions	CLEAR
Road Surface	DRY

30/7/19 傍晚 6.20pm 在 Serangerna Road
等待红绿灯的时候 后方一辆奔驰
车牌 SKJ 866T 转换车道 撞到我的车辆
后方 (车牌 GBA 6358P)
