**PRE-REPAIR INSPECTION REQUEST – SLZ7427C vs SJN251A on 25.08.2019**

## VEHICLE DAMAGE INSPECTION REPORT

Our File No: CS/AIG19015084/KYD3N2

<b>Reg No:</b>	SLZ7427C	<b>Engine No:</b>	27186030540713
<b>Make &amp; Model:</b>	MERCEDES-BENZ E250, 1.8 CGI ESTATE (A)	<b>Chassis No:</b>	WDD2120472A677927
<b>Reg. Date:</b>	15/04/2013 (Man. Year: 2012)	<b>Odometer:</b>	77098 km
<b>Colour:</b>	Metallic Blue		
<b>Engine Capacity:</b>	1796 cc		
<b>Market Value/New Car Price:</b>	N/A		
<b>Sum Insured (S\$):</b>	Market Value/New Car Price

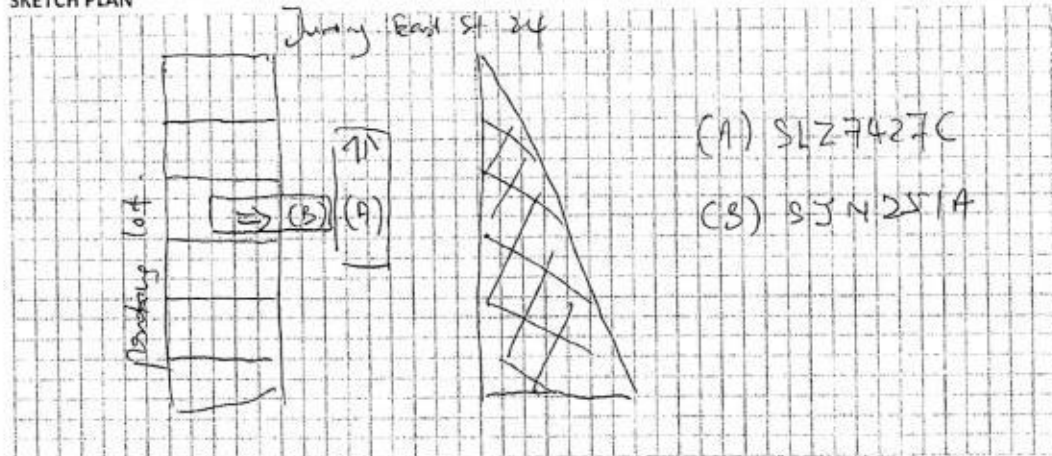
SKETCH PLAN

DESCRIBE CIRCUMSTANCES OF THE ACCIDENT

I was driving my car in the carpark drive way. Suddenly vehicle (B) SYN251A drive out from his parking lot and hit on my rear left side portion.
