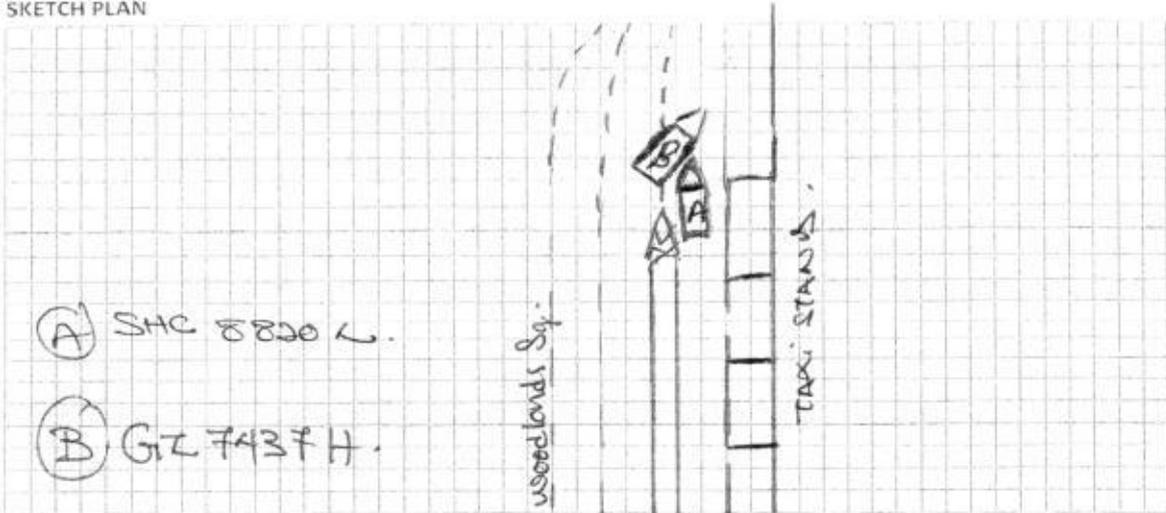
SKETCH PLAN

DESCRIBE CIRCUMSTANCES OF THE ACCIDENT

ON 26 Aug 2019 @ 12:30 hrs I VEH

A was driving straight on my lane

Suddenly VEH B from the left side dash

in and hit VEH (A) left front. at the

point of accident VEH A NO PAX.

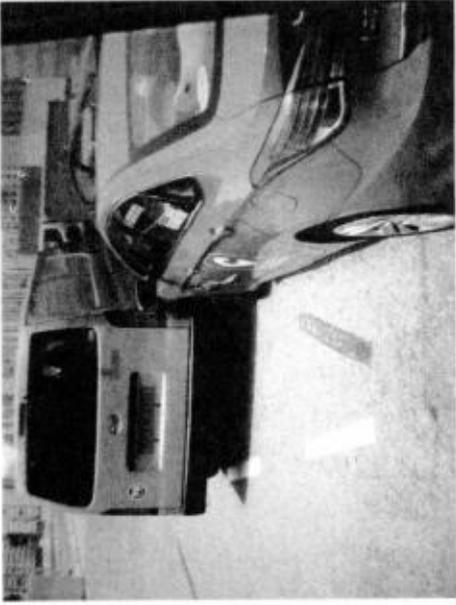
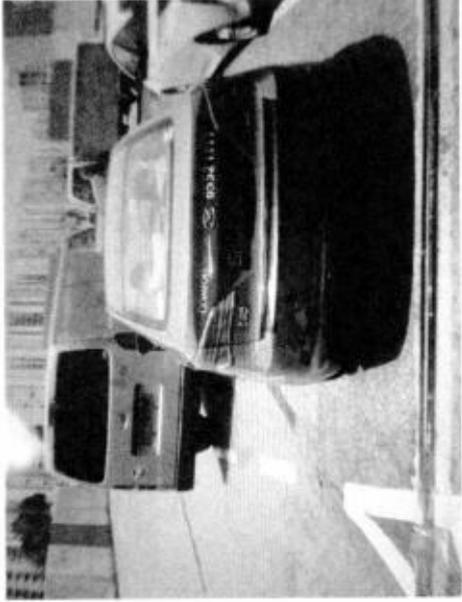
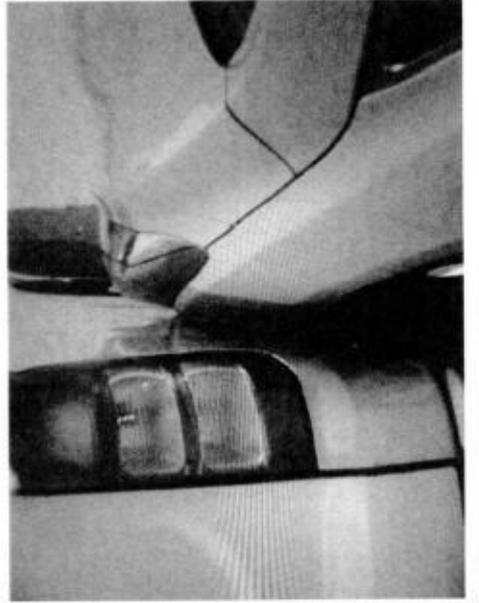
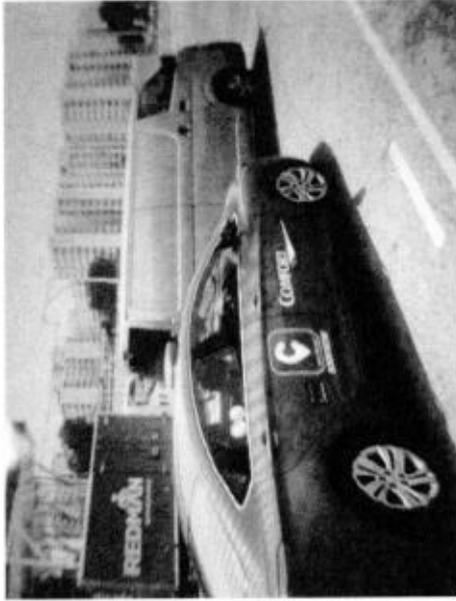
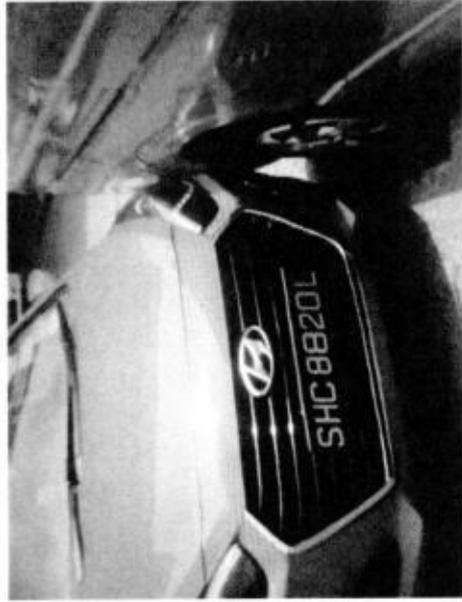
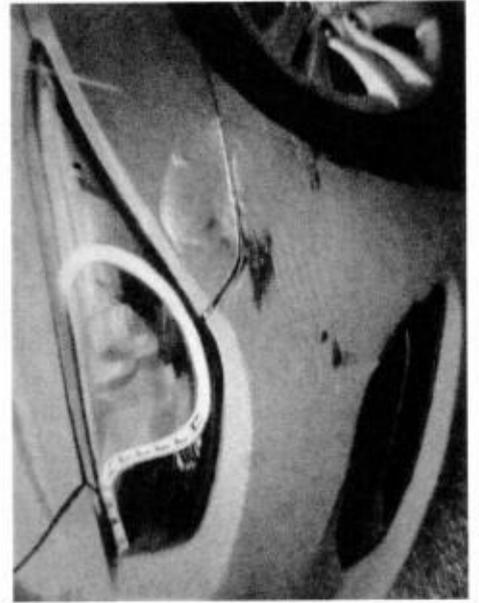
Des. of Damages: Frt / Rear / O/S / N/S / UIC / Rooftop or

n/s Front

THE VEHICLE SUSTAINED DAMAGES AT THE N/S FRONT PORTION.
DAMAGES SEE DETAILS.

Qty	Description of Parts	Condition	Estimate By Workshop (\$)	Our Adjusted (\$)
REPLACEMENT OF PARTS				
1	FRONT BUMPER COVER	CUT	1,052.20	1,052.20
1	FRONT BUMPER GRILLE (LH)	SERVICEABLE	41.60	-
1	FRONT BUMPER BRACKET TOP (LH)	SERVICEABLE	22.40	-
1	FRONT BUMPER BRACKET (LH)	SERVICEABLE	24.60	-
1	HEADLAMP (LH)	GRAZED	1,388.00	1,388.00
1	FRONT WHEEL HUB CAP,LH	SERVICEABLE	107.10	-
1	FRONT FENDER (LH)(NPA)	TO REPAIR SEE LABOUR	-	-
	LESS 20% DISCOUNT		-527.18	-488.04
			2,108.72	1,952.16
LABOUR				
	PANEL BEATING.INCLUSIVE OF THE REPAIR OF FRONT FENDER (LH).		400.00	200.00
	SPRAY PAINTING CHARGE.		600.00	400.00
	WIRING.		50.00	20.00
	TUFF KOTE.	NOT NECESSARY	50.00	-
	FRT WHEEL ALIGNMENT.	NOT NECESSARY	80.00	-
			1,180.00	620.00
GRAND TOTAL			3,288.72	2,572.16
RECOMMENDED COST OF LUMP SUM REPAIRS (TO ITS PRE-ACCIDENT CONDITION) (CONFIRMED)				2,050.00

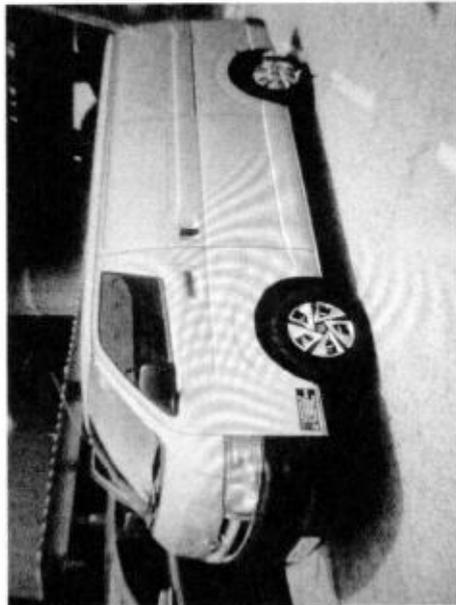
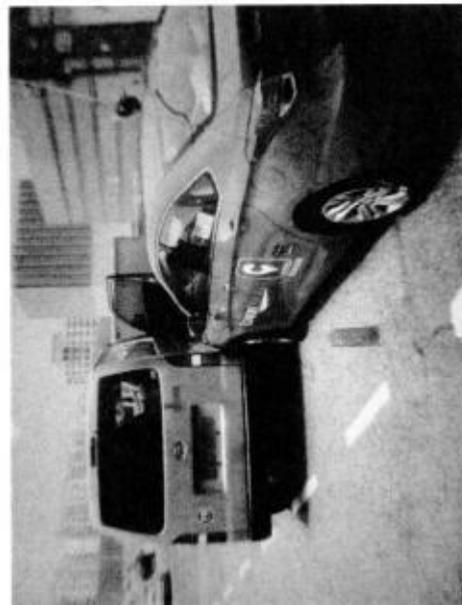
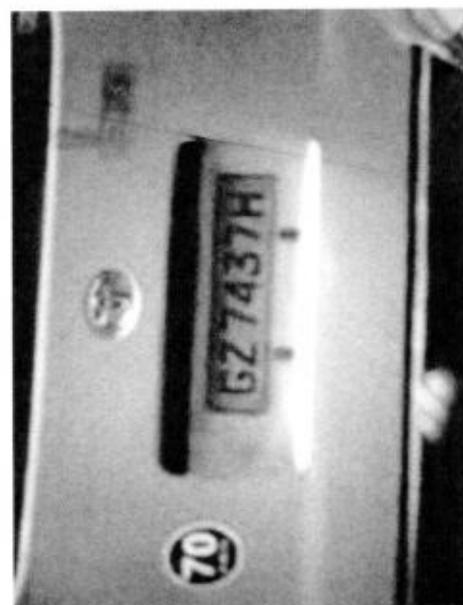
Remark: The veh had commenced its repair at the time of inspection.
