PRE-REPAIR INSPECTION - ACCIDENT INVOLVING OUR INSURED VEHIC...

NOTIFICATION OF ACCIDENT

Date Of Report	28/08/2019 12:05
Date Of Accident	28/08/2019 08:20
Exact Location Of Accident	KPE TUNNEL TOWARDS ECP
Country/State of Loss	SINGAPORE

VEHICLE DAMAGE INSPECTION REPORT

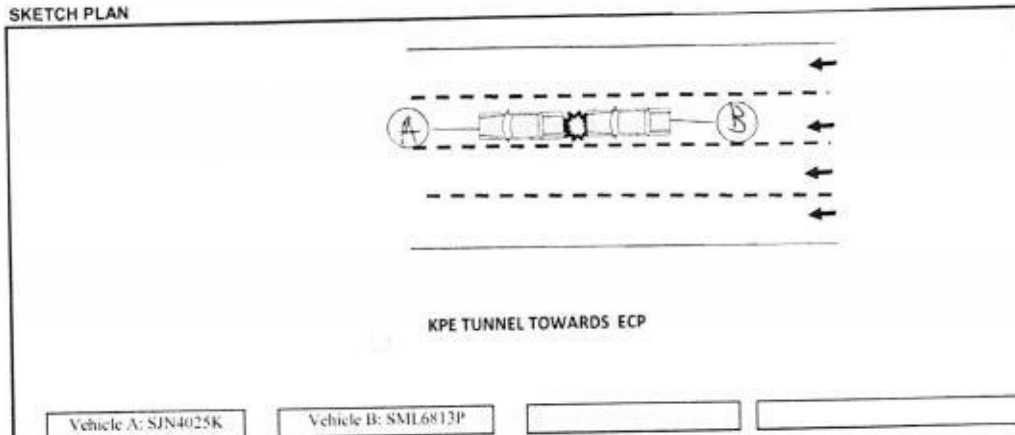
SKETCH PLAN

DESCRIBE CIRCUMSTANCES OF THE ACCIDENT

VEHICLE IN FRONT OF ME JAMMED BRAKE SUDDENLY AND I FOLLOWED SUIT. I MANAGED TO BRAKE IN TIME BUT VEHICLE B HIT INTO THE REAR PORTION OF MY VEHICLE.
