**TP Claims against NTUC Income: Follow-Through Survey**

**1. Policy Particulars :- THIRD PARTY CLAIM**

THE VEHICLE SUSTAINED DAMAGES AT THE O/S FRONT PORTION. DAMAGES SEE DETAILS.
---

**ADJUSTMENT ON REPAIR COST FOR VEHICLE NO. SHA 4175C**

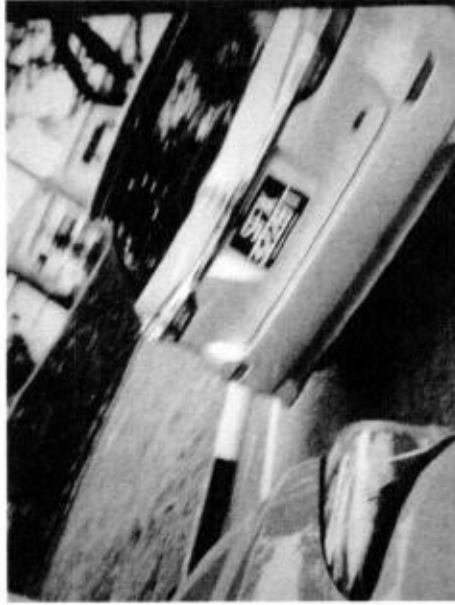
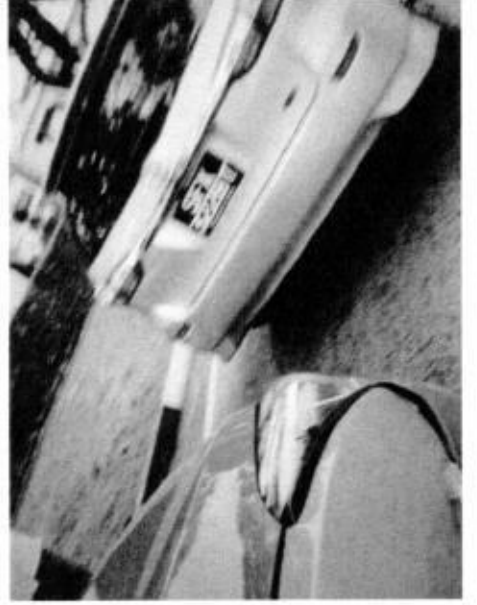
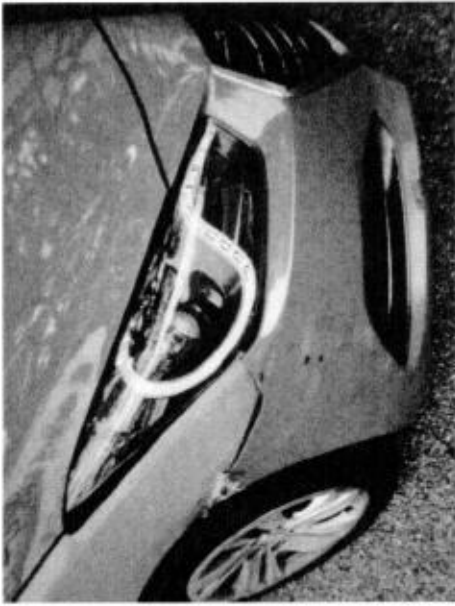
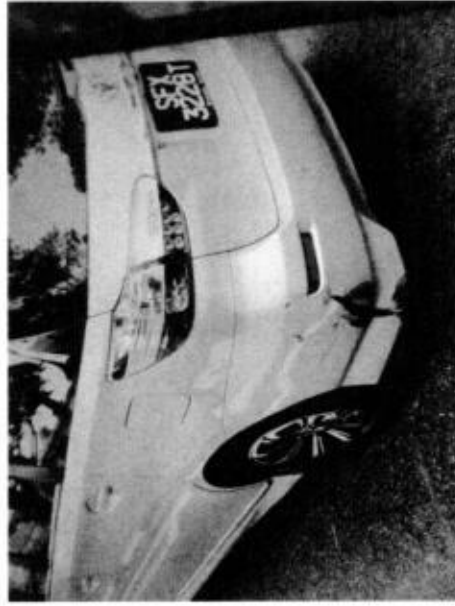
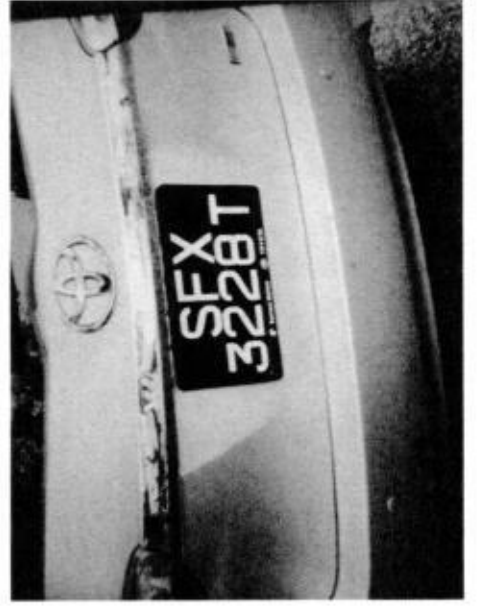
o/s front.

The U/C / Chassis frame / Body Structure affected due to collision.

Qty	Description of Parts	Condition	Estimate By Workshop (\$)	Our Adjusted (\$)
<b>REPLACEMENT OF PARTS</b>				
1	FRONT BUMPER COVER	DEFORMED	544.50	544.50
1	FRONT BUMPER GRILLE (RH)	SERVICEABLE	41.60	-
1	FRONT BUMPER BRACKET TOP (RH)	SERVICEABLE	22.40	-
1	FRONT BUMPER BRACKET (RH)	CRACKED	24.60	24.60
1	HEADLAMP (RH)	CRACKED	1,388.00	1,388.00
1	FRONT FENDER (RH)	BUCKLED	566.30	566.30
1	FRONT FENDER SHIELD (RH)	SERVICEABLE	175.90	-
1	FRONT FENDER RETAINER	SERVICEABLE	24.60	-
1	FRONT WHEEL HUB CAP, RH	SERVICEABLE	107.10	-
	LESS 20% DISCOUNT		-579.00	-504.68
			2,316.00	2,018.72
<b>SPECIAL NETT ITEMS</b>				
1	FRONT FENDER ADVERTISEMENT LOGO (RH)(SN)	NECESSARY	100.00	100.00

100.00	100.00
<b>LABOUR</b>				
	PANEL BEATING.		400.00	300.00
	SPRAY PAINTING CHARGE.		600.00	400.00
	WIRING CHARGE.		50.00	20.00
	TUFF KOTE.		50.00	20.00
	FRT WHEEL ALIGNMENT.	NOT NECESSARY	80.00	-
			1,180.00	740.00
<b>GRAND TOTAL</b>			<b>3,596.00</b>	<b>2,858.72</b>
<b>RECOMMENDED COST OF LUMP SUM REPAIRS (TO ITS PRE-ACCIDENT CONDITION) (CONFIRMED)</b>				<b>2,300.00</b>
