**1. Policy Particulars :- THIRD PARTY CLAIM**

**4. Description of Damages**

THE VEHICLE SUSTAINED DAMAGES AT THE REAR PORTION. DAMAGES SEE DETAILS.
--

### ADJUSTMENT ON REPAIR COST FOR VEHICLE NO. SHA 6045G

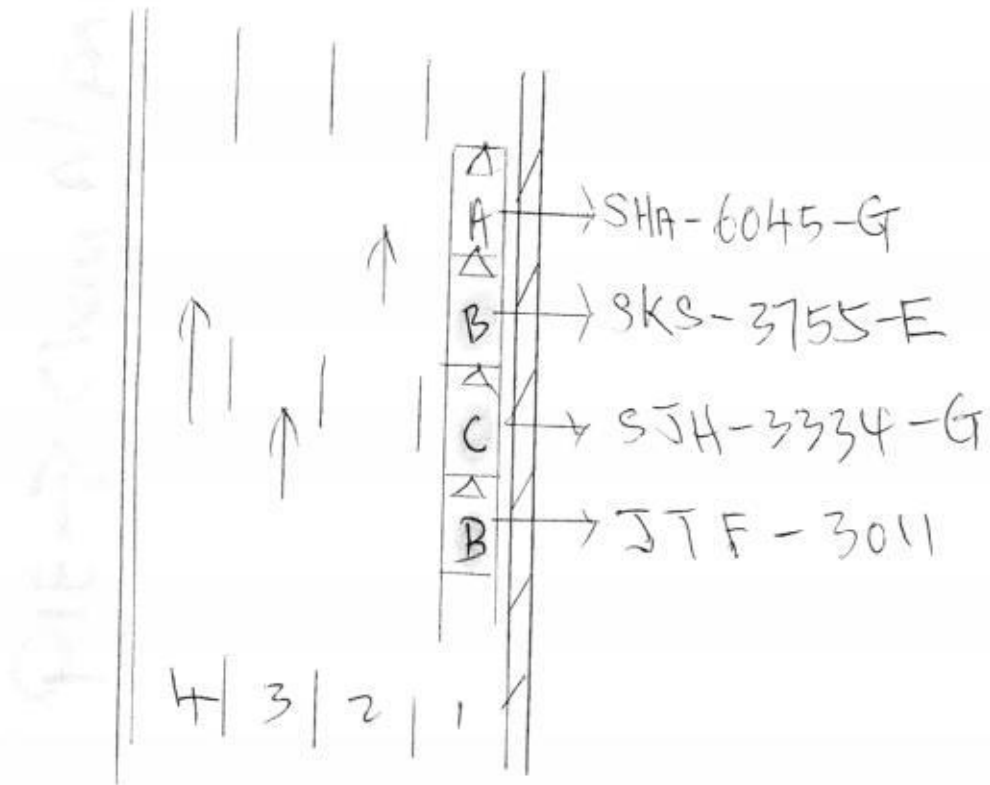
SKETCH PLAN

PIE/CITANGU AIRPORT.

SHA 6045 G.

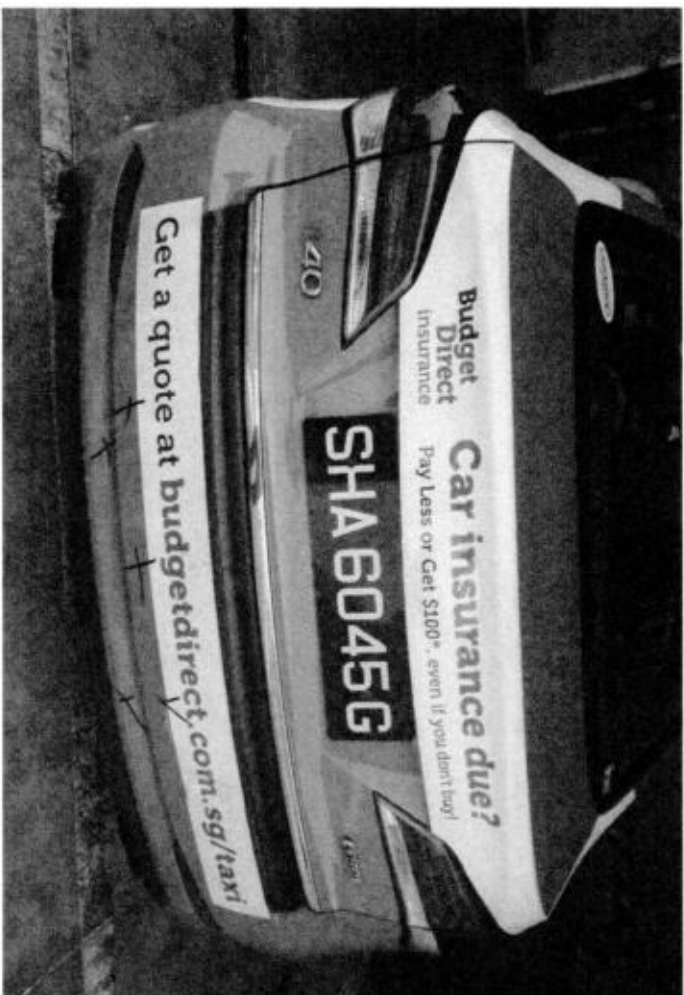
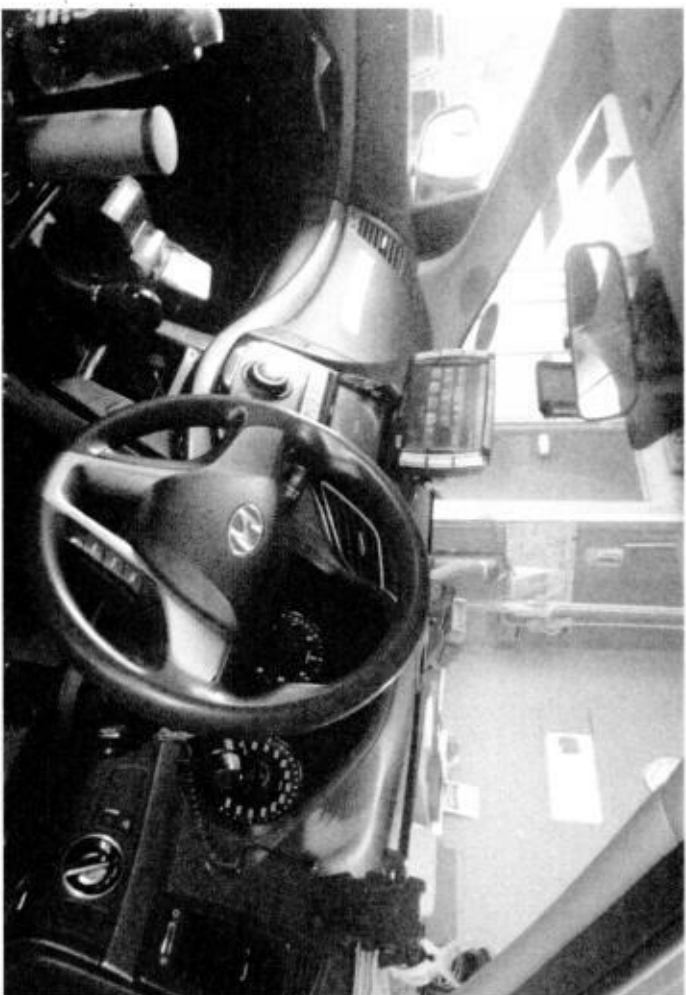
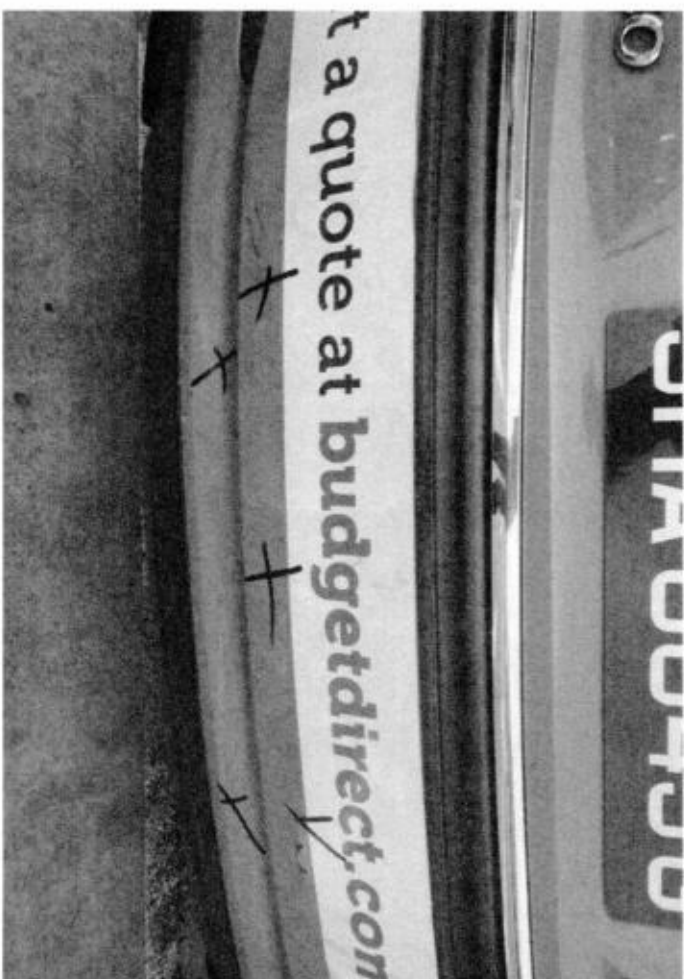
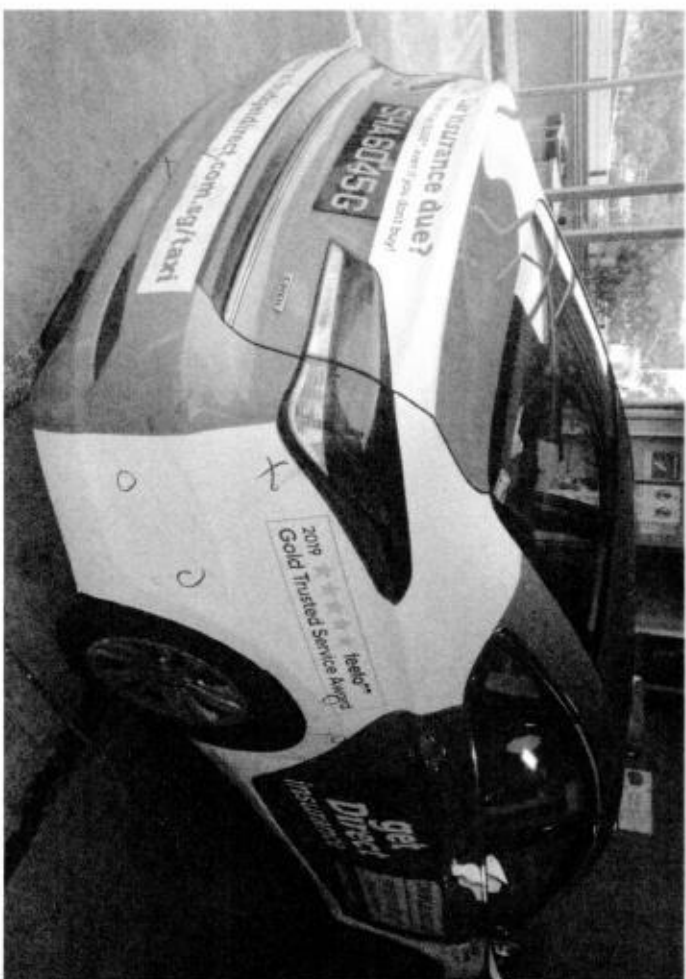
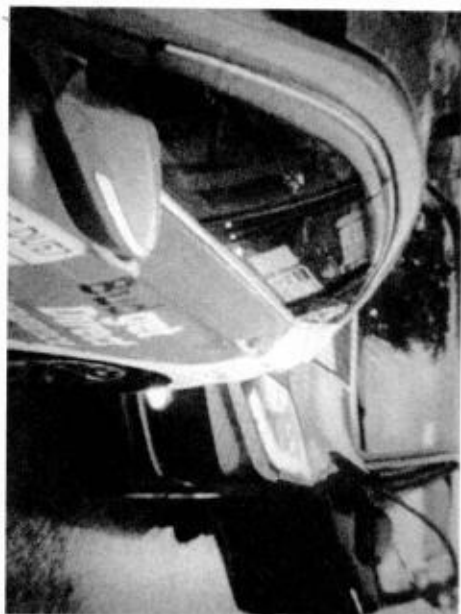
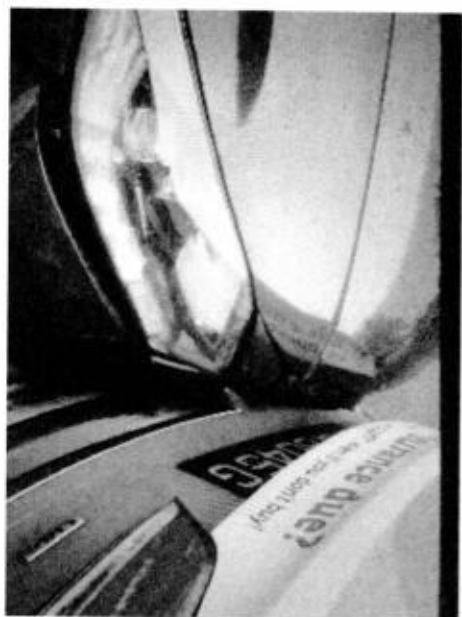
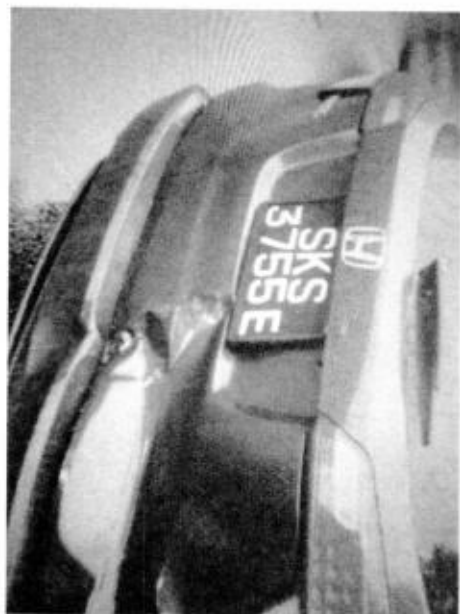
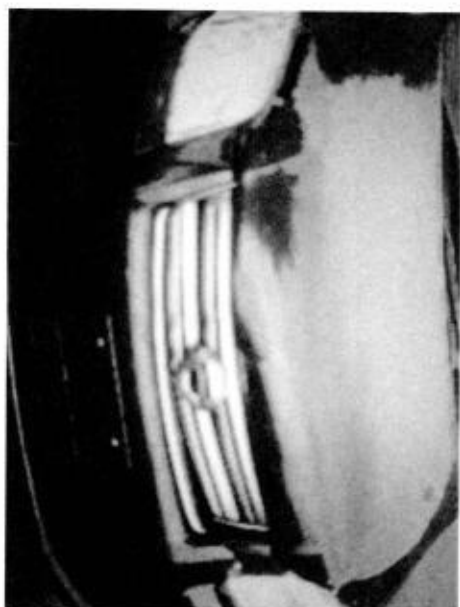
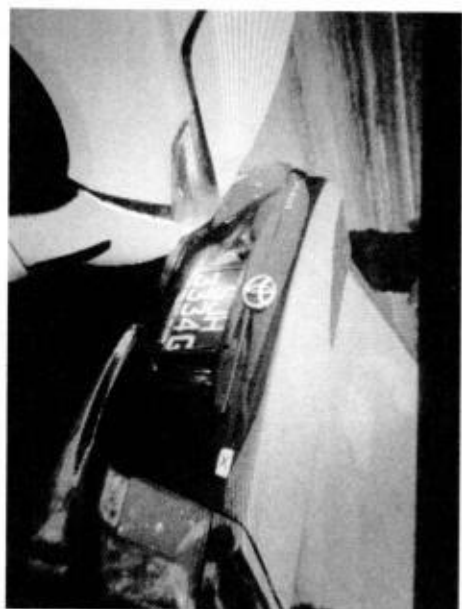
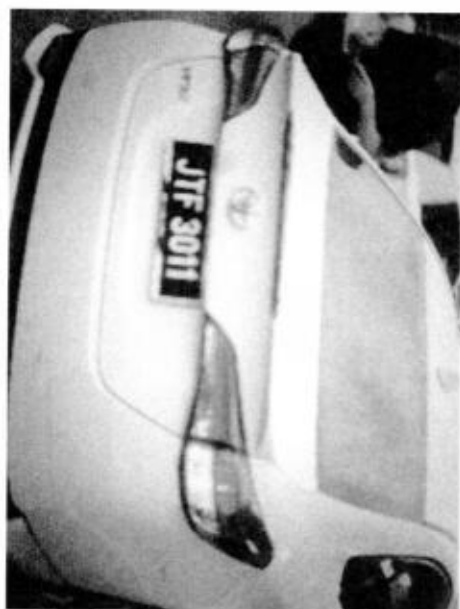
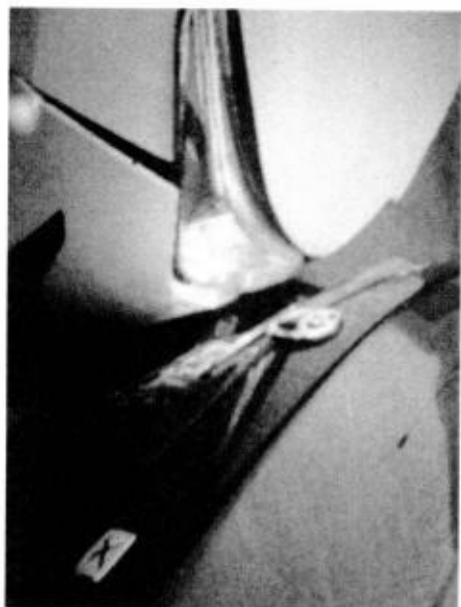
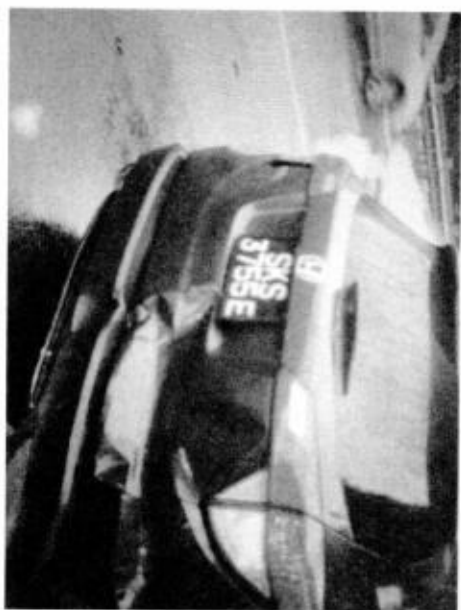
The U/C / Chassis frame / Body Structure affected due to collision.

Qty	Description of Parts	Condition	Estimate By Workshop (\$)	Our Adjusted (\$)
<b>REPLACEMENT OF PARTS</b>				
1	REAR BUMPER	DEFORMED	553.00	553.00
10	REAR BUMPER CLIP	NECESSARY	22.00	22.00
1	REAR BUMPER UNDER COVER	CUT	228.00	228.00
	LESS 20% DISCOUNT		-160.60	-160.60

642.40	642.40
<b>SPECIAL NETT ITEMS</b>				
1	REAR BUMPER ADVERTISEMENT LOGO (SN)	NECESSARY	50.00	50.00
1	REAR BUMPER RUBBER MAT (SN)	NECESSARY	50.00	50.00
2	REAR FENDER ADVERTISEMENT LOGO (LH/RH) @\$100.00 (SN)	NECESSARY	200.00	200.00
1	REVERSE SENSOR (SN)	SHORTED	135.70	135.70

435.70	435.70
<b>LABOUR</b>				
	PANEL BEATING.		400.00	200.00
	SPRAY PAINTING CHARGE.		300.00	200.00
	WIRING CHARGE.	NOT NECESSARY	50.00	-
	REMOVE/REFIX REVERSE SENSOR.		80.00	30.00

830.00	430.00
<b>GRAND TOTAL</b>			<b>1,908.10</b>	<b>1,508.10</b>
<b>RECOMMENDED COST OF LUMP SUM REPAIRS (TO ITS PRE-ACCIDENT CONDITION) (CONFIRMED)</b>				<b>1,200.00</b>
