REF: CS/SPF19015452/FVF302

From: Hafizul Farhan RAHMAT (SPF) <Hafizul_Farhan_RAHMAT@spf.gov.sg>
Sent: Monday, 2 September 2019 10:28 AM
To: assignments; Admin-D (LKKAuto)
Cc: Frankie THAY (SPF); Rosalyn TAN (SPF)
Subject: Pre-repair survey on SG 5098Z (vs GBC 967X)

ACCIDENT REPAIR ESTIMATES

ADJUSTMENT ON REPAIR COST FOR VEHICLE NO. SG 5098Z

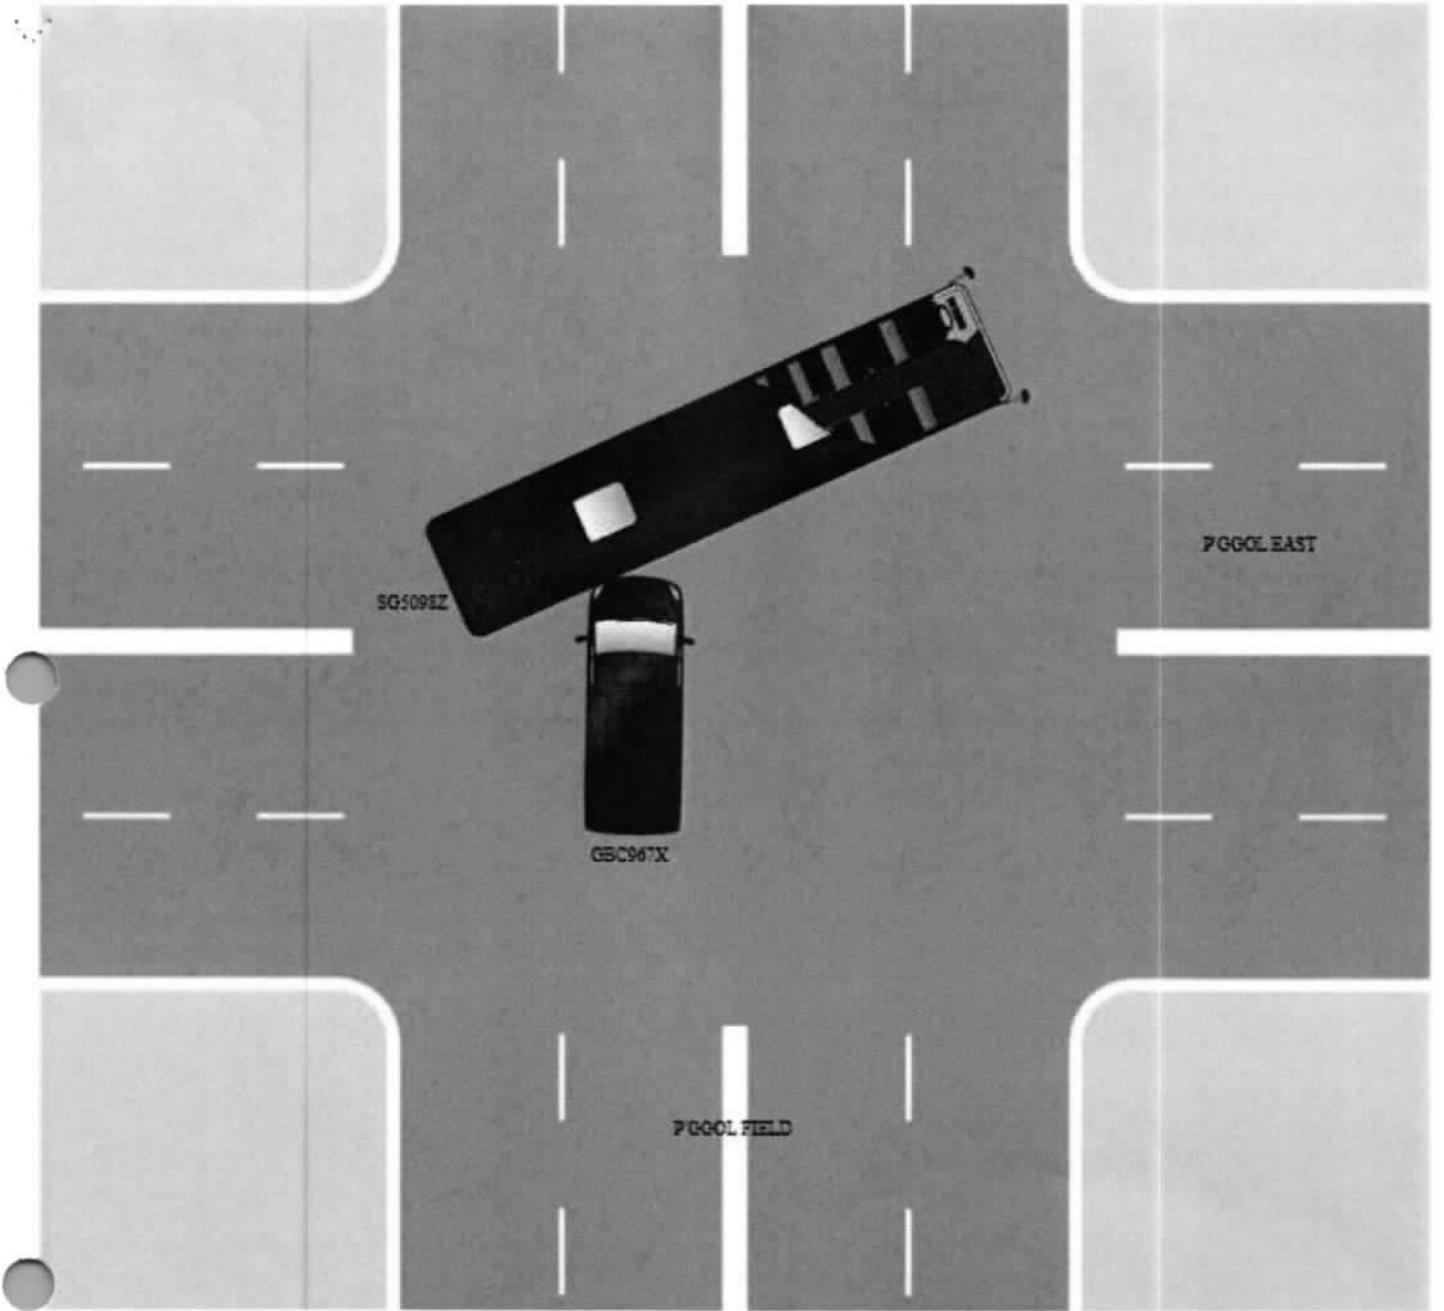
Sketch Plan

MY BUS WAS ON THE EXTREME LEFT LANE OF A 3-LANE RD ALONG PUNGGOL FIELD WHERE IT'S MEAN FOR GOING STRAIGHT & TURNING RIGHT WHILE THE REMAINING 2 LANES IS JUST PURELY MEAN FOR TURNING RIGHT. WHILST TURNING RIGHT TOWARDS B/S 65529 - AFT PUNGGOL FIELD ALONG PUNGGOL EAST WHEN A BLUE NISSAN POLICE VAN THAT WAS ON THE MIDDLE LANE HEAD STRAIGHT INSTEAD OF TURNING RIGHT. AS A RESULT, THE FRONT LEFT MIRROR & CORNER BUMPER OF THE NISSAN VAN GRAZED AGAINST THE REAR RIGHT PANEL OF MY BUS

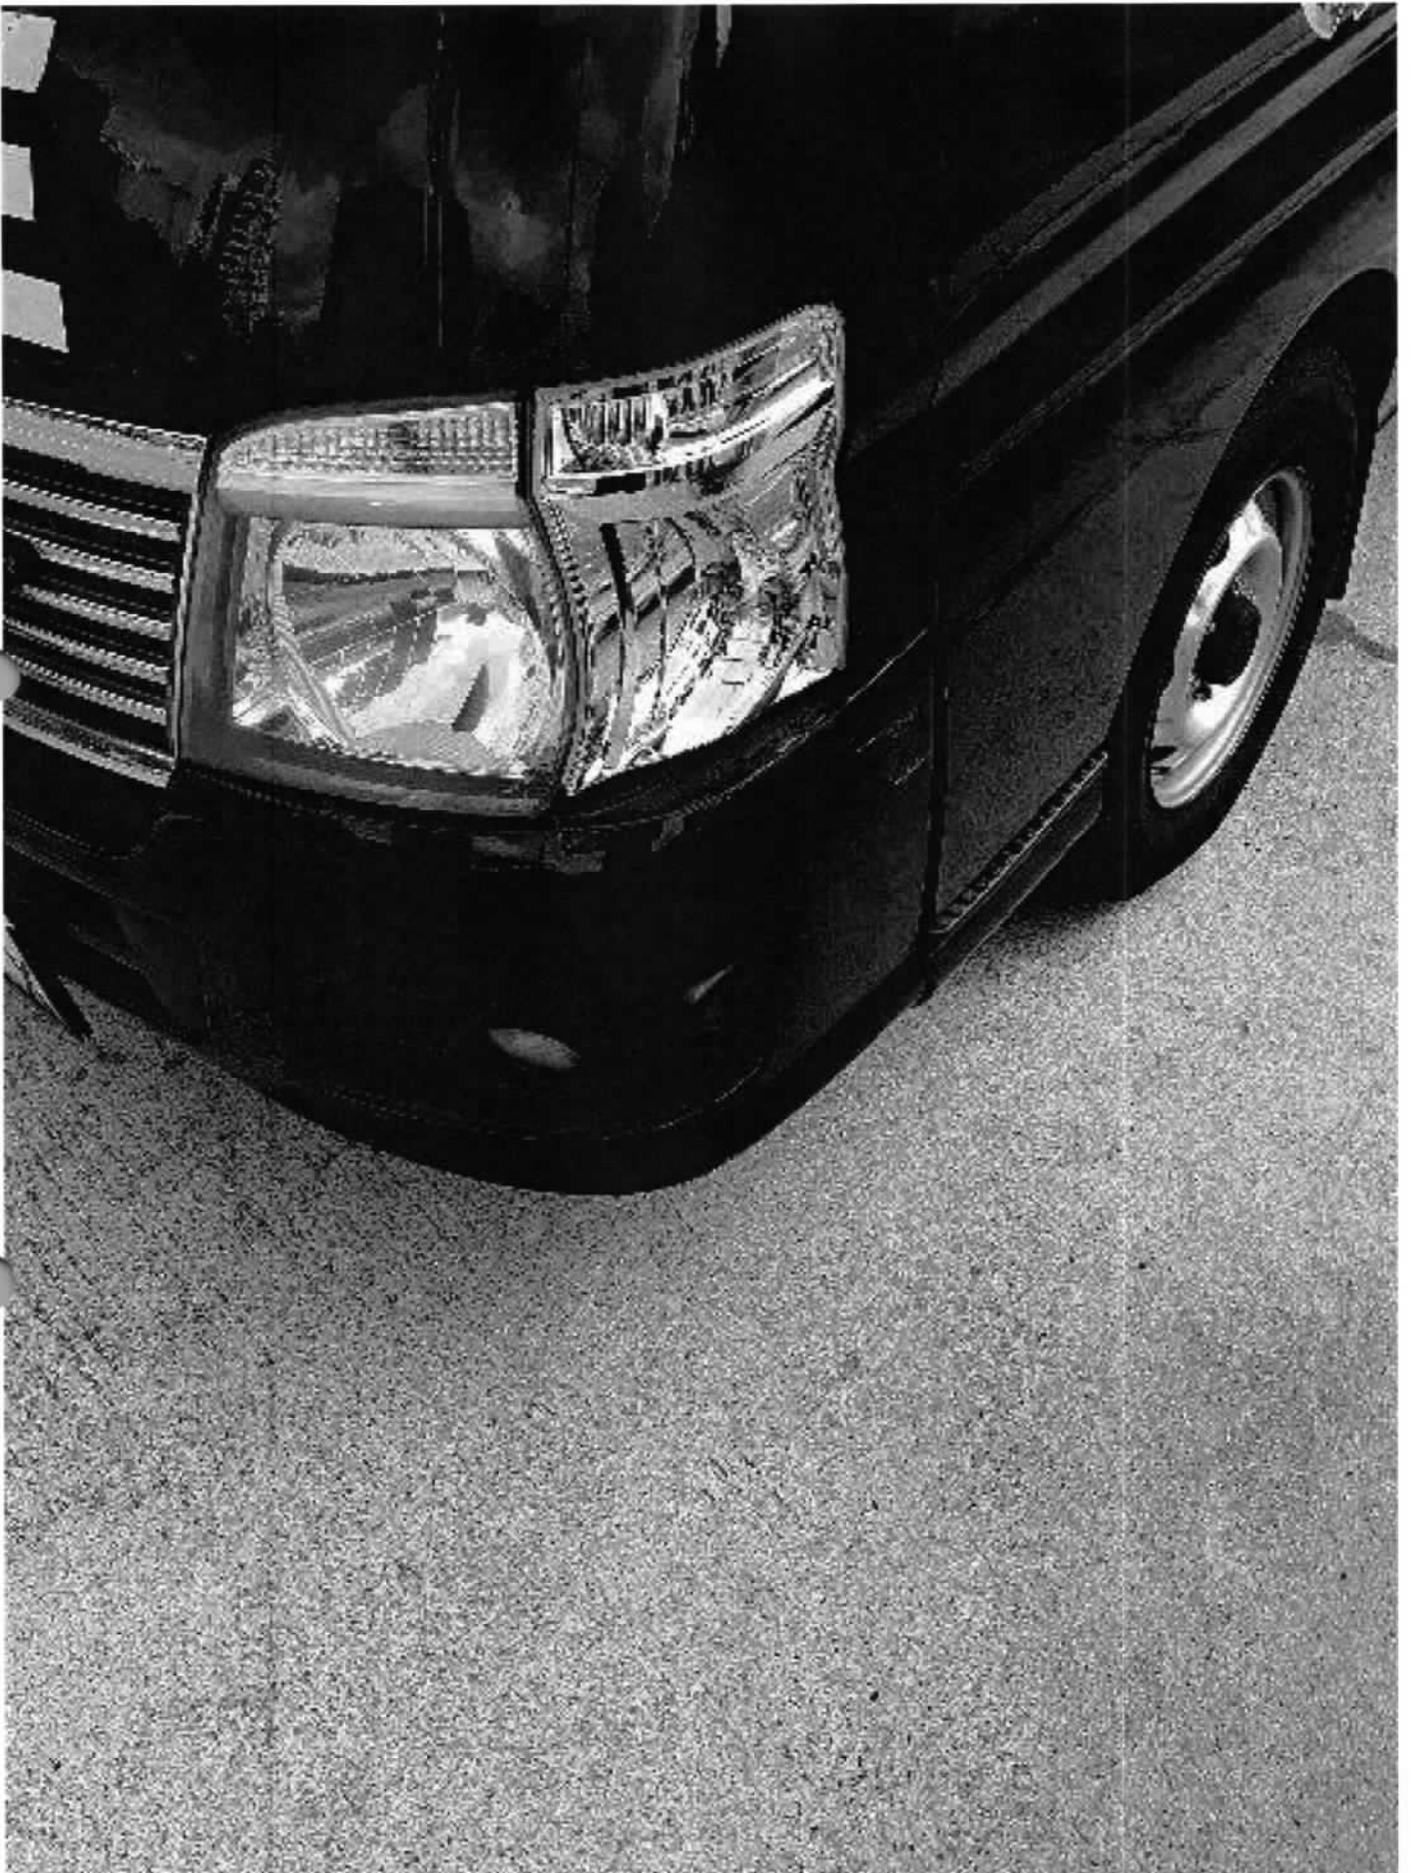
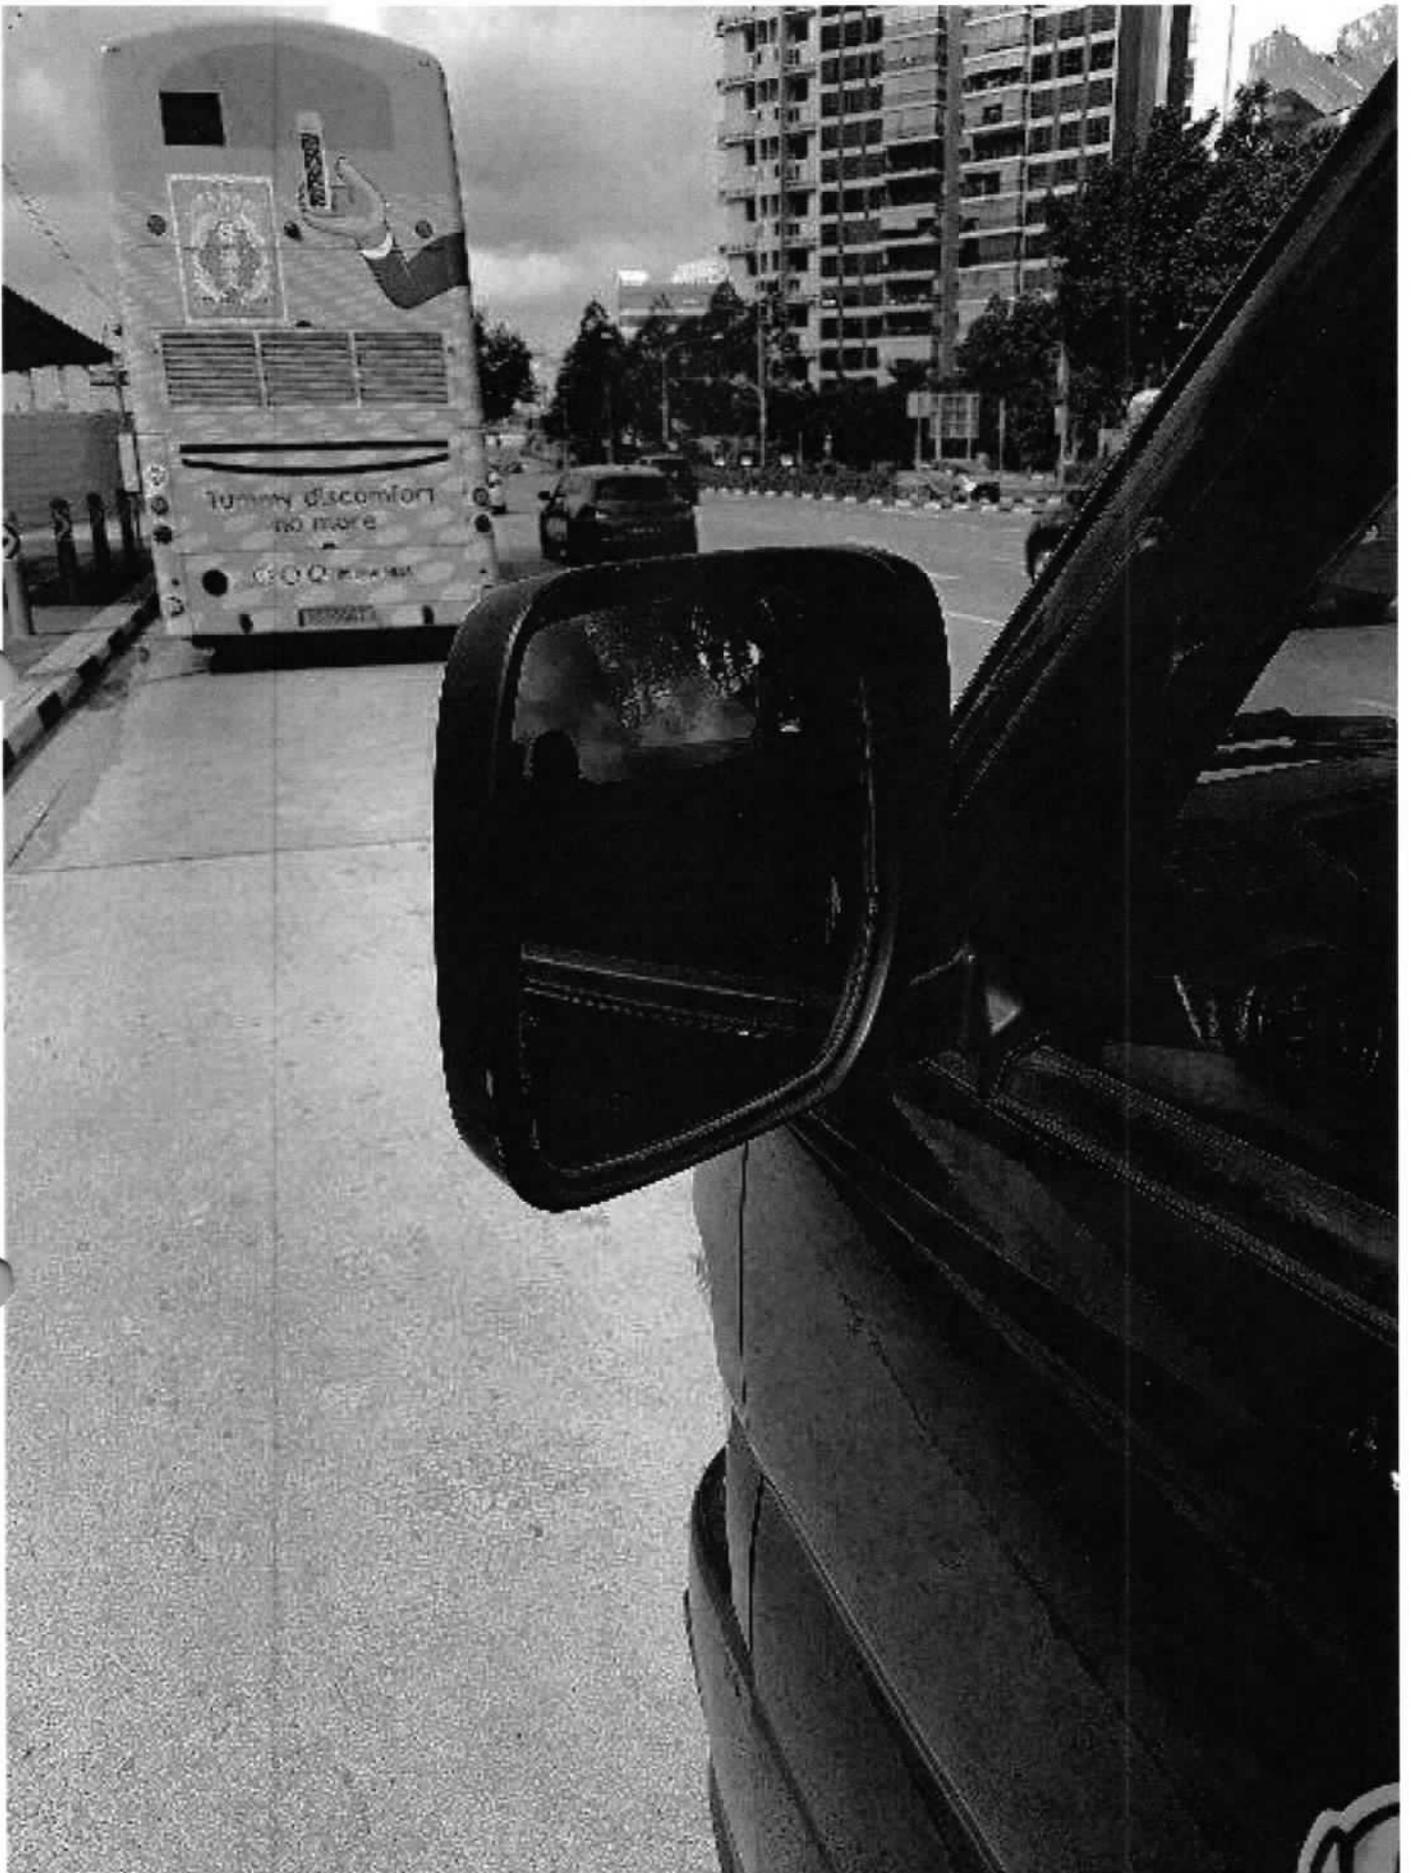
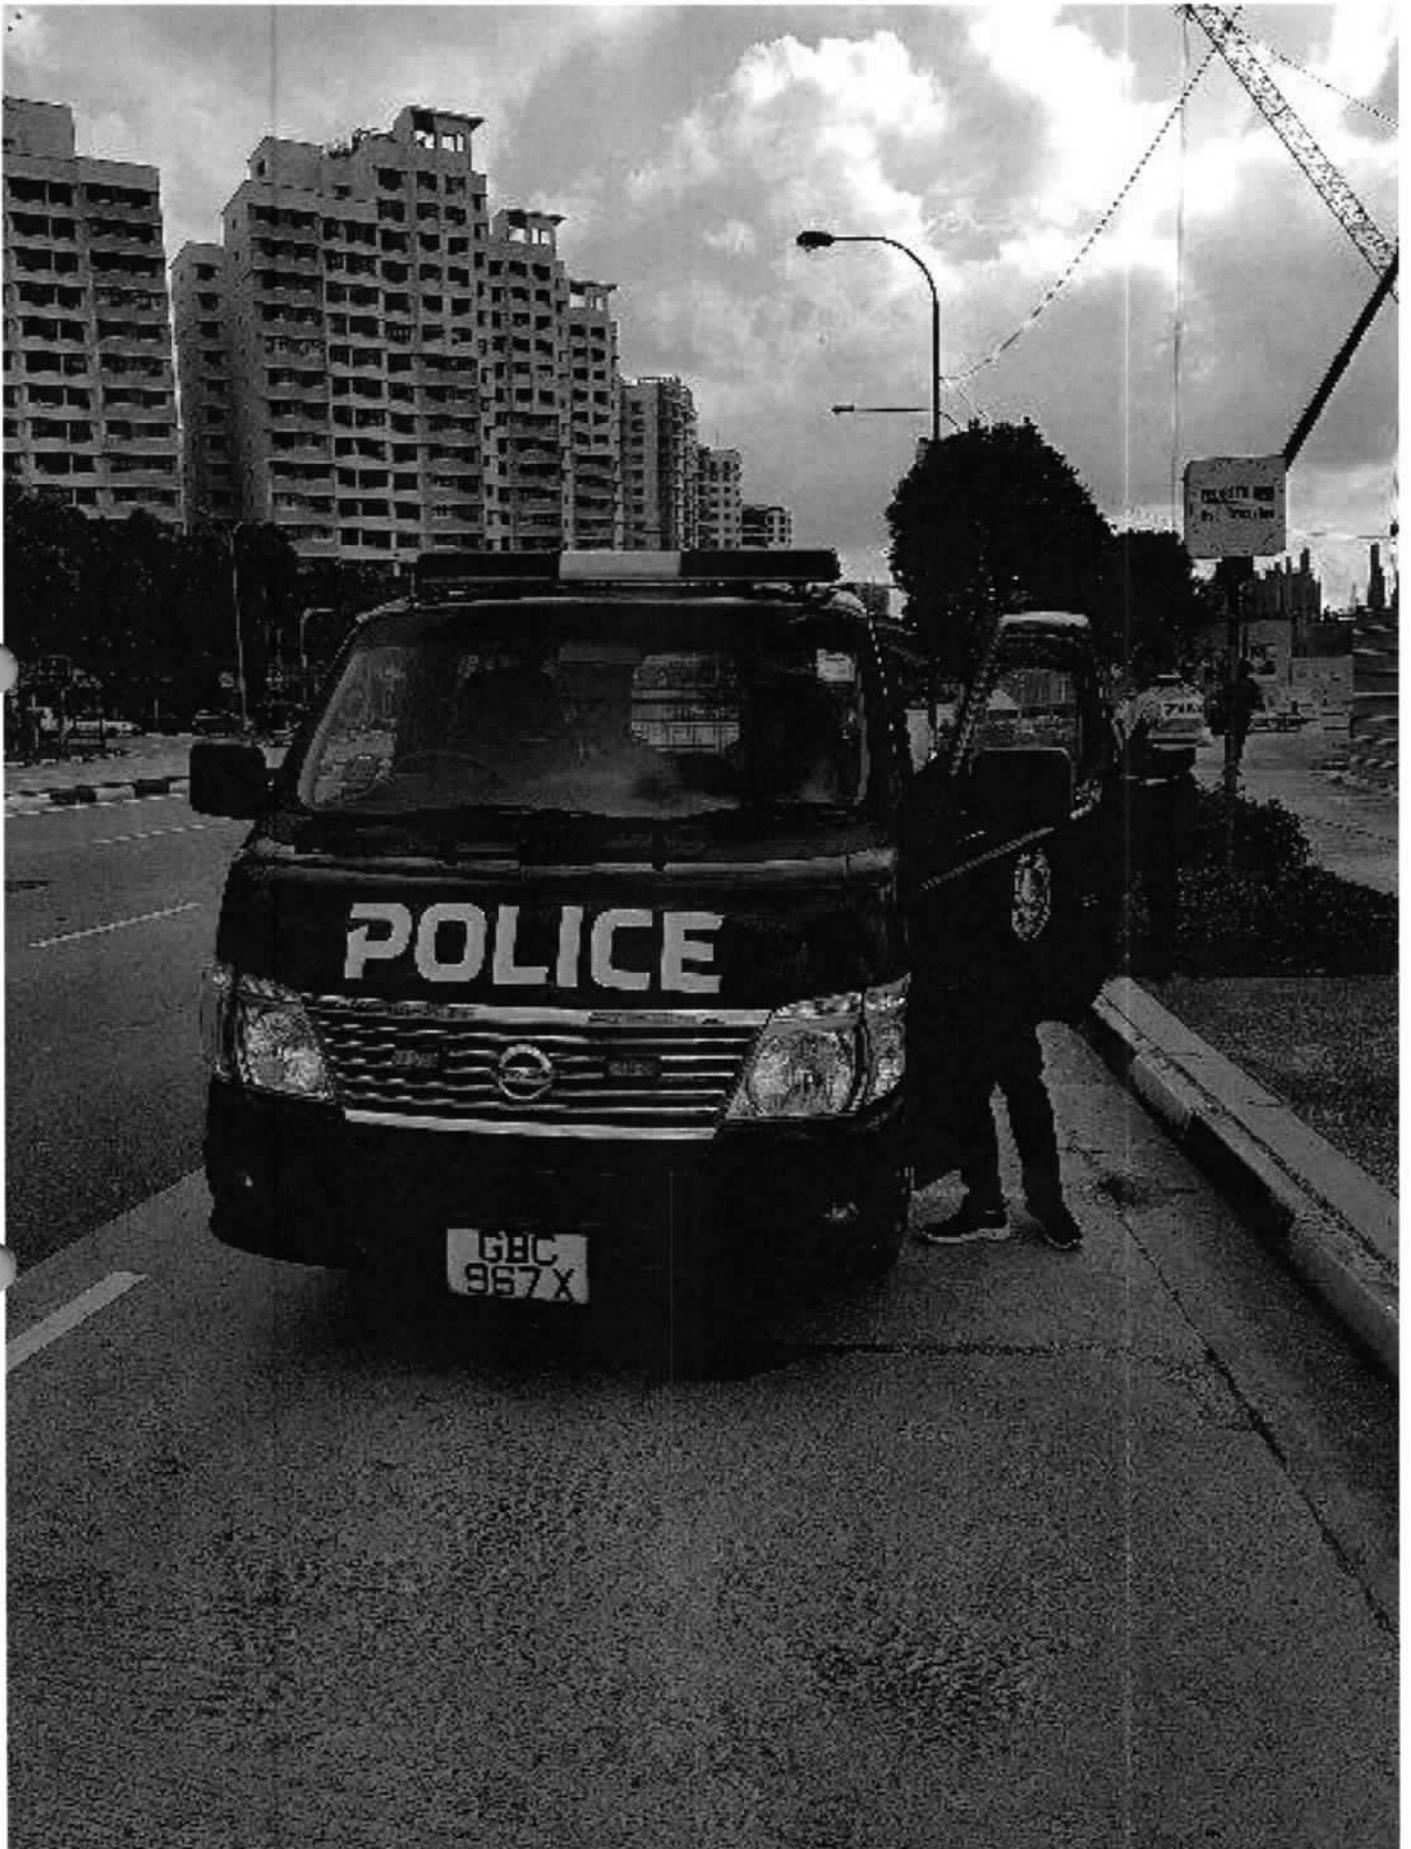
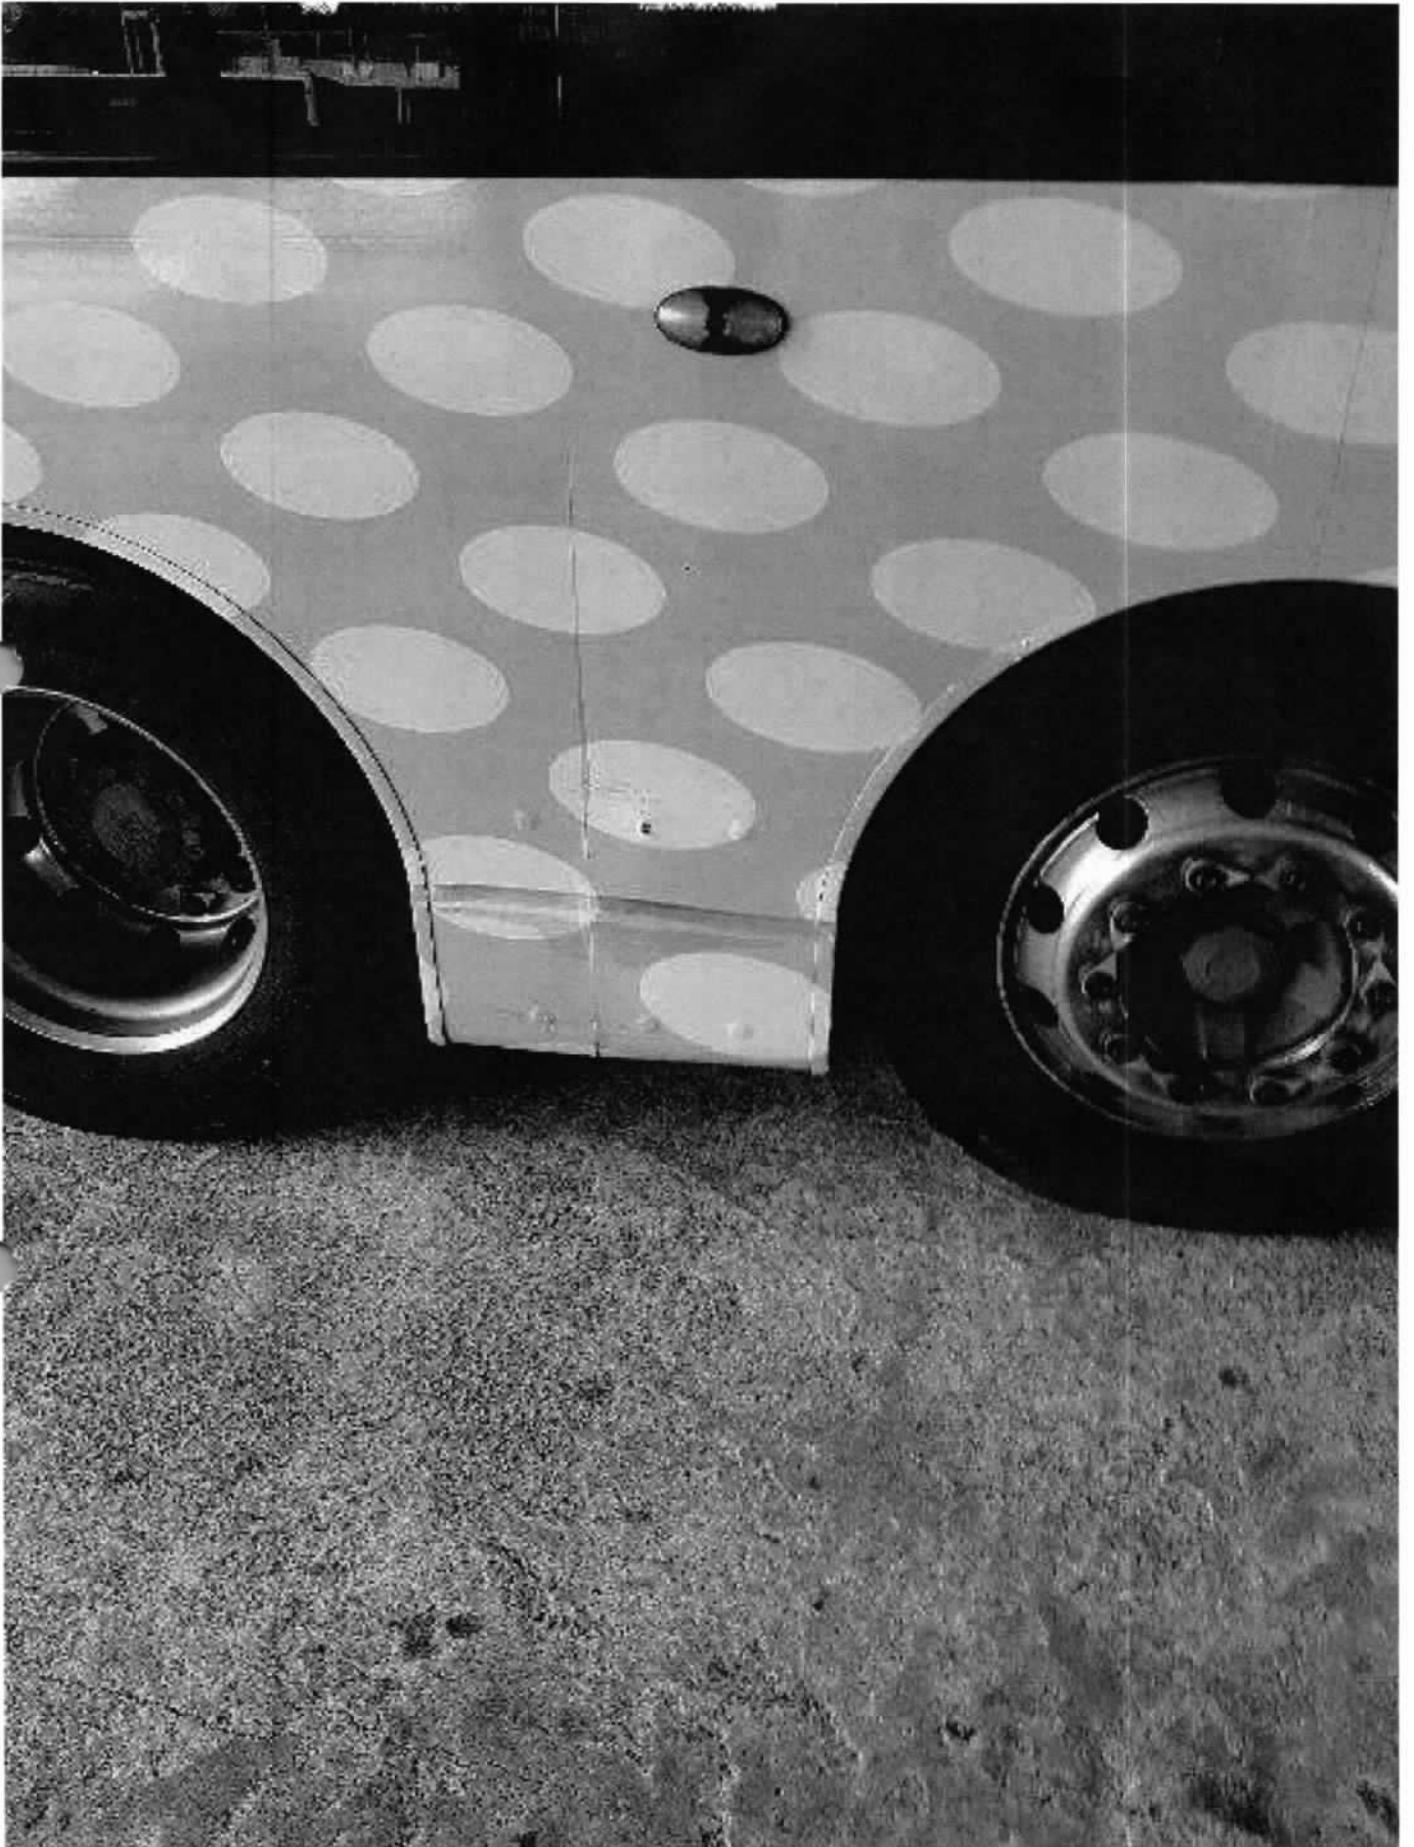
Accident Photo

Due to the accident, the side of my bus was damage and dented. As for the police van, there was some minor damage to its left headlight.

4. Description of Damages			
THE VEHICLE SUSTAINED DAMAGES AT THE O/S BODY. DAMAGES SEE DETAILS.			
5. General Information			
Accident Date	23/08/2019	Inspection Date	02/09/2019
Survey held at	205 BRADDELL ROAD BLK D		
Repairer	COMFORTDELGRO ENGINEERING PTE LTD		
5a. Remarks			
A)THE INSPECTION WAS CONDUCTED ON A"WITHOUT PREJUDICE" BASIS. B)IN ACCORDANCE TO YOUR INSTRUCTIONS, WE HAVE NOT AUTHORISED REPAIRS.			
5b. Estimate Days of Repair			
ESTIMATED NORMAL PERIOD FOR REPAIR:		3 Working Days

Qty	Description of Parts	Condition	Estimate By Workshop (\$)	Our Adjusted (\$)
	LABOUR			
	REPAIR O/S NO.5 REAR WHEELARCH PANEL.		360.00	280.00
	REPAIR O/S NO.6 REAR WHEELARCH PANEL.		360.00	280.00
	REPLACE ECTERIOR ADVERTISEMENT STICKER.		480.00	400.00
	RESPRAY ALL ACCIDENT BODY PANEL.		450.00	380.00
			1,650.00	1,340.00
	GRAND TOTAL		1,650.00	1,340.00
RECOMMENDED COST OF REPAIRS				1,340.00
