NTUC INCOME INSURANCE CO-OPERATIVE LTD Ref: NS/INC19015537/K1qf3n2

1. Policy Particulars :- THIRD PARTY CLAIM

4. Description of Damages

ADJUSTMENT ON REPAIR COST FOR VEHICLE NO. SH 8582S

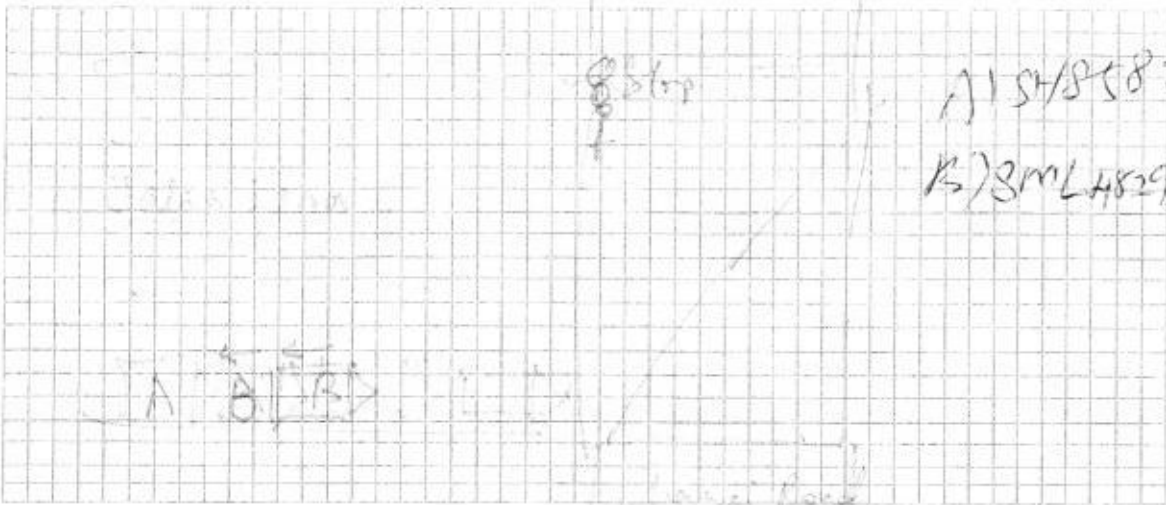
SKETCH PLAN

On 30/8/19 at about 1330hrs while I Veh A was stationary waiting behind Veh B, Veh B suddenly reversed and collided and contacted the front portion of my vehicle.

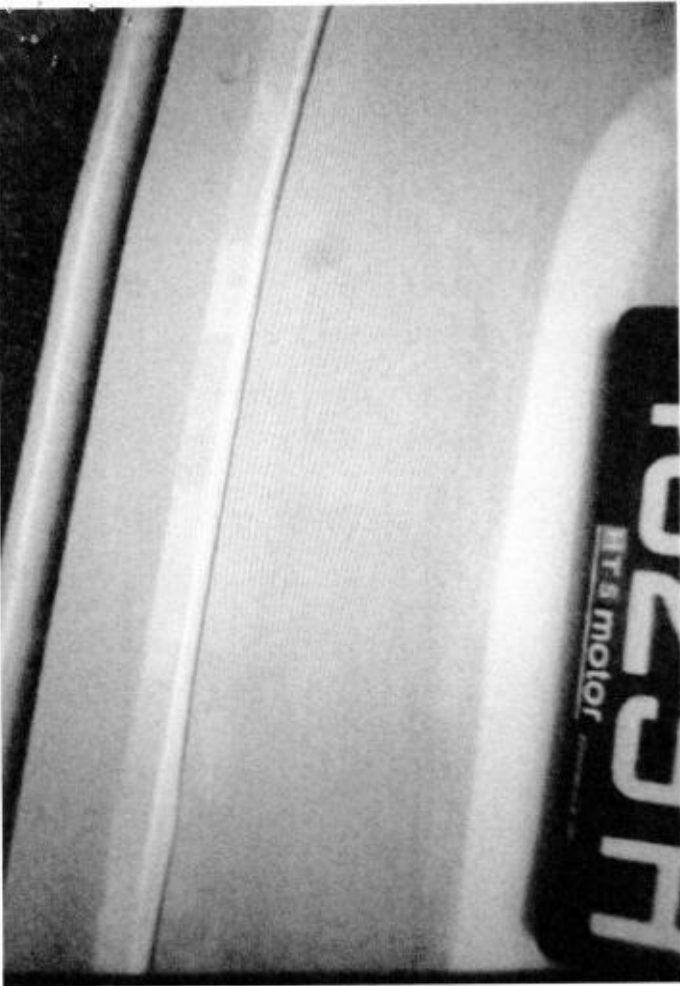
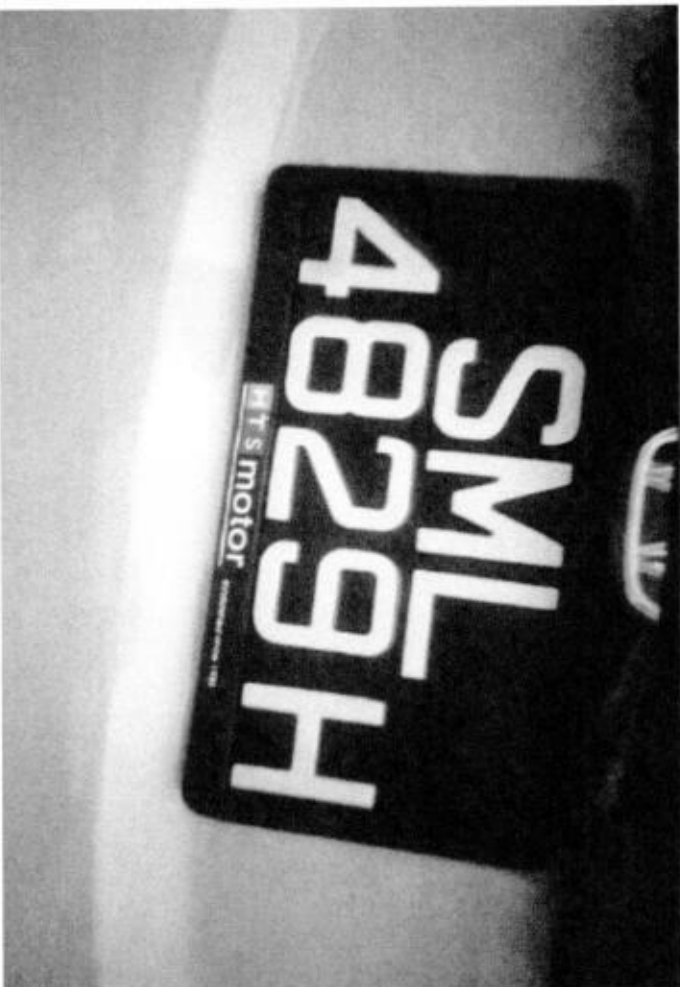
THE VEHICLE SUSTAINED DAMAGES AT THE FRONT PORTION.
DAMAGES SEE DETAILS.

Qty	Description of Parts	Condition	Estimate By Workshop (\$)	Our Adjusted (\$)
REPLACEMENT OF PARTS				
1	FRONT BUMPER	SERVICEABLE	418.30	-
10	FRONT BUMPER CLIPS @\$2.20	NOT NECESSARY	22.00	-
1	RADIATOR GRILLE	CRACKED	1,227.50	1,227.50
	LESS 20% DISCOUNT		-333.56	-245.50
			1,334.24	982.00
SPECIAL NETT ITEMS				
1	FRONT NUMBER PLATE (SN)	CRACKED	25.00	25.00
1	FRONT NUMBER PLATE CASING (SN)	SERVICEABLE	30.00	-
			55.00	25.00
LABOUR				
	PANEL BEATING.		300.00	200.00
	SPRAY PAINTING CHARGE.	NOT NECESSARY	300.00	-
	WIRING CHARGE.	NOT NECESSARY	50.00	-
			650.00	200.00
GRAND TOTAL			2,039.24	1,207.00
RECOMMENDED COST OF REPAIRS (CONFIRMED)				1,207.00
