OD/TP Re-inspection / Evaluation

Our Ref : PP/ET/CT.1896.TP.7-19

**Re : Third Party Claim
Vehicle Registration No. SLC 1896 S**

VEHICLE INSPECTION REPORT

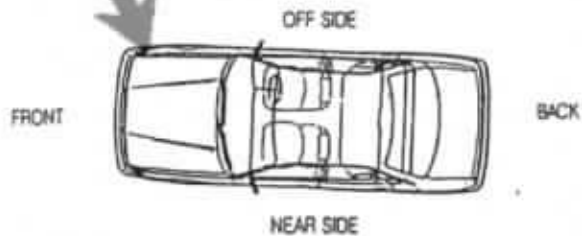
Damages sustained were consistent with the subject vehicle being involved in a collision with another vehicle and the impact was delivered onto the o/s front portion of the vehicle. Apparently, the o/s front wheel was struck-upon, thus, misaligning its wheel camber/geometry.

Damages sustained were the bonnet & its inner reinforcement- dented/bent/buckled/warped over an extensive area, bonnet hinge o/s & n/s- bent/misaligned, bonnet inner lock/catch- bent/shifted, front bumper assembly, o/s front fender & its inner panel- dented/buckled/crumpled/warped, front top panel/headlamp panel o/s- thrust inwards/buckled and front door pillar o/s- buckled, etc-----

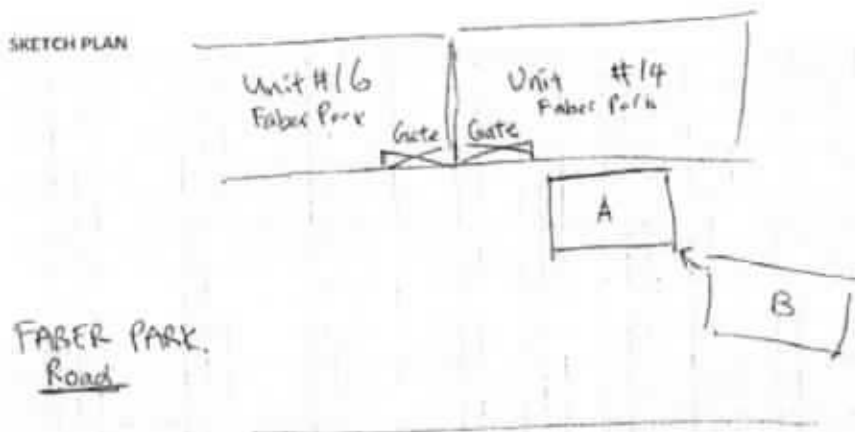
SKETCH PLAN

I was at home sleeping when I heard a loud bang outside my house. My neighbour rang the doorbell, to inform me my car outside had been hit. My car, which was parked, had been hit by a young female driver (SKR 7531M). She was with another passenger and a dog. She had hit the right side of my car. She apologized to me many times and said she was playing with her phone. The other passenger also apologized. My car was covered with a car cover (as shown in picture), it was stationary and parked at the side of a road.
