VEHICLE DAMAGE INSPECTION REPORT

Our File No: CS/CTI19015812/R1QF3E2

Reg No: SJG4656B

Make & Model: TOYOTA PRIUS, 1.5 HYBRID (A)

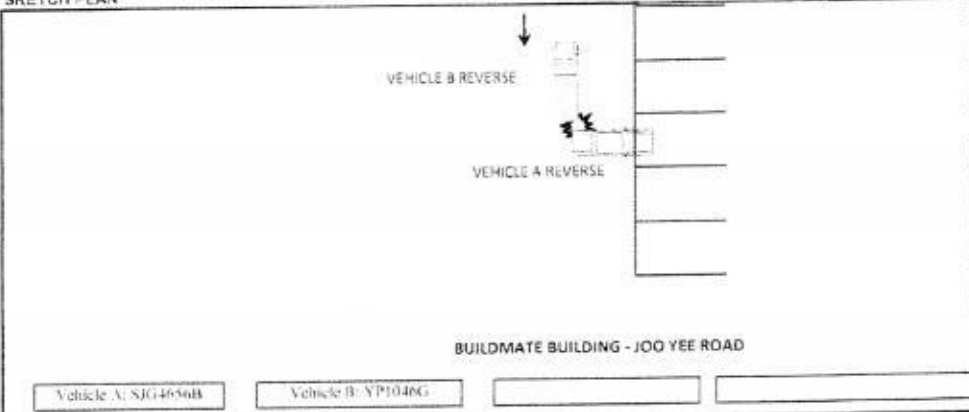
SKETCH PLAN

VEHICLE B REVERSE

VEHICLE A REVERSE

BUILD MATE BUILDING - JOO YEE ROAD

Vehicle A: SJG4656B Vehicle B: NP1046G

I REVERSED MY VEHICLE WHEN VEHICLE B WAS STATIONARY. AS I CONTINUED TO REVERSE, VEHICLE B STARTED TO REVERSE AS WELL. I STOPPED MY VEHICLE IMMEDIATELY AND HORN AT HIM BUT VEHICLE B STILL CONTINUE TO REVERSE AND HIT INTO THE LEFT PASSENGER DOOR OF MY VEHICLE.
