To Inspect Vehicle No: SLB 5657U

# ASSIGNMENT

Make: BMW 214D C.C. 1416

## VEHICLE DAMAGE INSPECTION REPORT

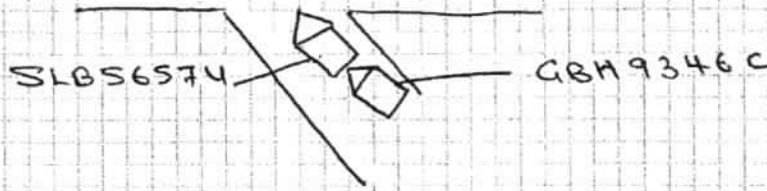
### SKETCH PLAN

- On element AVE 6, slip road into AVE (TURS), was on the right most lane and was trying to join AVE (TURS) when GBH9346C collided into the rear of my car.
