VEHICLE DAMAGE INSPECTION REPORT

Our File No: CS/CTI19016584/KQD3E2

Claimant
Vehicle No : SLK6606MInsured
Vehicle No : GG9000X

Make & Model: HONDA JAZZ, 1.5 (A)

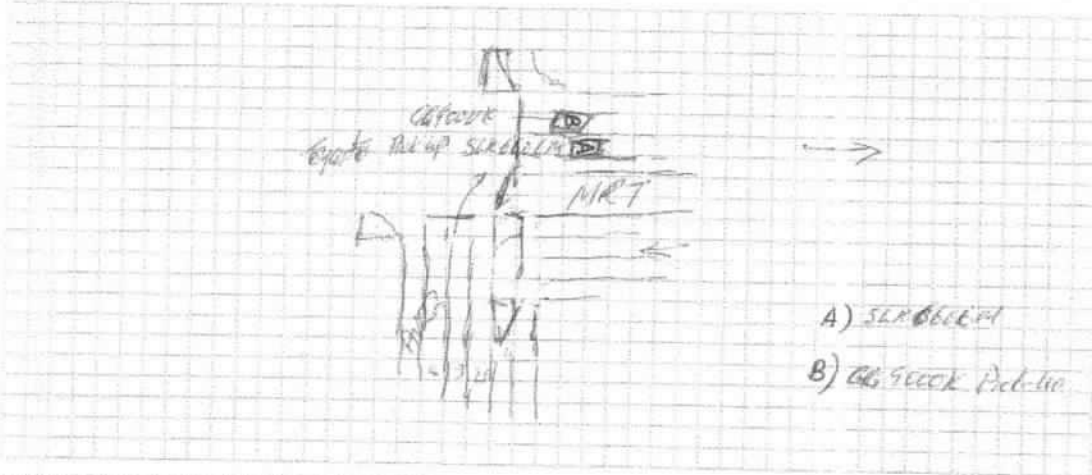
SKETCH PLAN

on Saturday 14/09/19 travelling on Avenue 2 turning towards Corner South West.
 After I have already made my turn is indicated in the traffic light at about 1.30pm.
 Suddenly from behind my car the pick-up Toyota 666000K ran forward my car and hit it.
 on the left side near the front door thus damaging it.
