REF: 08/CTI/19016963 / Utd304

To Inspect Vehicle No: SMN2310P

VEHICLE DAMAGE INSPECTION REPORT

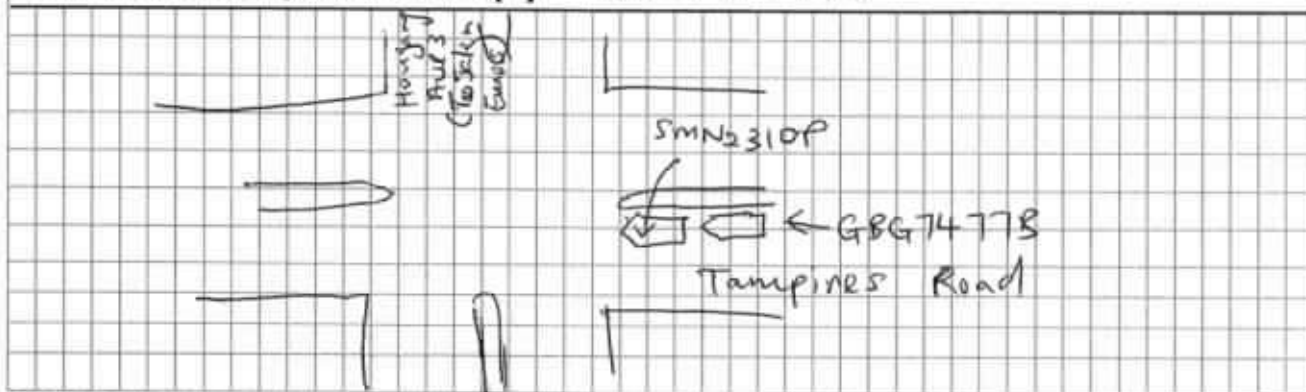
SKETCH PLAN

Stopped at turning lane of junction at Tampines Road side. After 10-15 seconds, GBG7477B banged into the rear of my stationary car.
