To Inspect Vehicle No: SGQ 13514

**RW AUTOMOTIVE APPRAISERS SERVICES**

VEHICLE DAMAGE INSPECTION REPORT

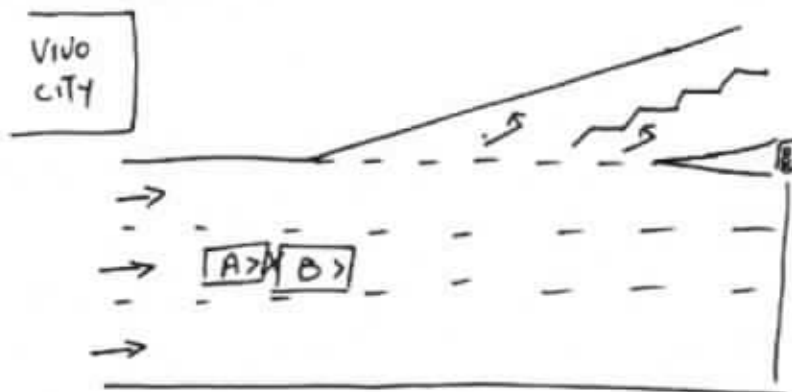
SKETCH PLAN

ON 18/6/19 ABOUT 615 PM, I WAS TRAVELLING ON TELOK BUANGAH ROAD TOWARDS HARBOUR FRONT CENTRE. I HAD A DUE VISION AND ~~WAS~~ I SAW VEH B'S (IN FRONT) BRAKE LIGHT BUT I DID NOT STOP IN TIME HENCE COLLIDED INTO ITS REAR. MY FRONT BONNET, BUMPER, LIGHT IS ALL DAMAGE. I ^{WAS} ADMITTED TO SGH FOR FURTHER CHECKUP.

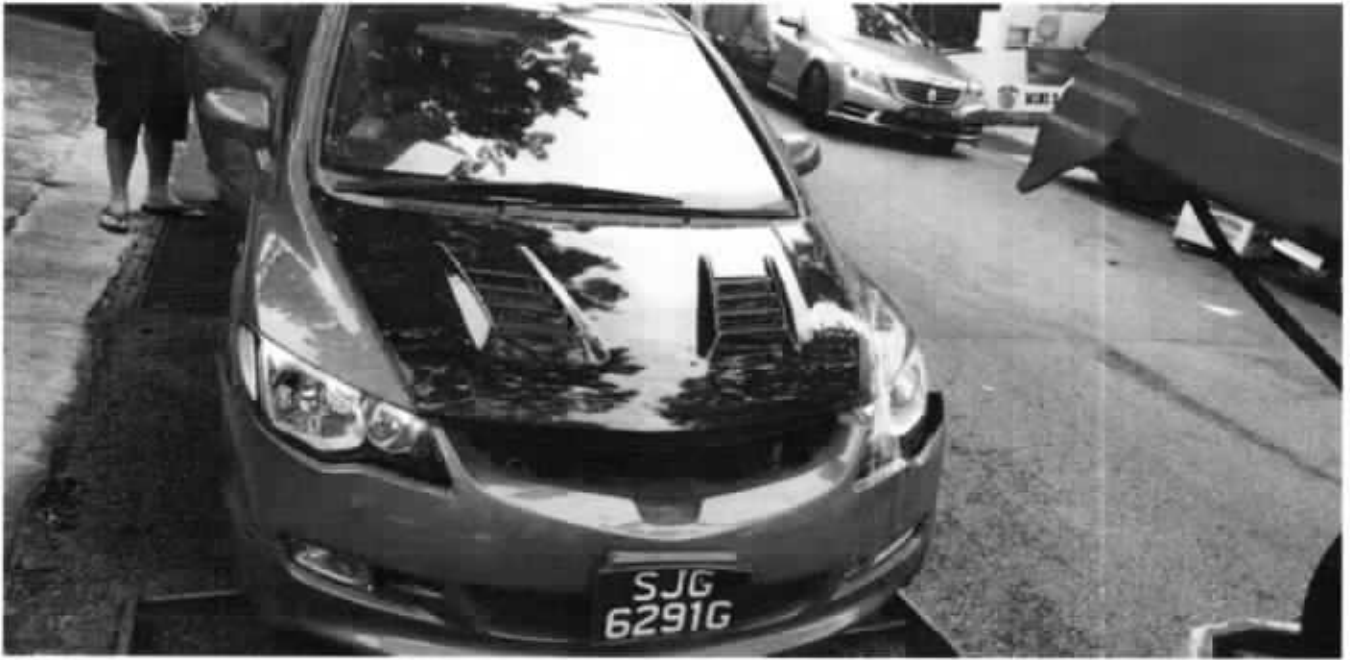
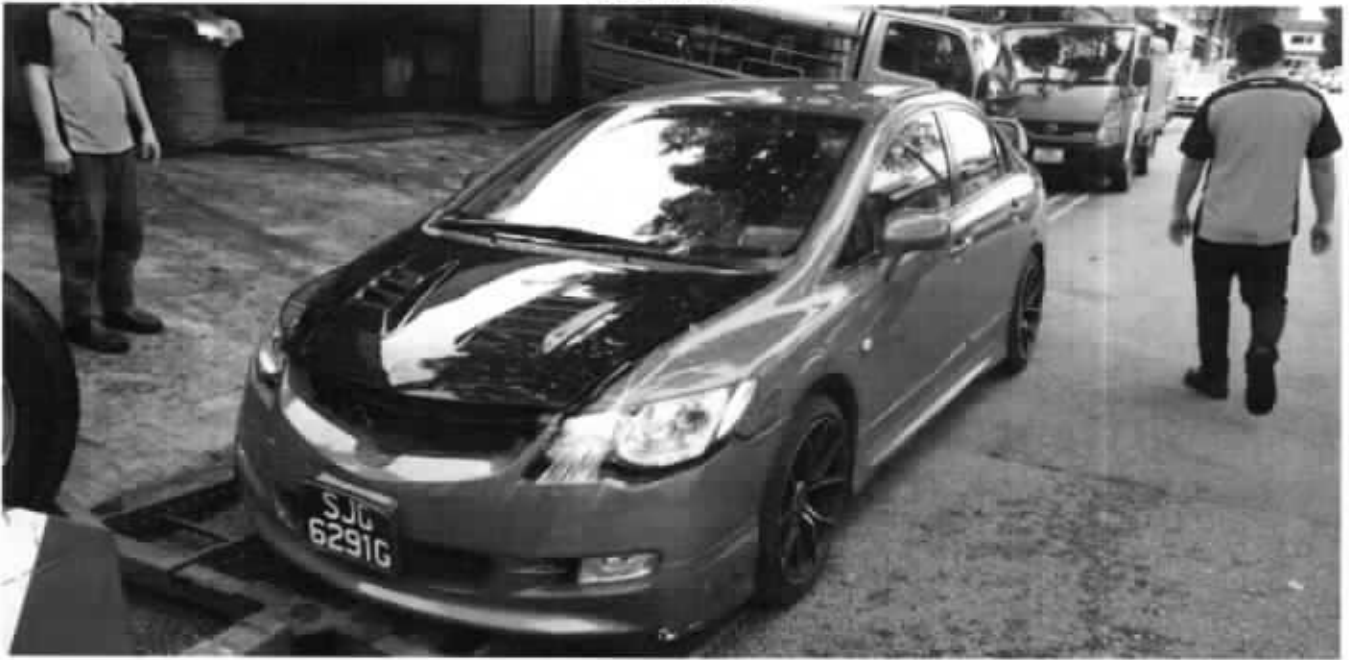
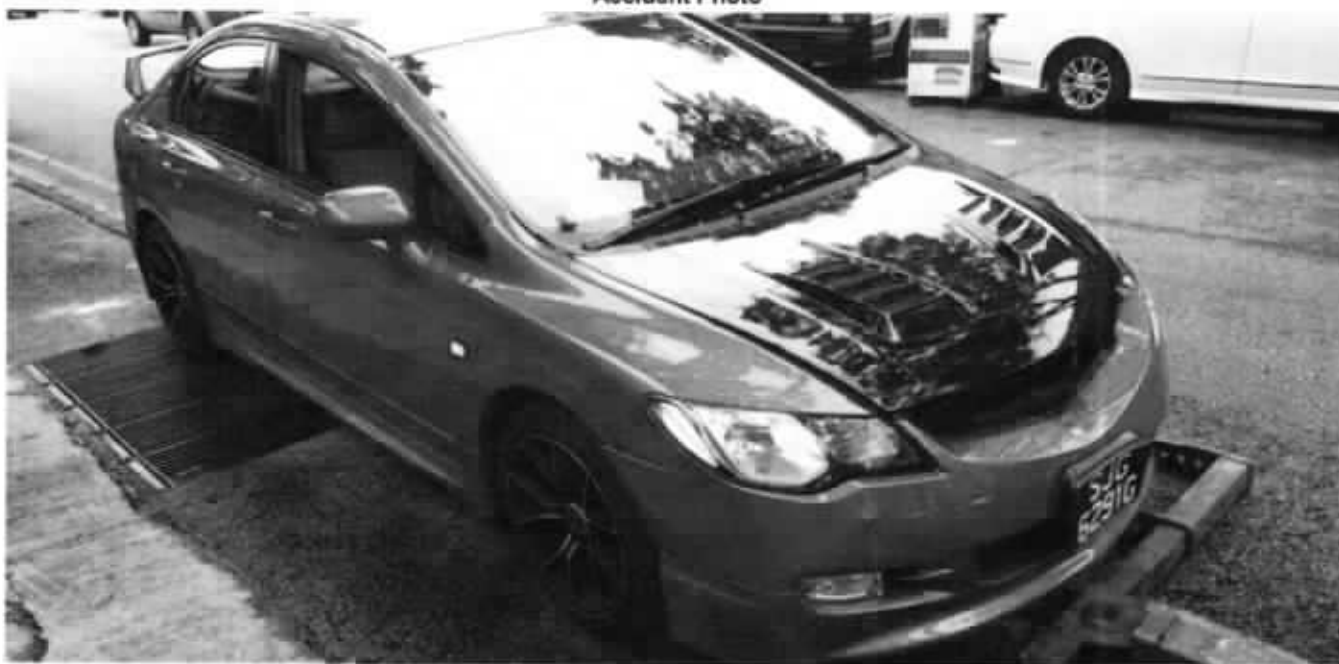
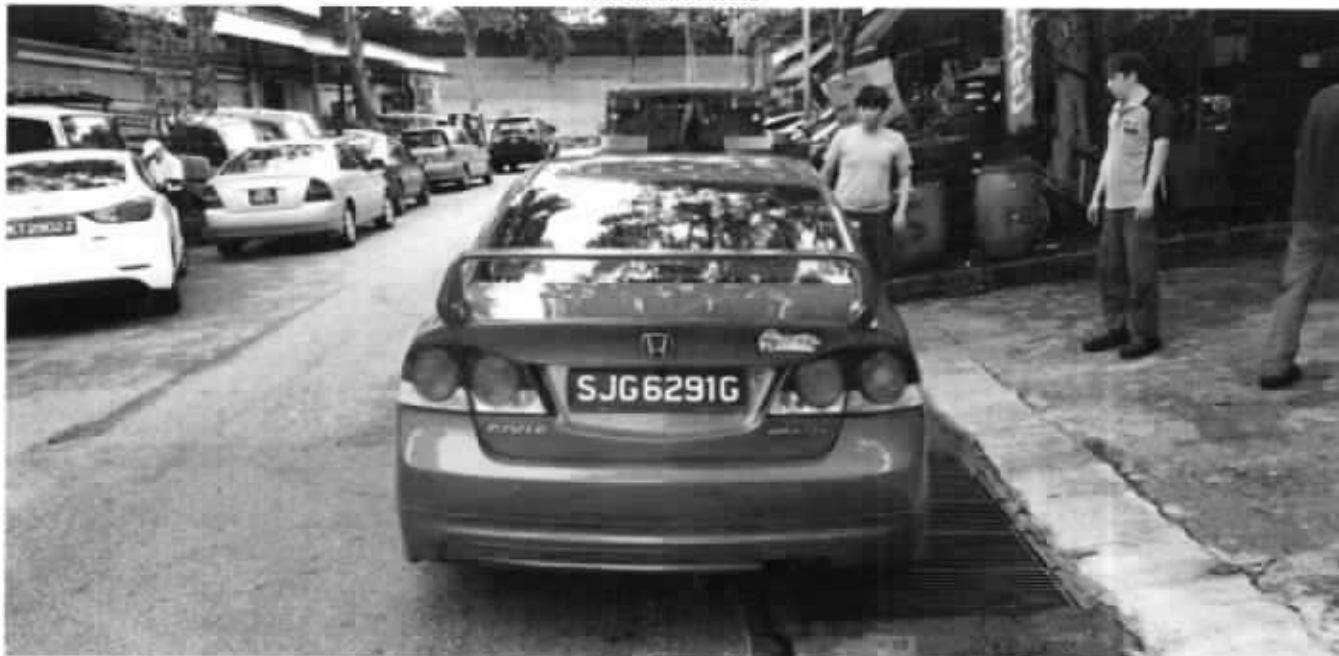
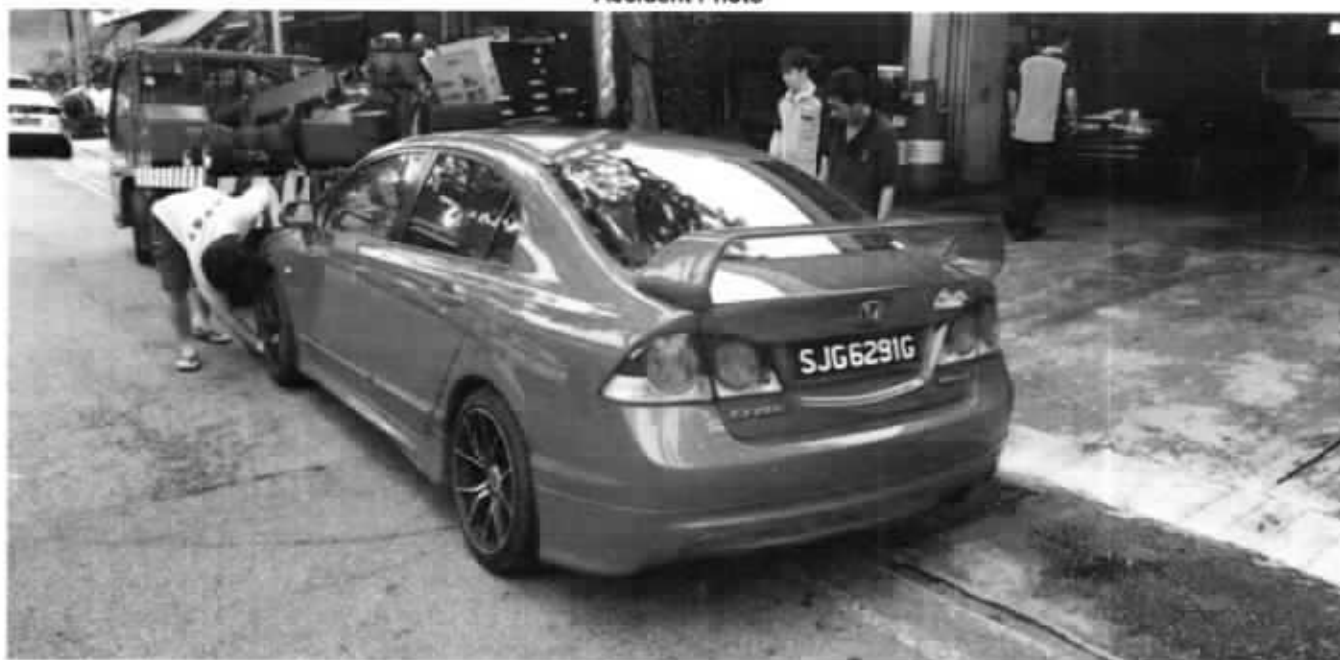
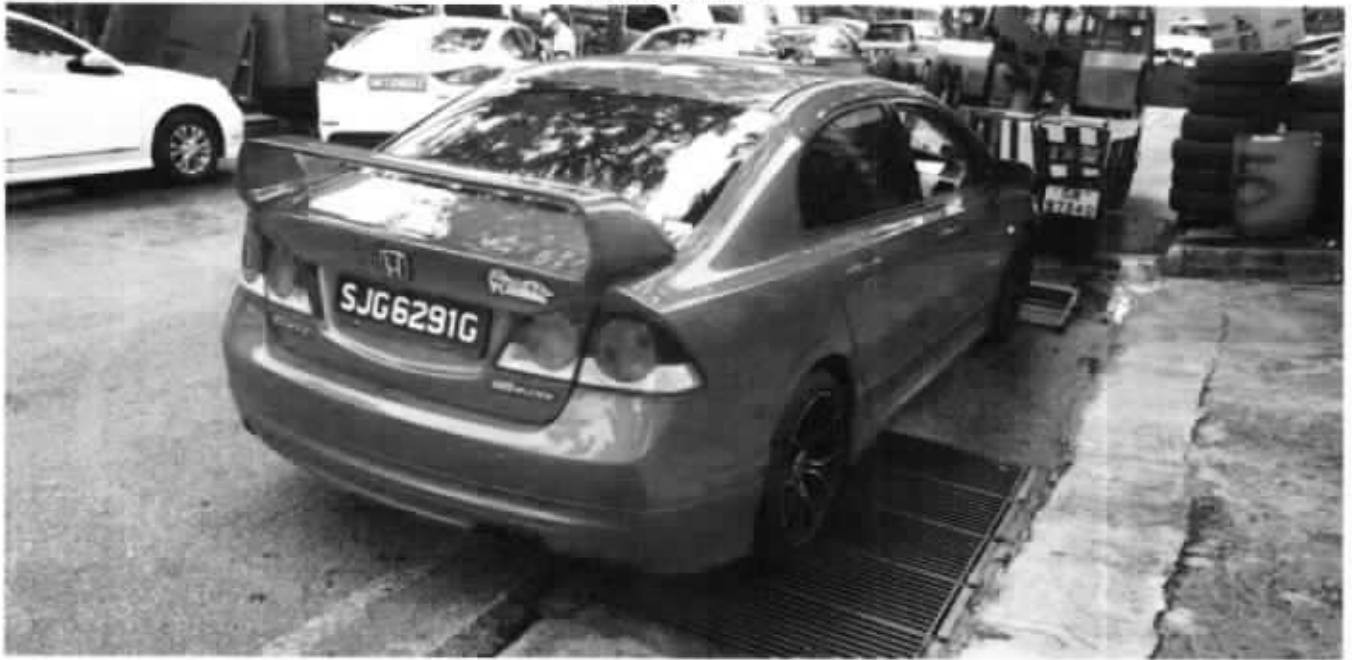
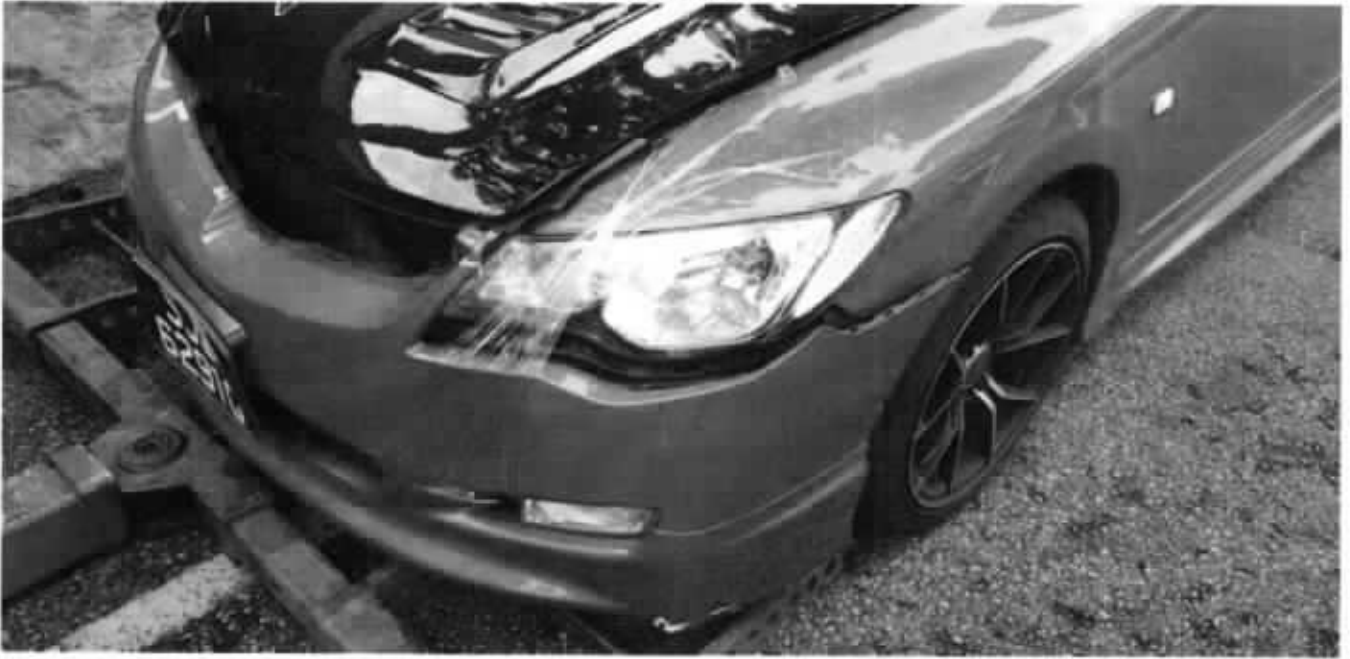
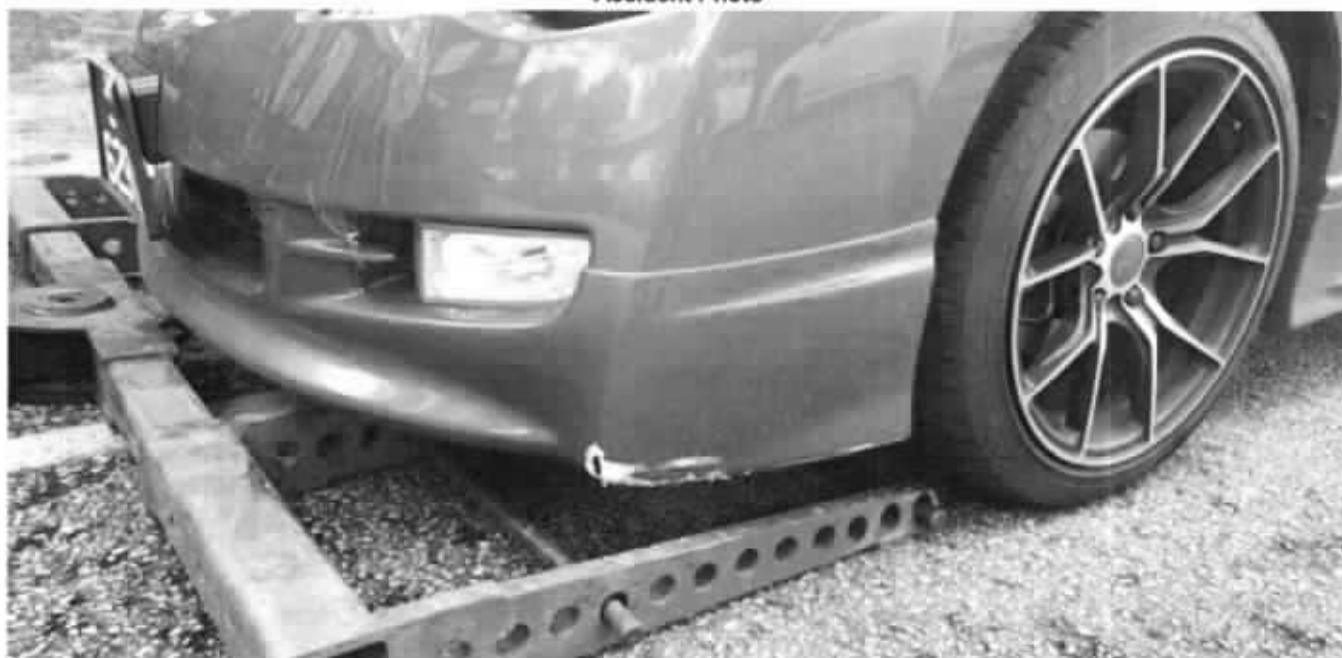
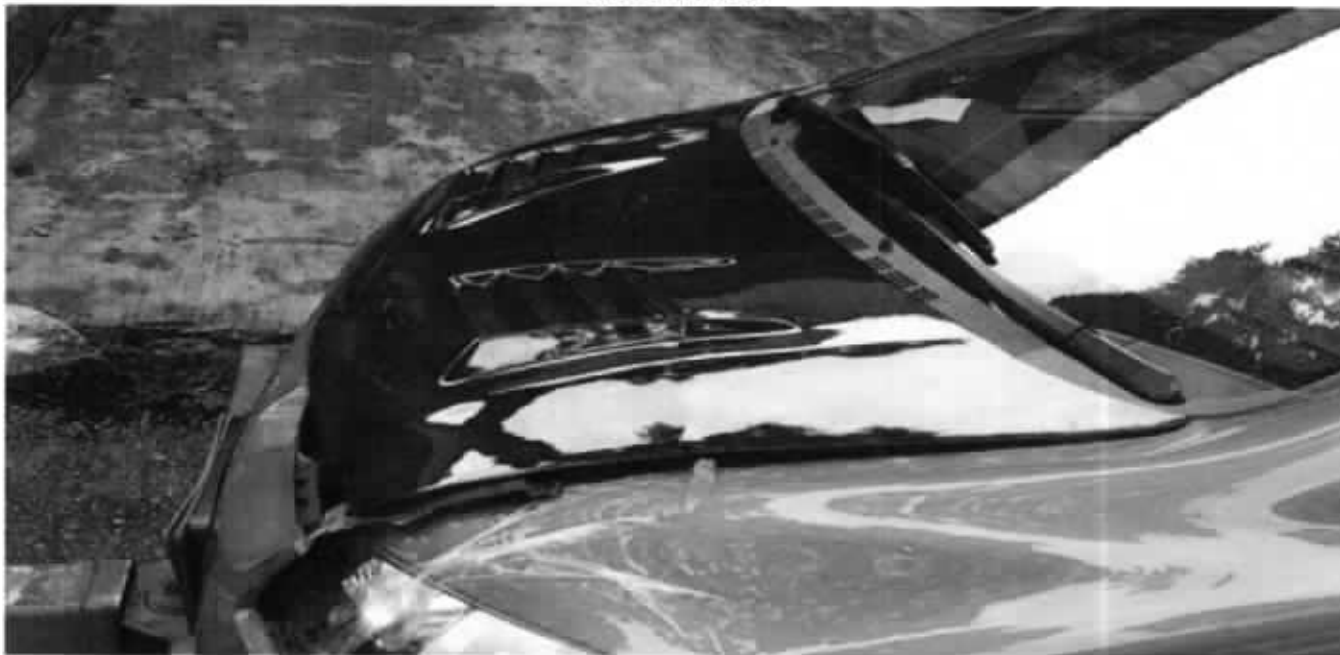
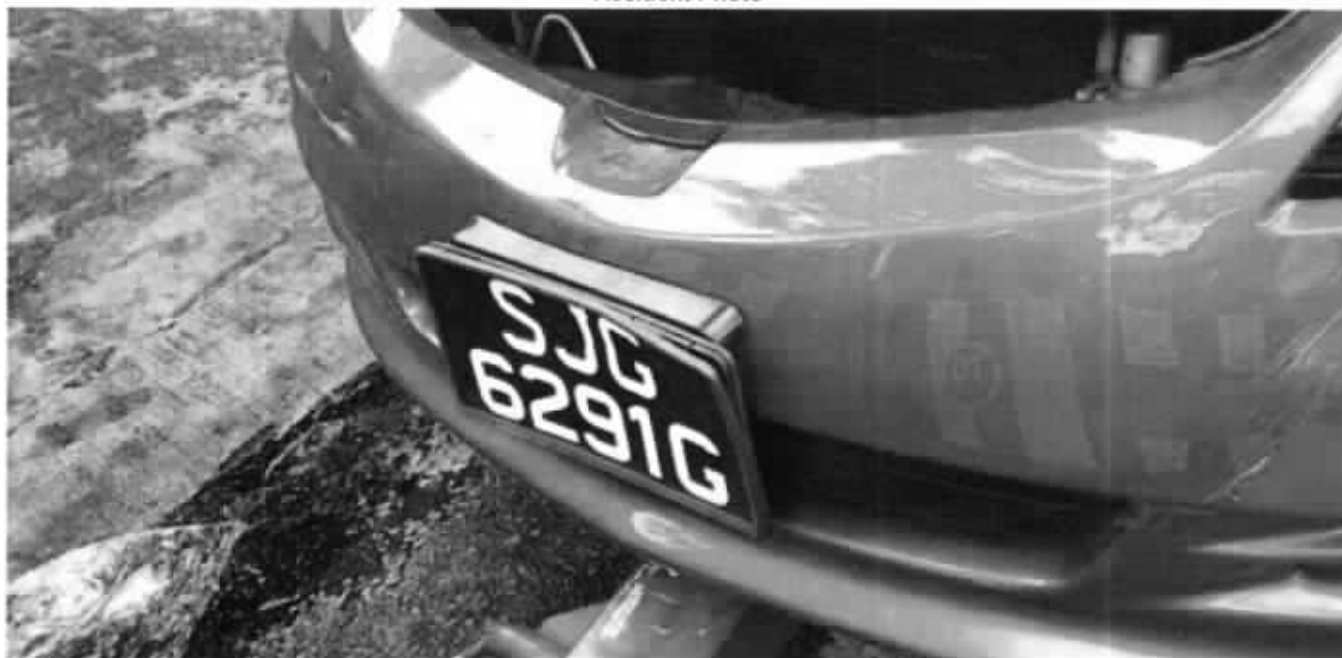
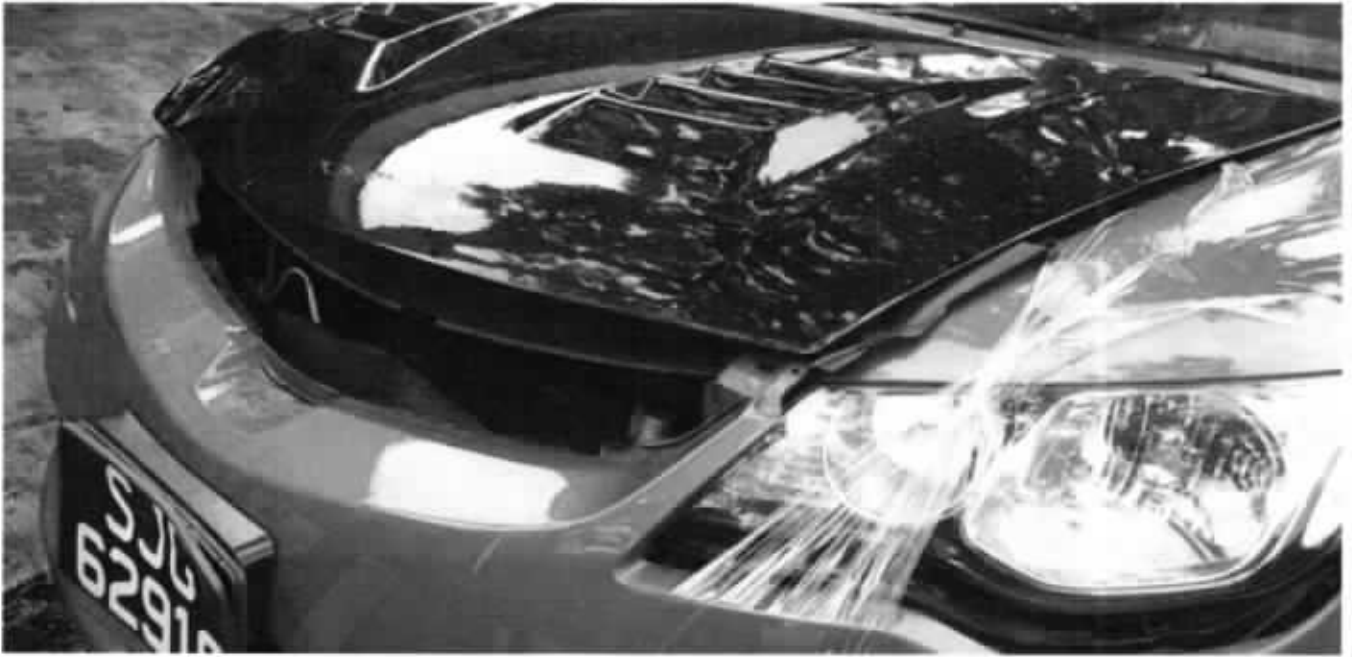
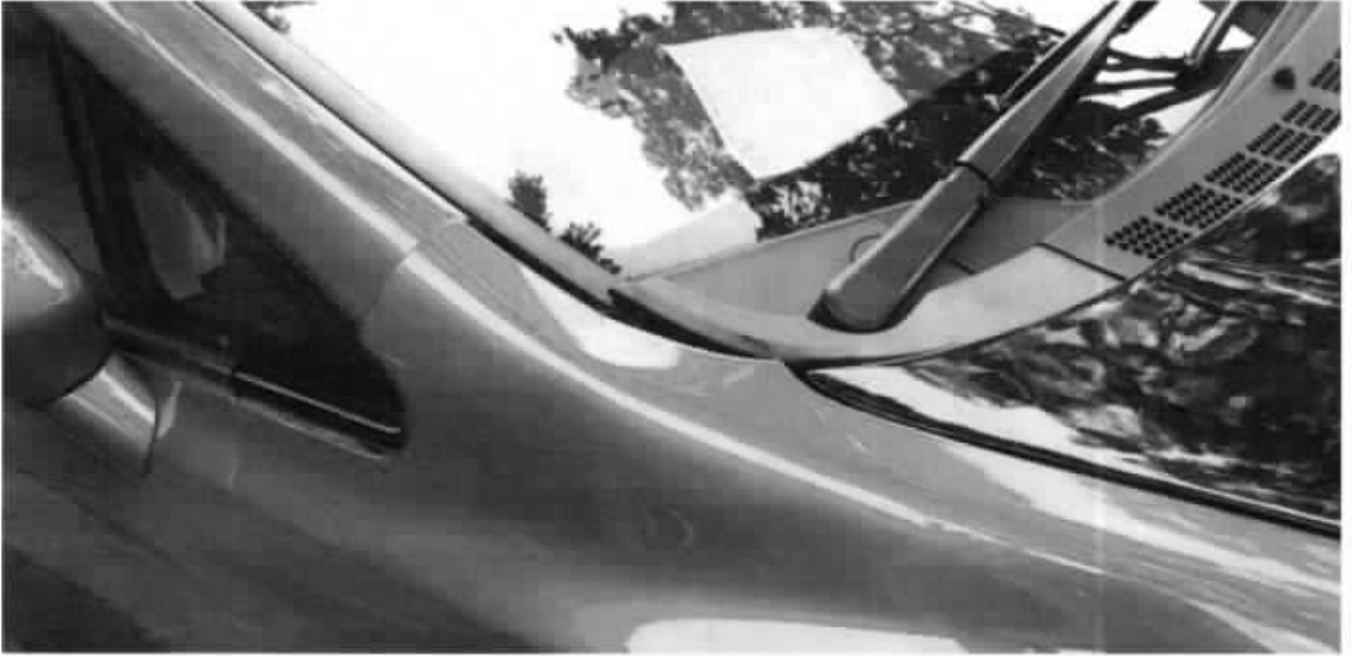
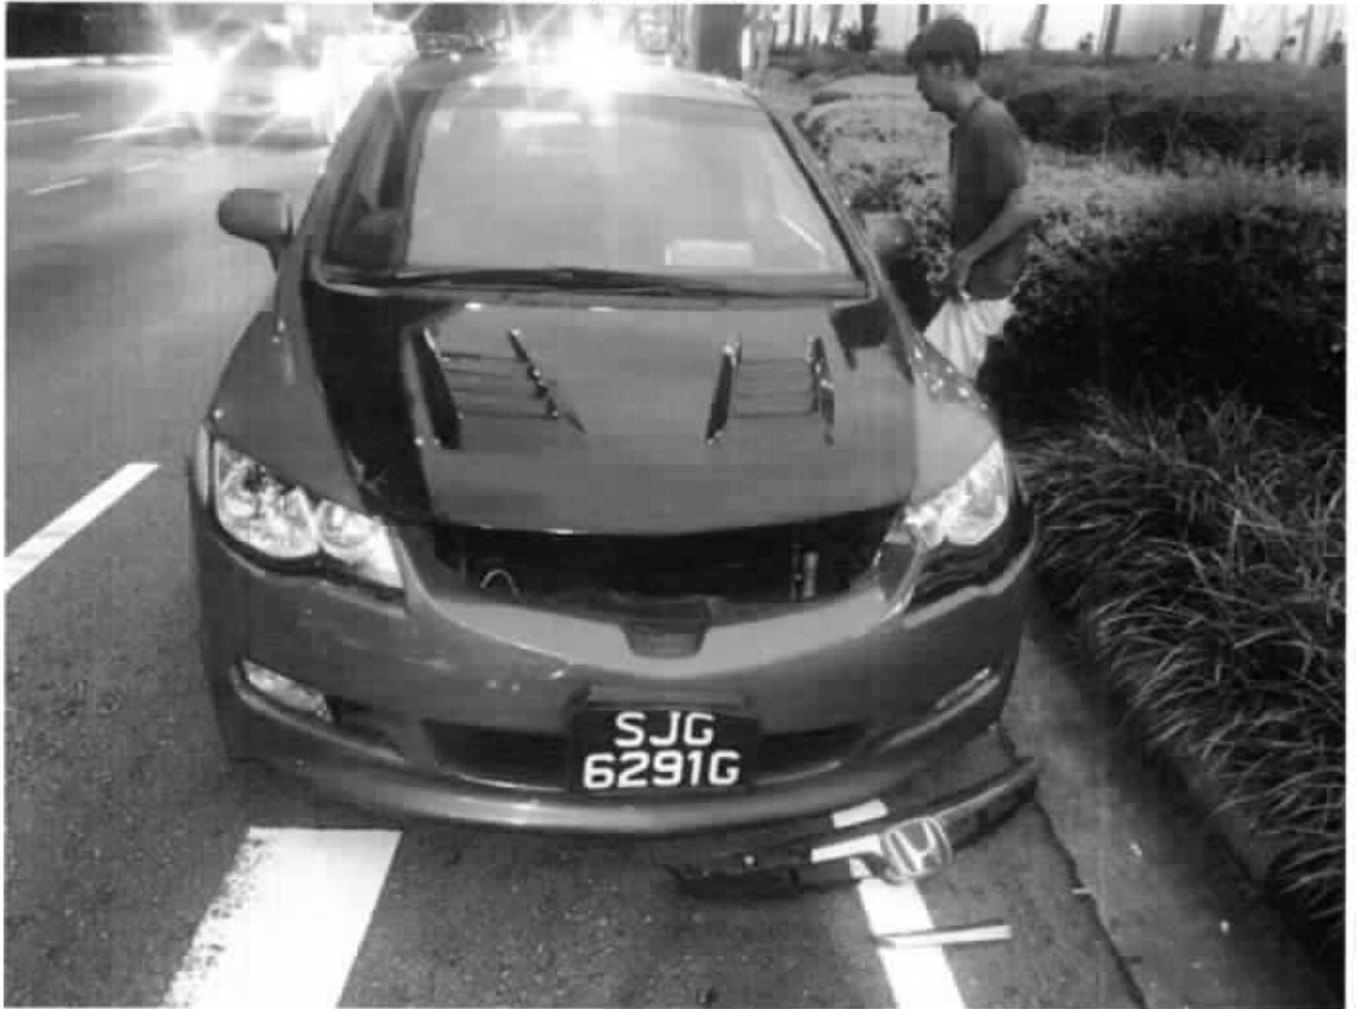
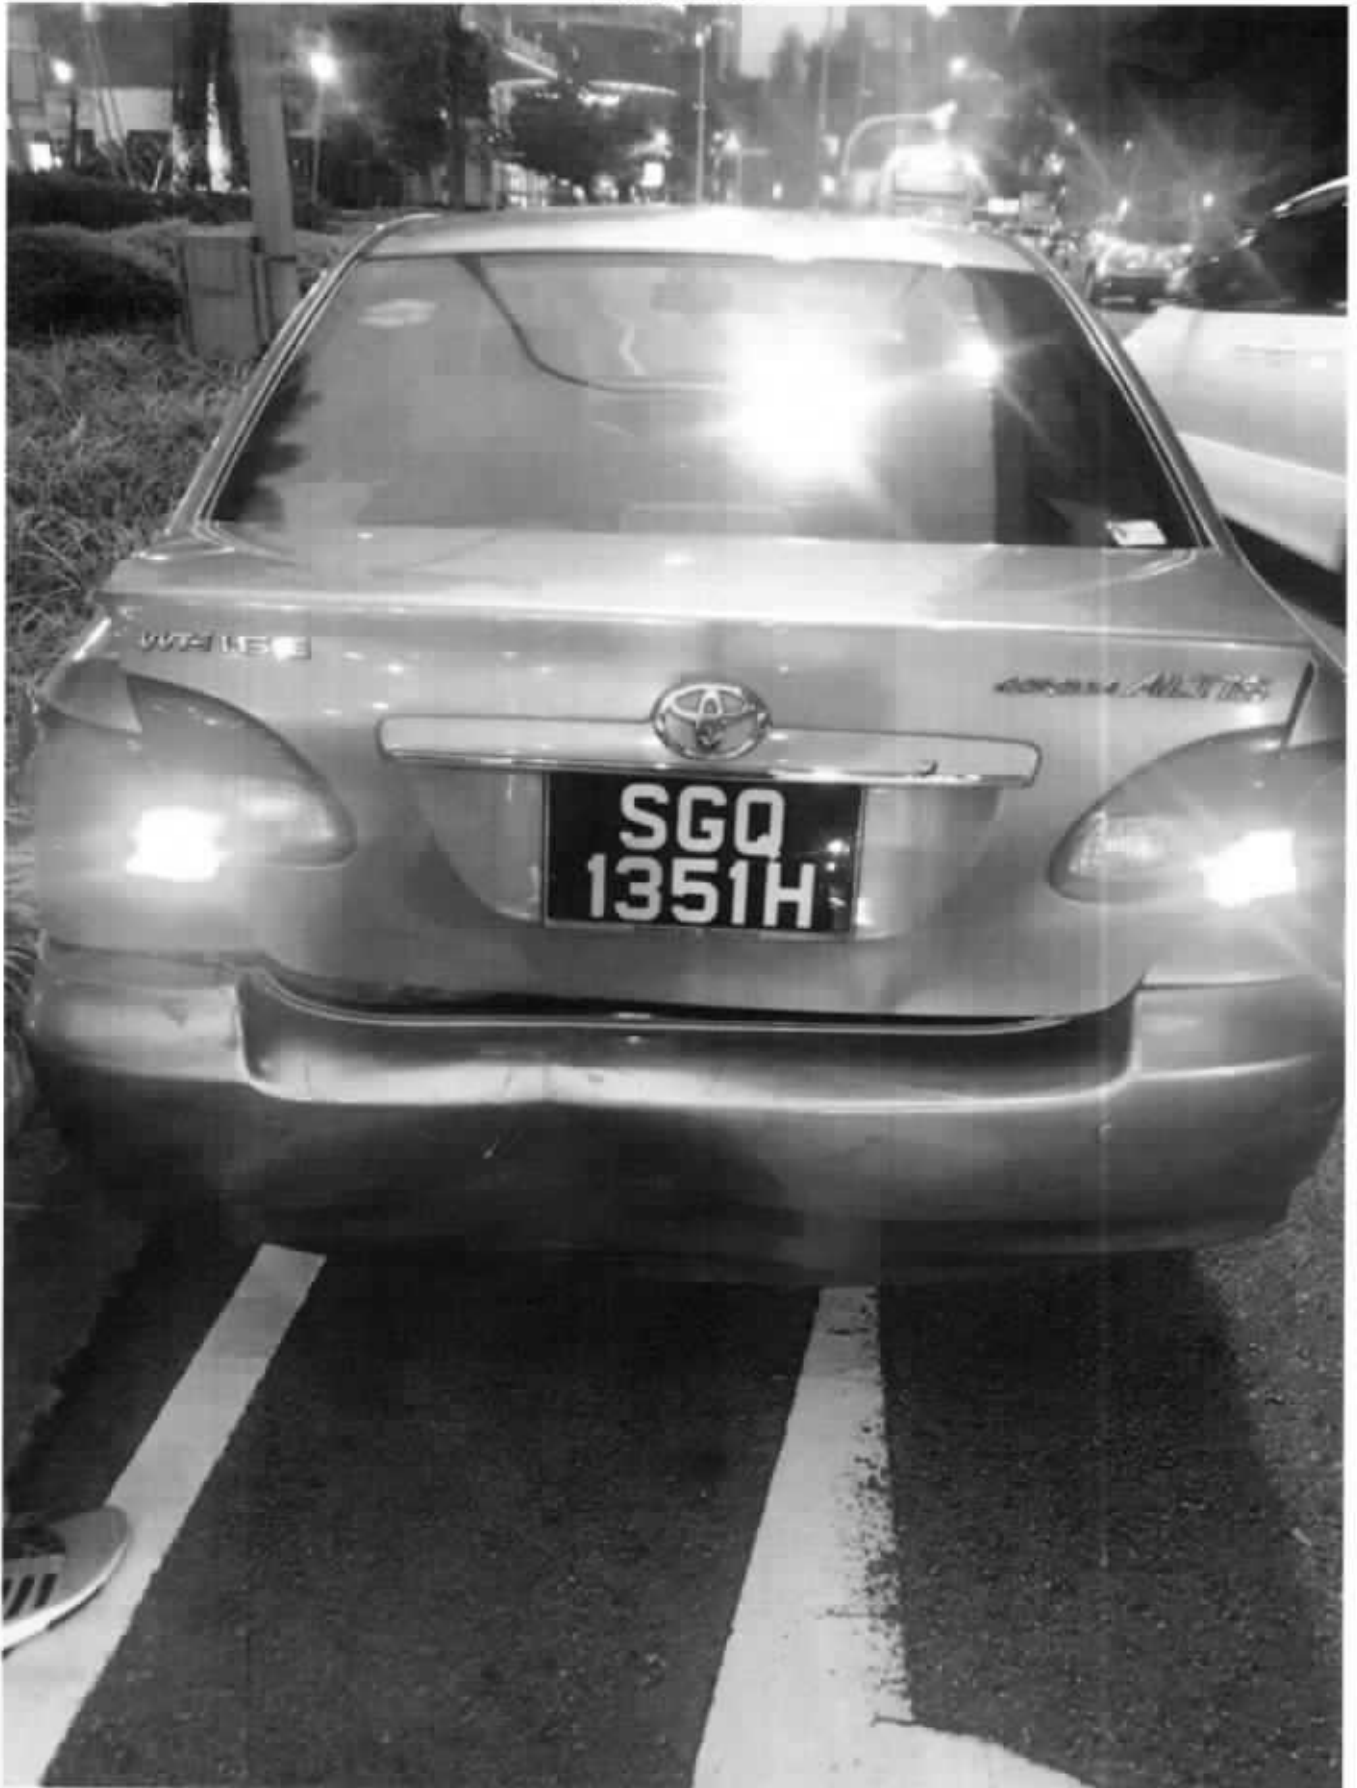
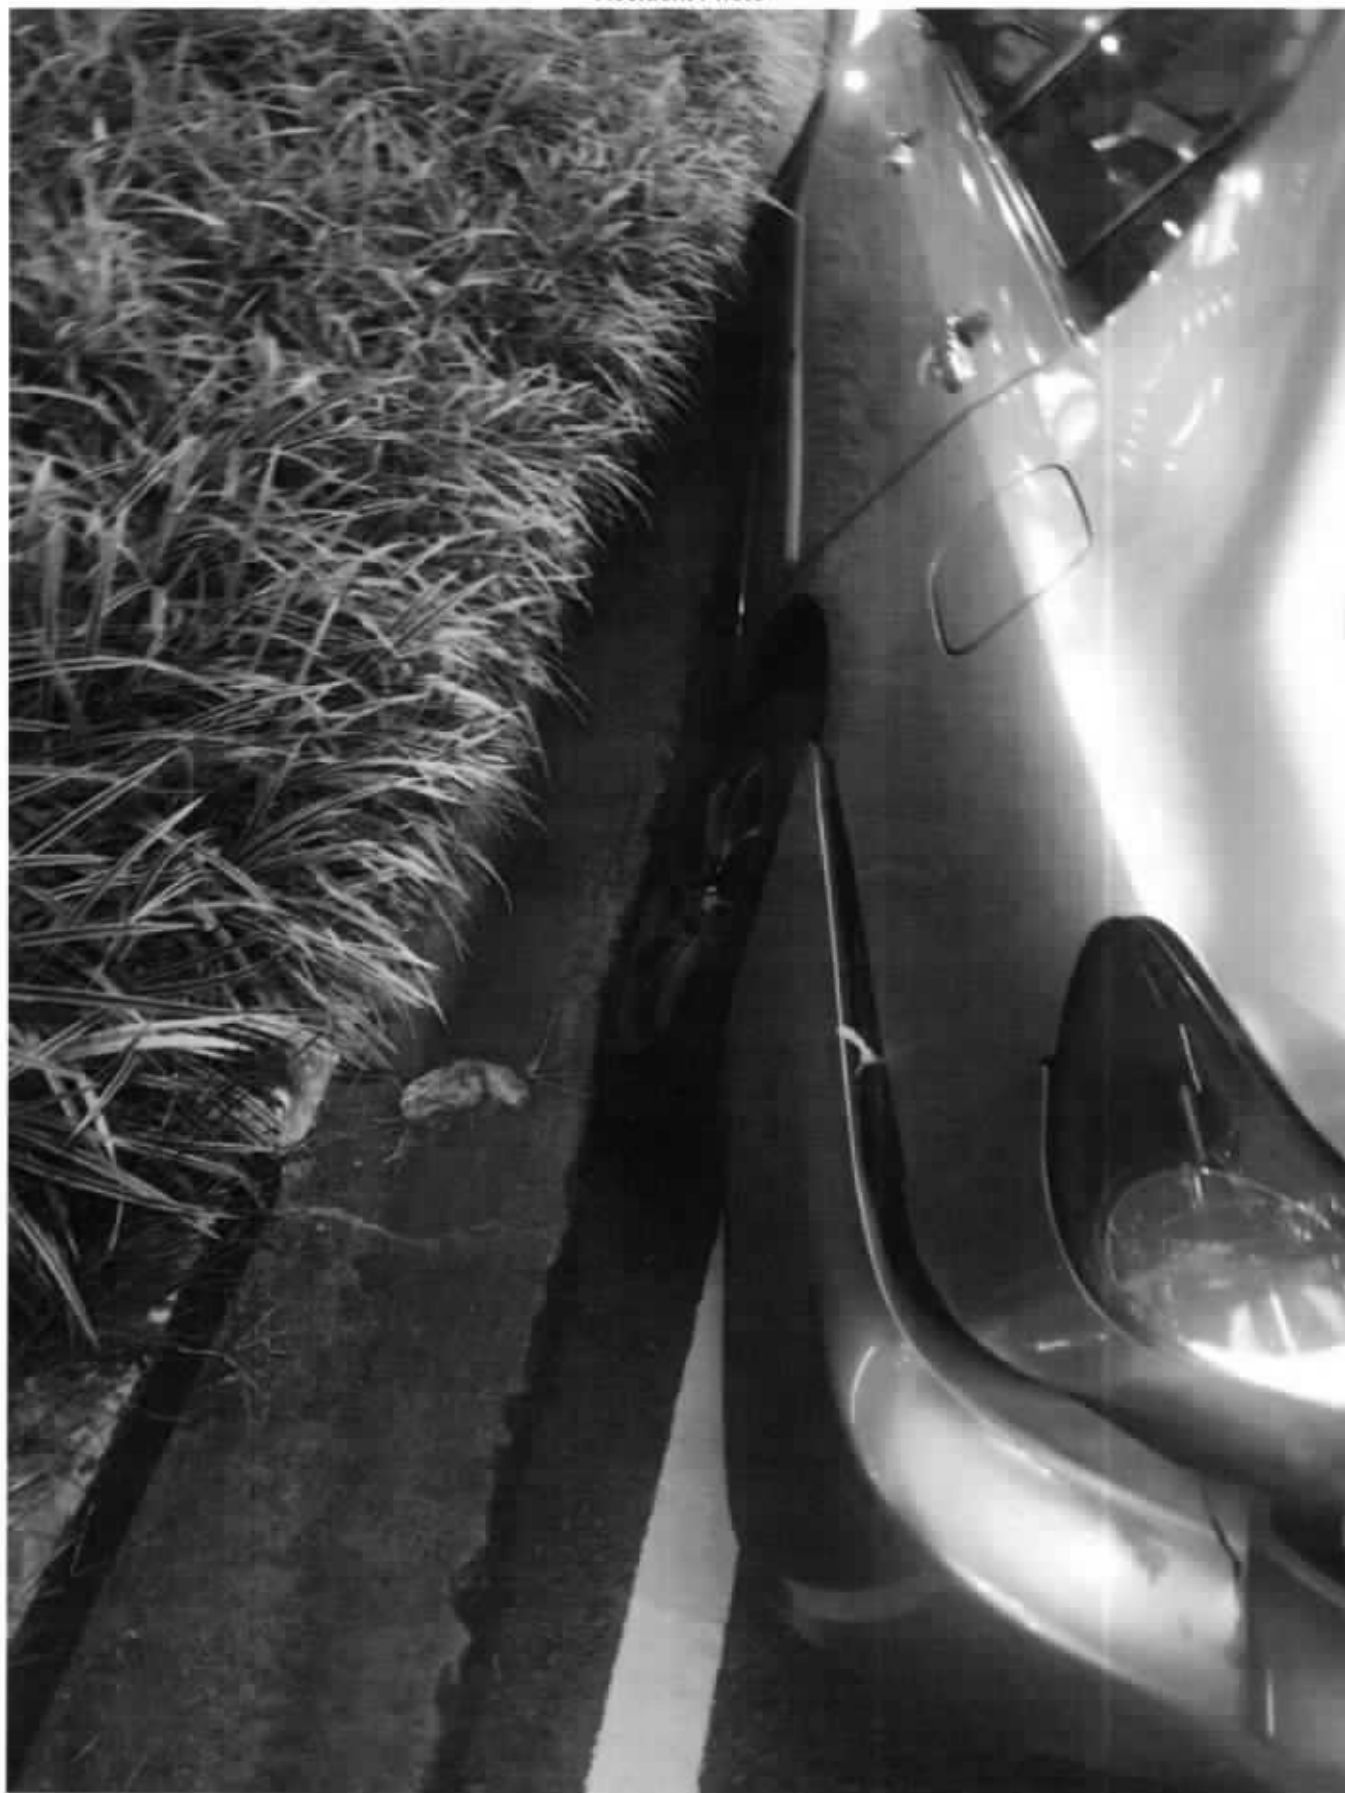
ON 18/06/19 ABOUT 6:15PM, I WAS TRAVELLING ON TELOK BLANGAH ROAD TOWARDS HARBOUR FRONT CENTRE. I HAD A BLUR VISION AND I SAW VEHICLE B'S (IN FRONT) BRAKE LIGHT BUT I DID NOT STOP IN TIME; HENCE COLLIDED INTO ITS REAR. MY FRONT BONNET, BUMPER, LIGHT IS ALL DAMAGE. I WAS ADMITTED TO SGH FOR FURTHER CHECK-UP.

Vehicle Registration Number	SGQ1351H
Vehicle Make/Model/Colour	TOYOTA / ALTIS
Details Of Properties	VEH B
Vehicle Category	PRIVATE CAR
Name of Driver	LEOW HIAN CHYE
NRIC/Passport Number	S7524195Z
Contact Number	
Address	
Postcode	
Insurance Company Name	
Nature Of Damage	REAR PORTION
No. Of Passenger (Including Driver)	1

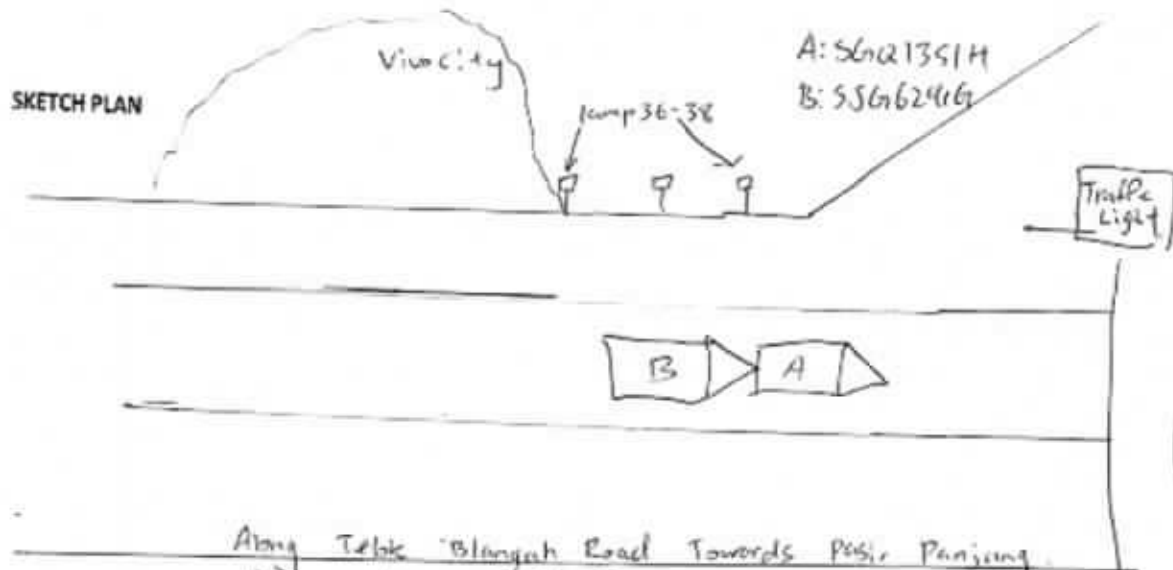
SKETCH PLAN

Along Teluk Blangah Road Towards Pasir Panjang
Between lamp pole 36-38
