To Inspect Vehicle No: SGQ 13514

**RW AUTOMOTIVE APPRAISERS SERVICES**

VEHICLE DAMAGE INSPECTION REPORT

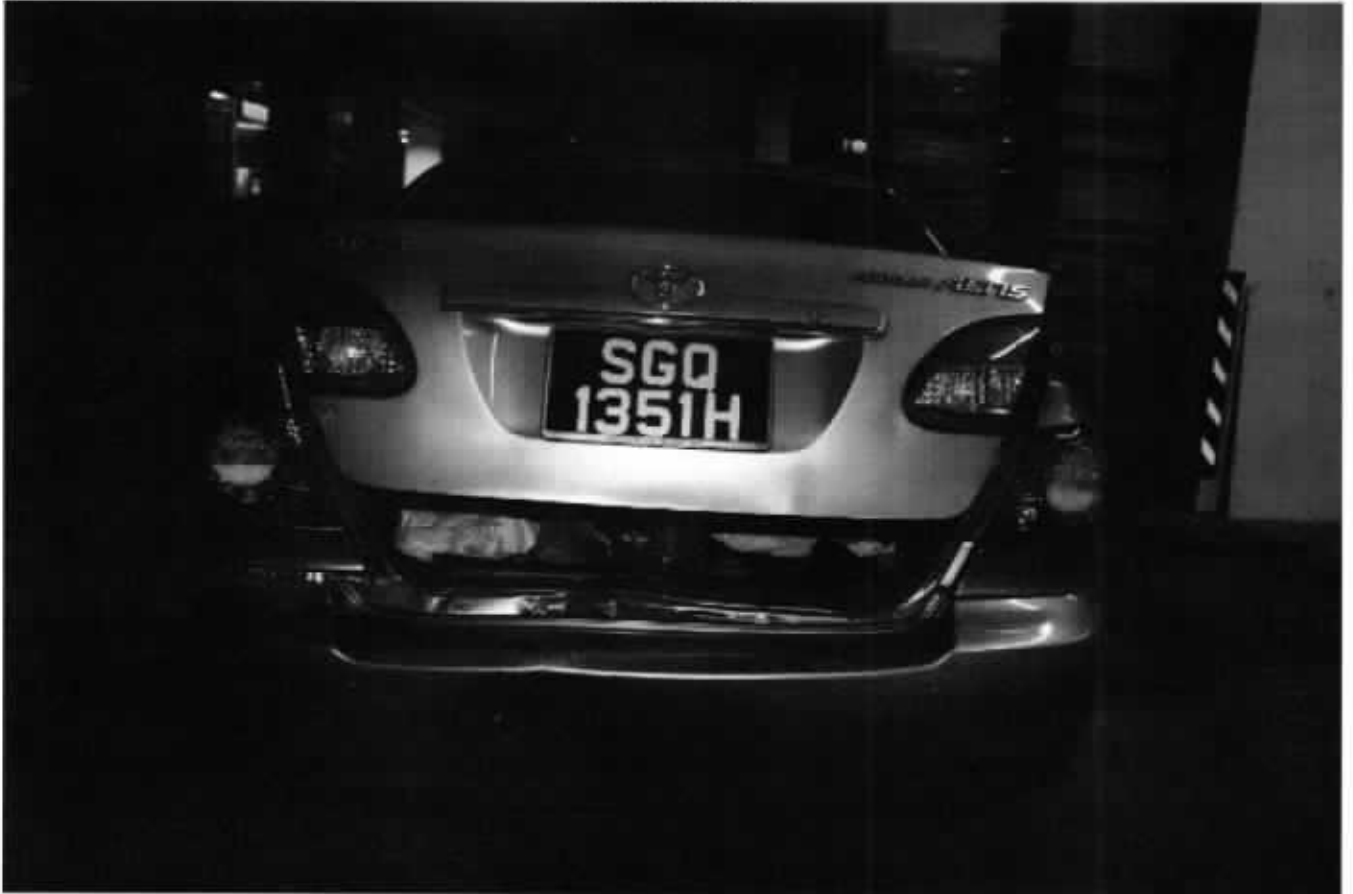
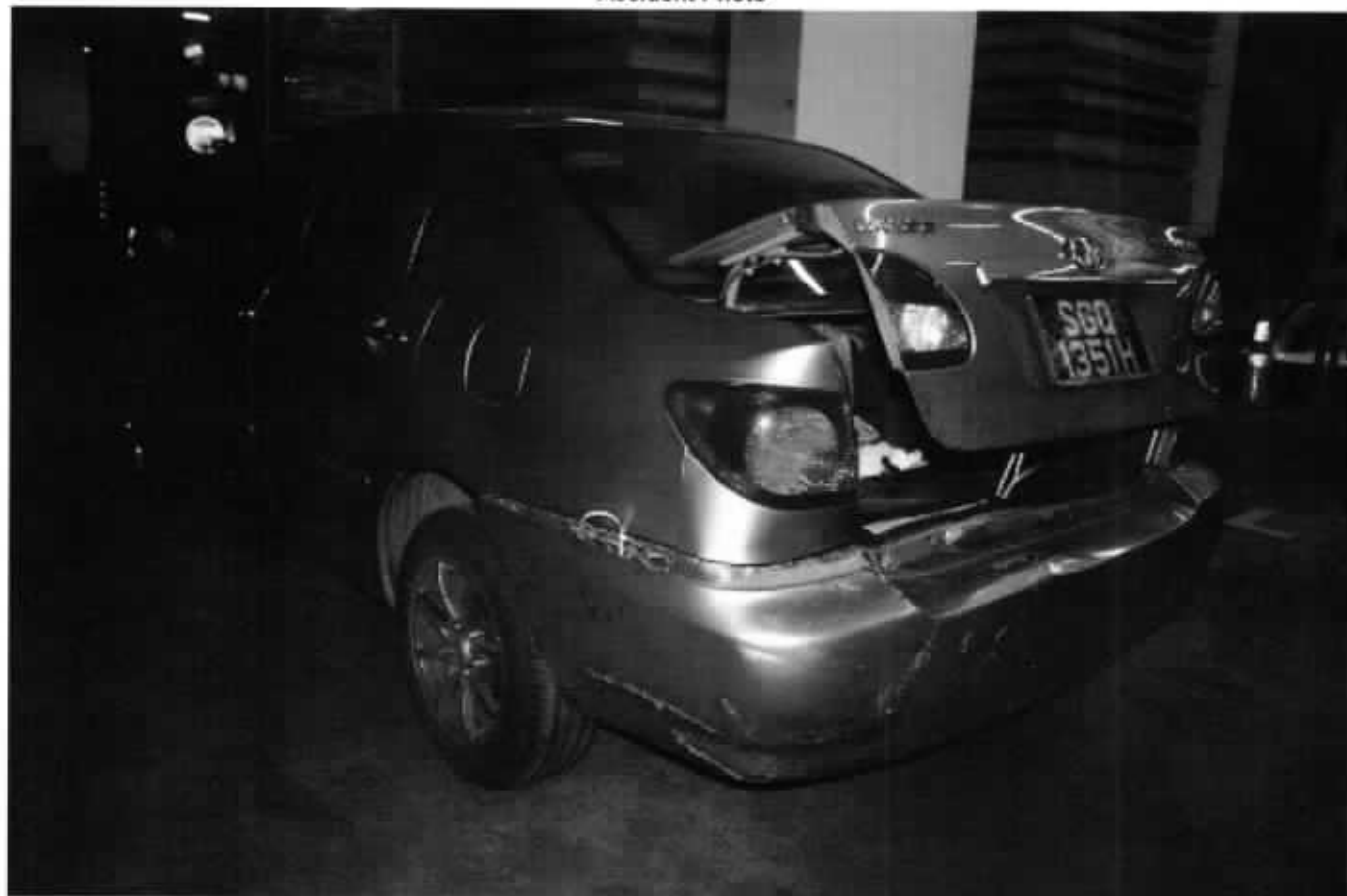
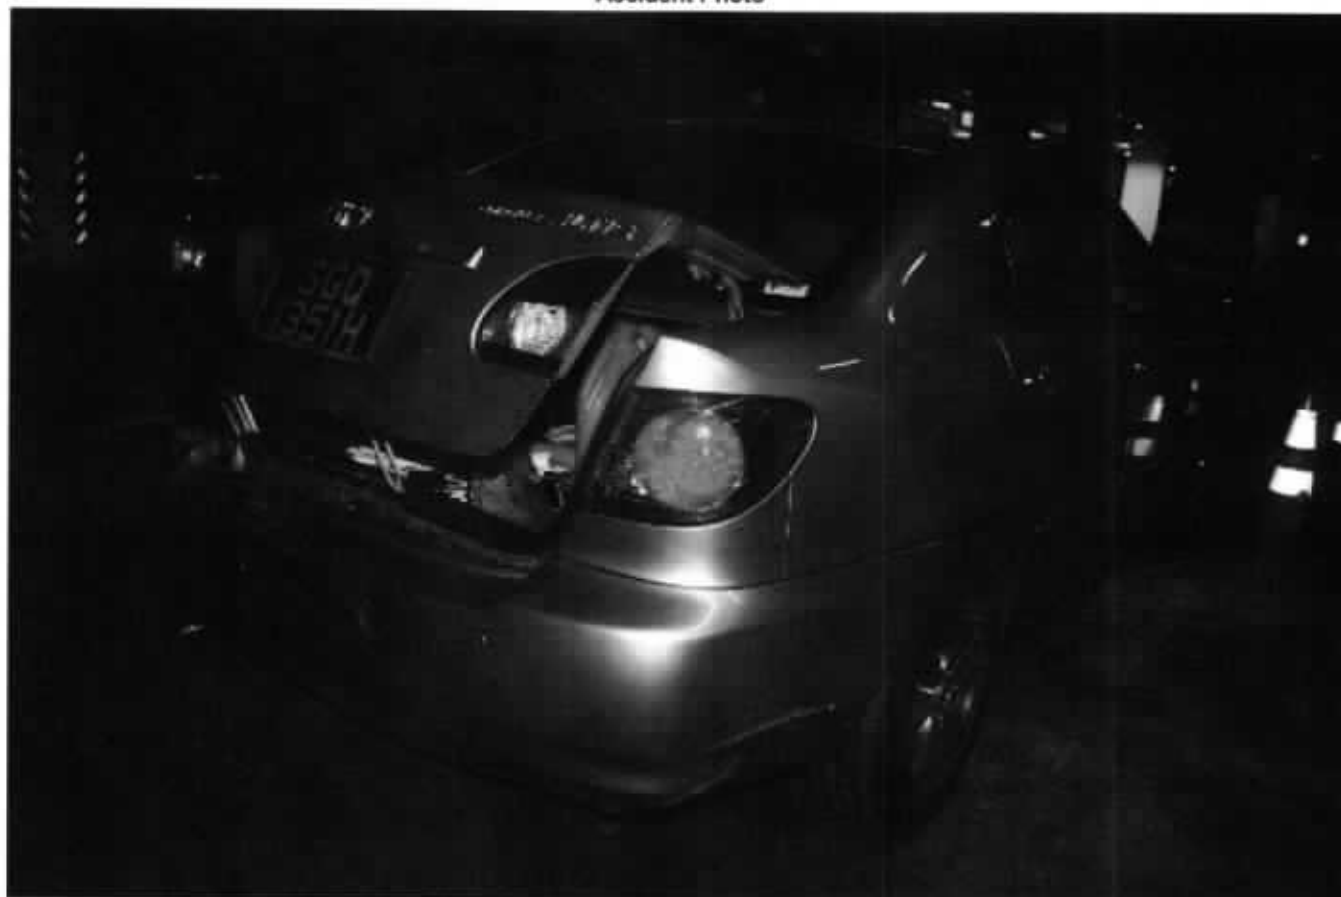
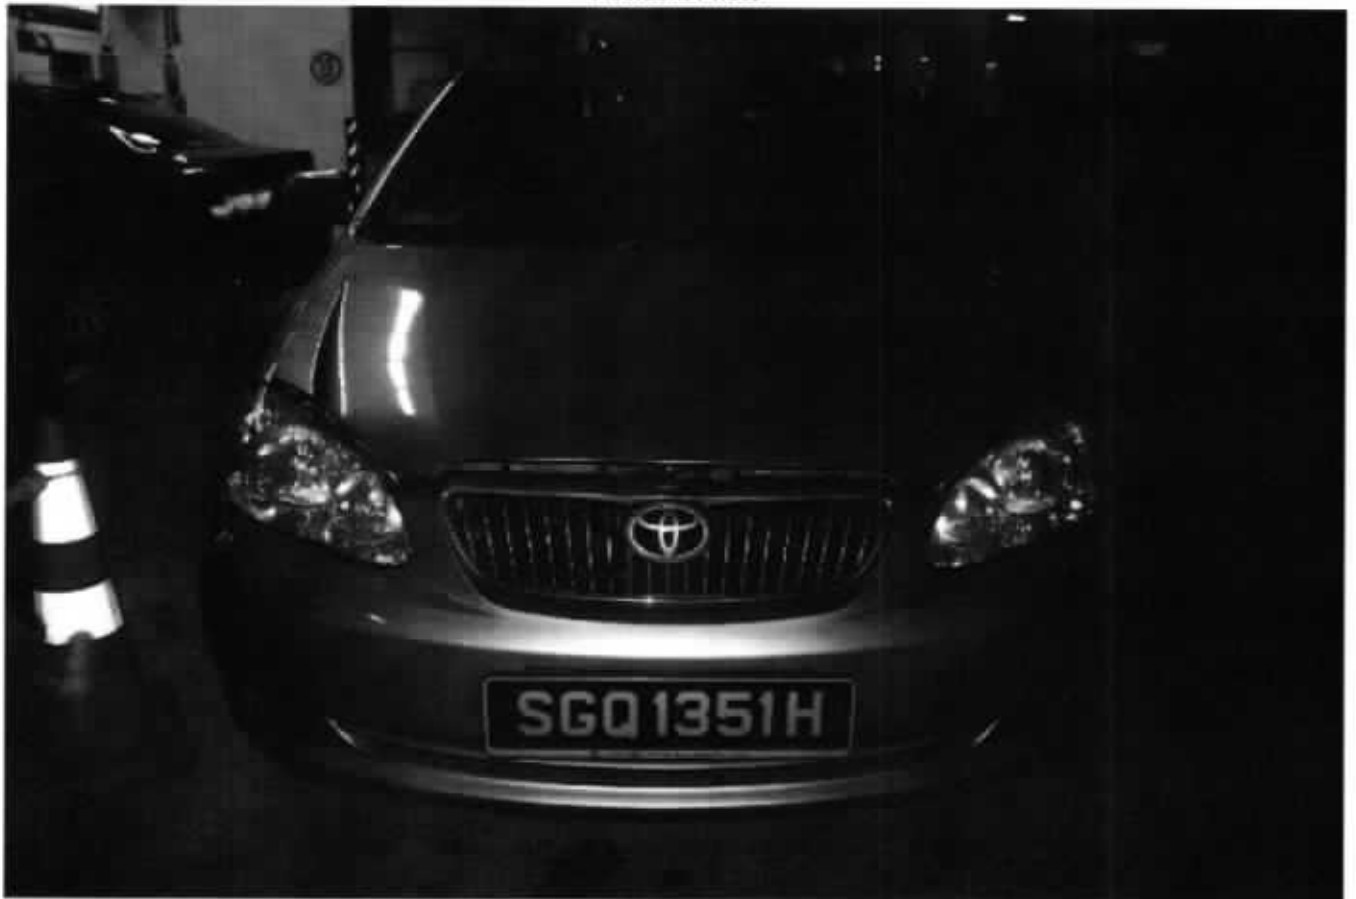
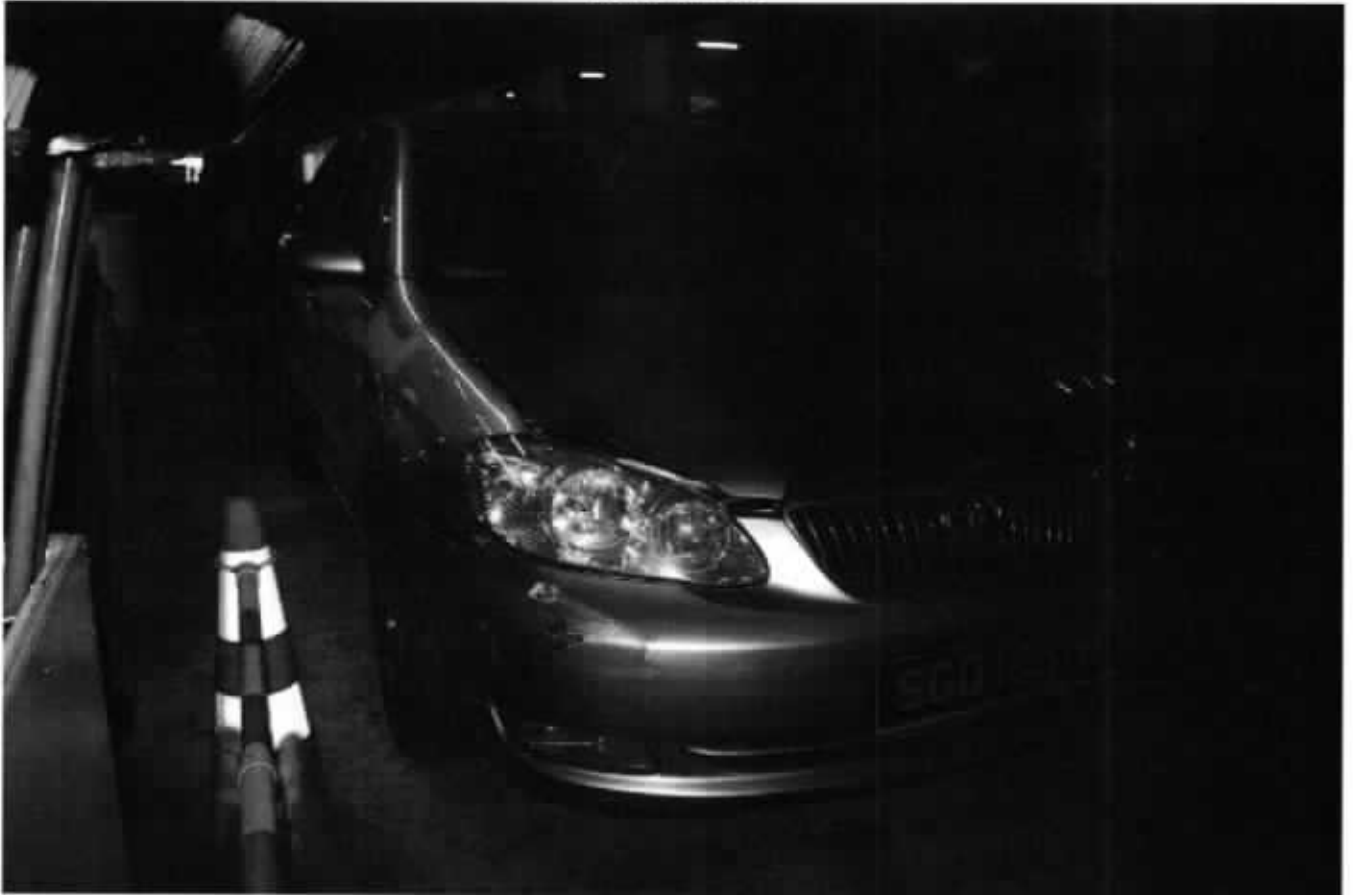
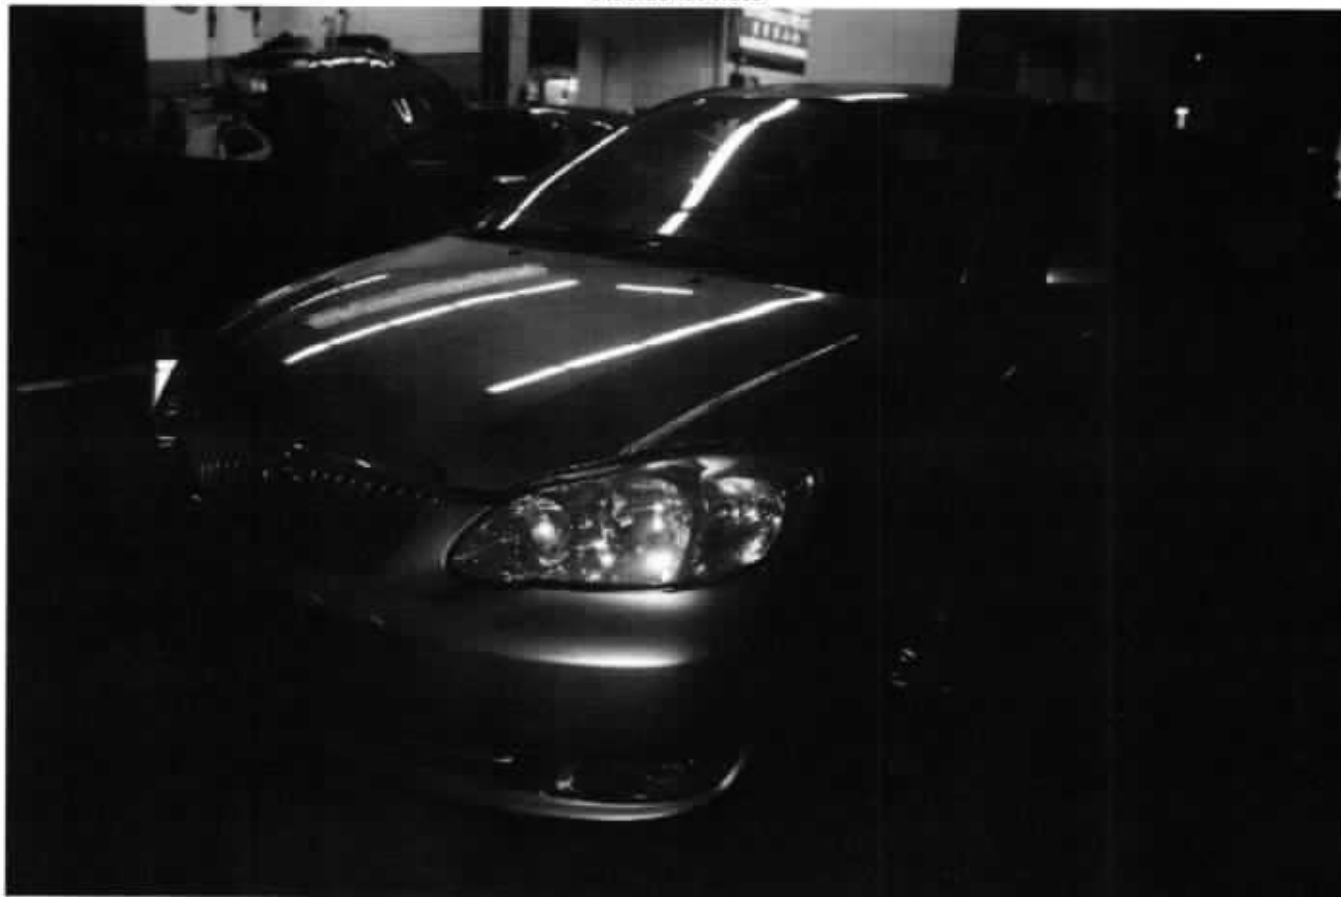
4)	2	Rear bumper dampers	Dented	\$ 86.40	\$ 86.40 X JVC
5)	1	Rear end panel	Dented	\$ 700.80	\$ 700.80 X S80
6)	1	Rear end panel top garnish	Cracked	\$ 68.90	\$ 68.90 ✓

7)	1	Rear tail lamp RH	Cracked	\$ 233.80	\$ 233.80 X JVC
8)	1	Rear tail lamp LH	Cracked	\$ 233.80	\$ 233.80 ✓
9)	1	Rear tail lamp panel LH	Dented	\$ 381.20	\$ 381.20 ✓

13)	1	Rear boot lid weatherstripe	Cut	\$ 63.10	\$ 63.10 ✓
14)	1	Rear boot lid outer moulding	Cracked	\$ 155.10	\$ 155.10 X JVC
15)	2	Rear boot lid hinges	Bent	\$ 263.60	\$ 263.60 X JVC

16)	2	Rear boot lid reflectors	Cracked	\$ 161.40	\$ 161.40 X JVC
17)	1	Rear 'Toyota' logo	Necessary	\$ 35.20	\$ 35.20 ✓
18)	1	Rear '1.8' emblem	Necessary	\$ 26.10	\$ 26.10 ✓

28)	1	Rear fender air vent LH	Distorted	\$ 76.70	\$ 76.70 X JVC
29)	1	Rear spare tyre panel	Dented	\$ 850.40	\$ 850.40 X JVC
30)	1	Rear spare tyre panel top cover	Cracked	\$ 163.20	\$ 163.20 X JVC

31)	1	Rear spare tyre panel side cover LH	Distorted	\$ 40.50	\$ 40.50 X JVC
32)	1	Rear windscreen moulding	Necessary	\$ 75.20	\$ 75.20 ✓
33)	1	Rear chassis member LH	Repairable	\$ 478.30	\$ -
Less 25%				\$ 8,820.40	\$ 6,342.10
				\$ 1,705.10	\$ 1,585.53
				\$ 5,115.30	\$ 4,756.58

42)	Cut out, replace and weld rear end panel, rear left fender, rear left tail lamp panel and rear spare tyre panel. Panel beat rear right fender. Straighten rear chassis. Remove and replace all damaged parts.	\$ 3,000.00	\$ 2,700.00	1400 ✓
43)	Check wiring and lightings.	\$ 100.00	\$ 80.00	30 ✓
44)	Remove and reinstall rear windscreen glass.	\$ 150.00	\$ 120.00	✓
45)	Remove and reinstall rear upholstery, cushion seats and roof lining to enable repair.	\$ 320.00	\$ 280.00	50 ✓
46)	Repair rear exhaust silencer.	\$ 120.00	\$ 60.00	X
47)	Remove and replace rear reverse sensors.	\$ 100.00	\$ 80.00	20 ✓
48)	Conduct waterproof test after repair.	\$ 120.00	\$ 80.00	X
49)	Rust proofing treatment on affected area.	\$ 300.00	\$ 250.00	30 ✓
50)	Spray painting on affected area.	\$ 2,400.00	\$ 2,200.00	1000 ✓
Total (Labour):		\$ 6,610.00	\$ 5,810.00	
Total:		\$ 12,685.30	\$ 11,526.58	265

The repairer has agreed to undertake repairs at a lump sum of \$9,220.00 corresponding to labour charges, spray painting and replacement of parts.
