THIRD PARTY SURVEY ACCIDENT HAPPENED ON 25 Jul 2017

Registration No : SLN 582 X
Model : Toyota Prius
Year / Capacity : 2017/1798
Chassis No : JTDKB3FU703556271
Engine No : 2ZRS039855
Mileage : 16644
Colour : Silver

ADJUSTMENT ON REPAIR COST FOR VEHICLE NO. SLN 582X

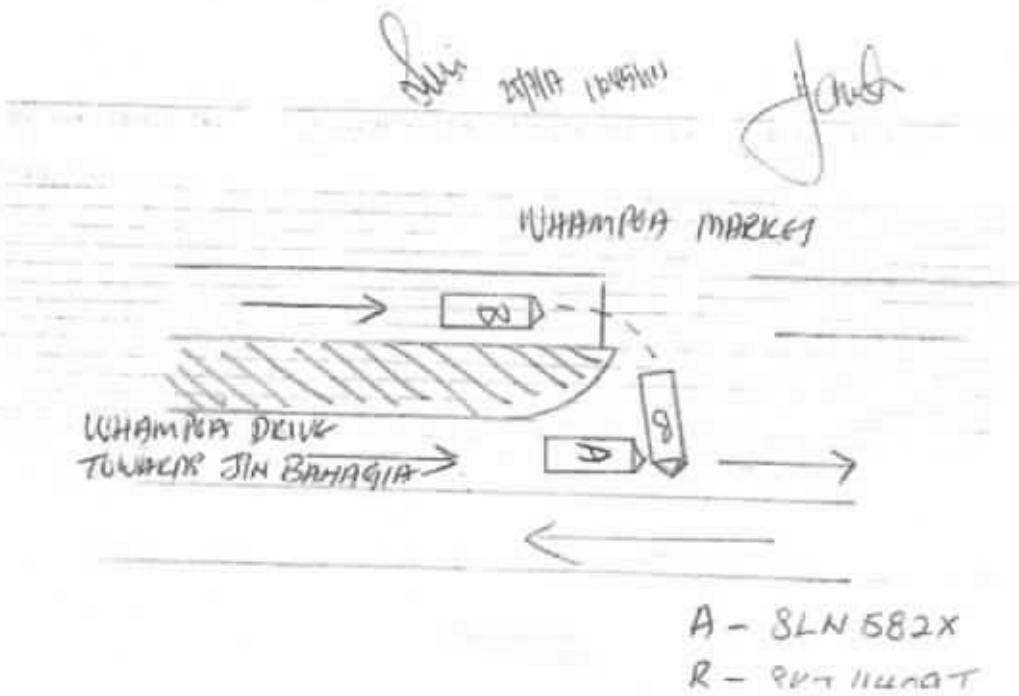
Describe Circumstances of the Accident:

ON 25/07/2017 AT ABOUT 1433HRS, I WAS DRIVING MY VEHICLE (SLN582X) ALONG WHAMPOA DRIVE TOWARDS JALAN BAHAGIA. WHEN A VEHICLE (SKT4409T) SUDDENLY TRIES TO MAKE AN ILLEGAL U-TURN. I COULD NOT REACT ON TIME AND COLLIDED ON TO THE RIGHT FRONT OF (SKT4409T).

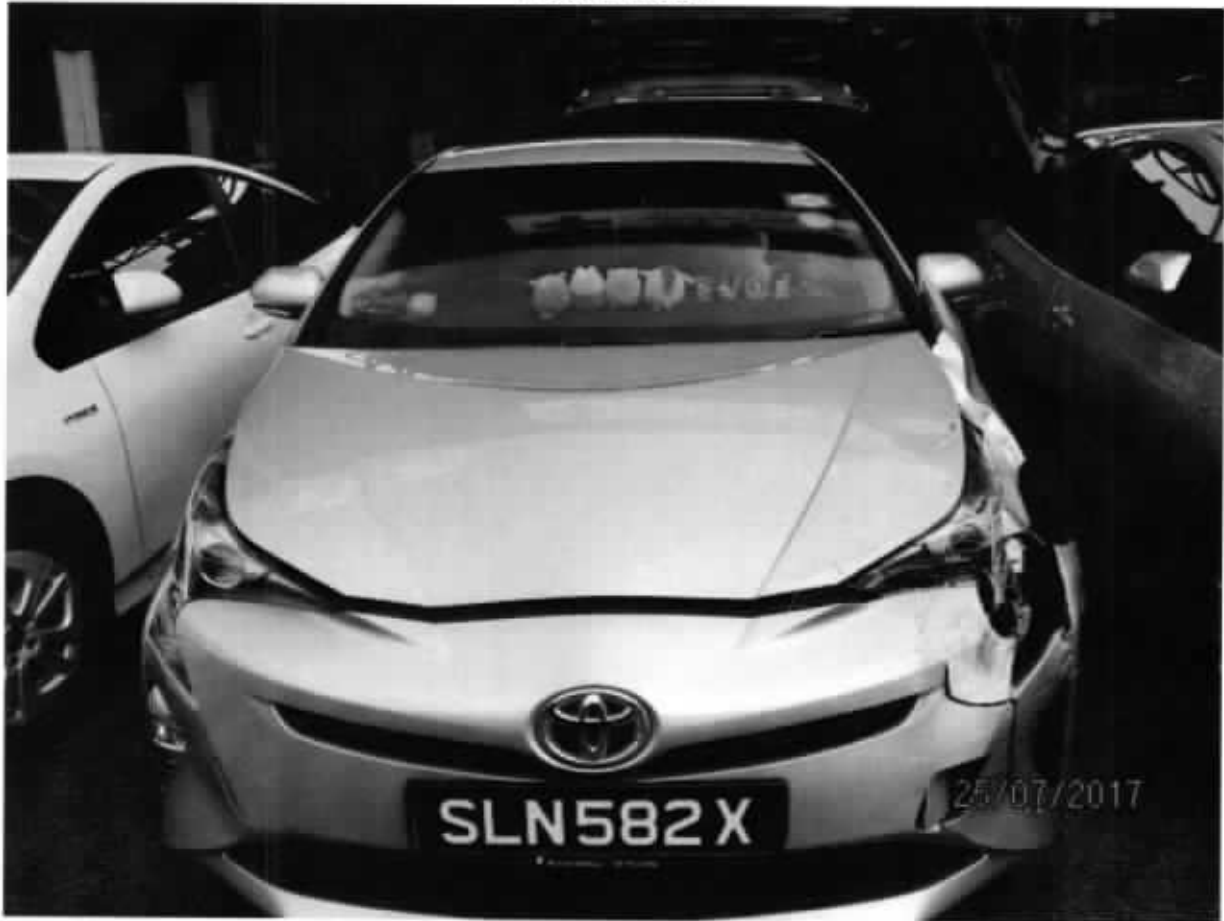
Accident Photo 1

I then went out of my vehicle to make a check. There is scratches and dents on both the front left portion of my vehicle. There is also cracks on the front bumper. There is also some oil spillage but I am unable to determine where it came from. I then exchanged particulars with the other driver.
