### Preliminary Advice

Insured Vehicle No	: SKR8057J	Accident Date	: 27/09/2019
TP Vehicle No	: SHD6878D	Assignment Date	: 01/10/2019
Make	: HYUNDAI I40	Est. Duration of Repair	: 3
Date of Inspection	: 1/10/2019		
Inspection At	: COMFORTDELGRO ENRINEERING PTE LTD

### VEHICLE DAMAGE INSPECTION REPORT

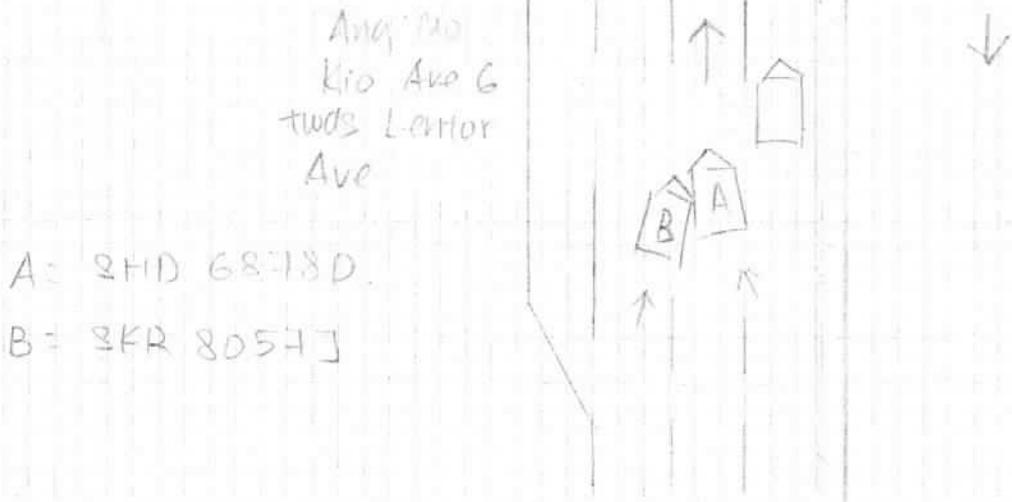
SKETCH PLAN

On 27/9/19 at about 17:35 hrs, I was driving at above said location with 3 passengers onboard. I switched on signal light to alert other road user of my intention then filtering to middle lane after I ensured traffic is clear. When I changed to middle lane, Veh B suddenly come out from extreme left lane. As a result, Veh B front right portion collided onto my taxi left front portion. No injury reported in this accident.

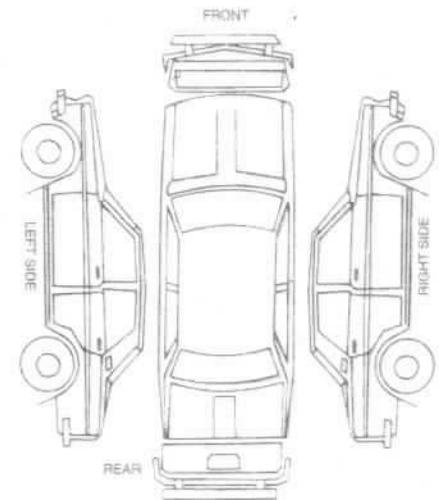
*TOKIO - Left front*
