REF: es/CTI/19017372 / Bsd306 Special Instruction:Surveyor: Mr KimASSIGNMENT (Office)From (Person): Tan Kah Kong of CTI Date/Time: 2/10/19 @ 3:36pm

OD / TP / WS / TP RES / OD RES / EVA / INV / MV / CSTo Inspect Vehicle No: GBB 5113R Insured: GBG 9066Rat Workshop m/s Team Autopro Tel: 6258 1955of 160 Sin Ming Drive #01-14Policy No: _____ Claim No: SNM19D204611

The U/C / Chassis frame / Body Structure affected due to collision.

VEHICLE DAMAGE INSPECTION REPORT

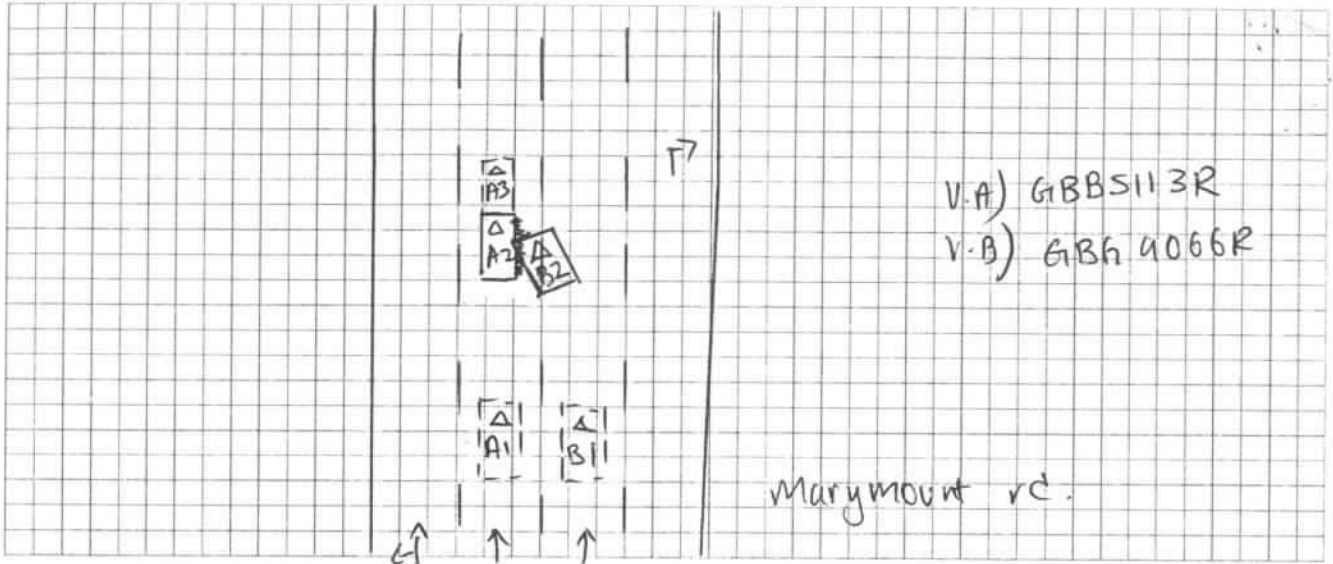
SKETCH PLAN

On the stated date and time, I vehicle 'A' GBB5113R was travelling on the stated venue. I was travelling straight in my lane, suddenly vehicle 'B' from the right cut into my lane had collided against my entire vehicle right portion. Later we went to the side of the road and vehicle 'B' explained that he was avoiding a car in front of him, hence he swerve towards my lane. Later I noticed my vehicle entire right portion was damaged due to this accident.

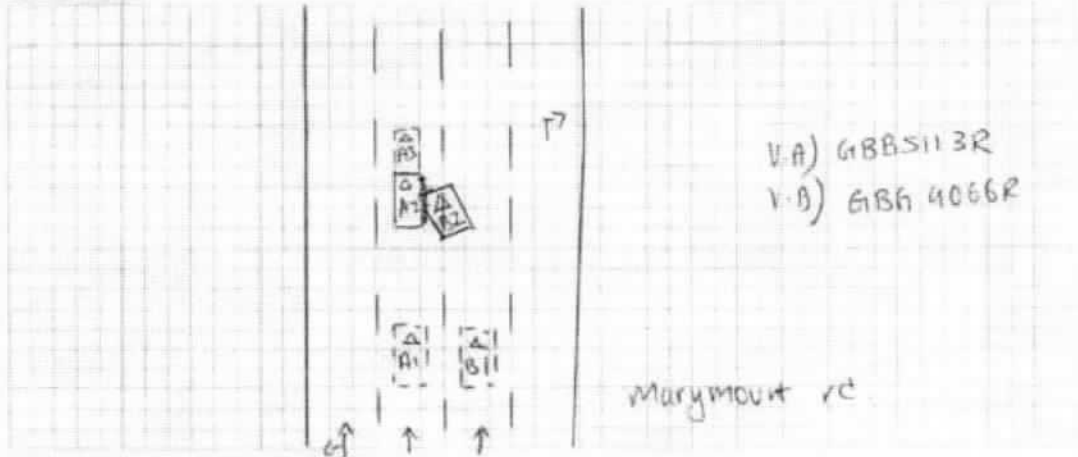
Sketch Plan #2

On the stated date and time, I vehicle 'A' GBB5113R was travelling on the stated venue. I was travelling straight in my lane, suddenly vehicle 'B' from the right cut into my lane had collided against my entire vehicle right portion. Later we went to the side of the road and vehicle 'B' explained that he was avoiding a car in front of him, hence he swerve towards my lane. Later I noticed my vehicle entire right portion was damaged due to this accident.
