## SINGAPORE ACCIDENT STATEMENT

## National Assessment Centre Services

### 1. Policy Particulars :- THIRD PARTY CLAIM

## ADJUSTMENT ON REPAIR COST FOR VEHICLE NO. SHA 1533Y

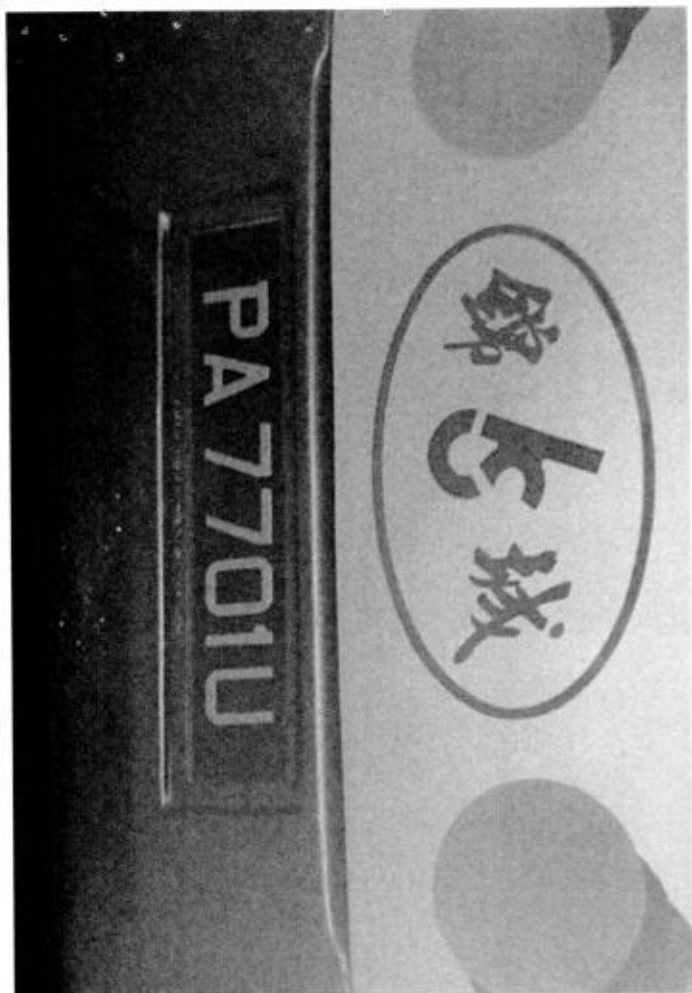
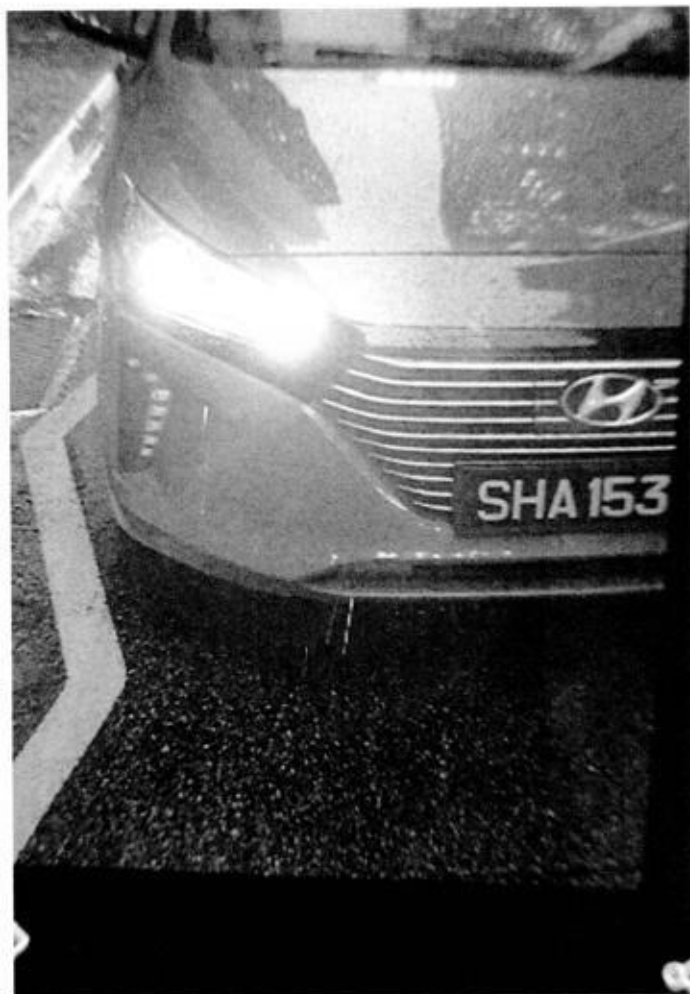
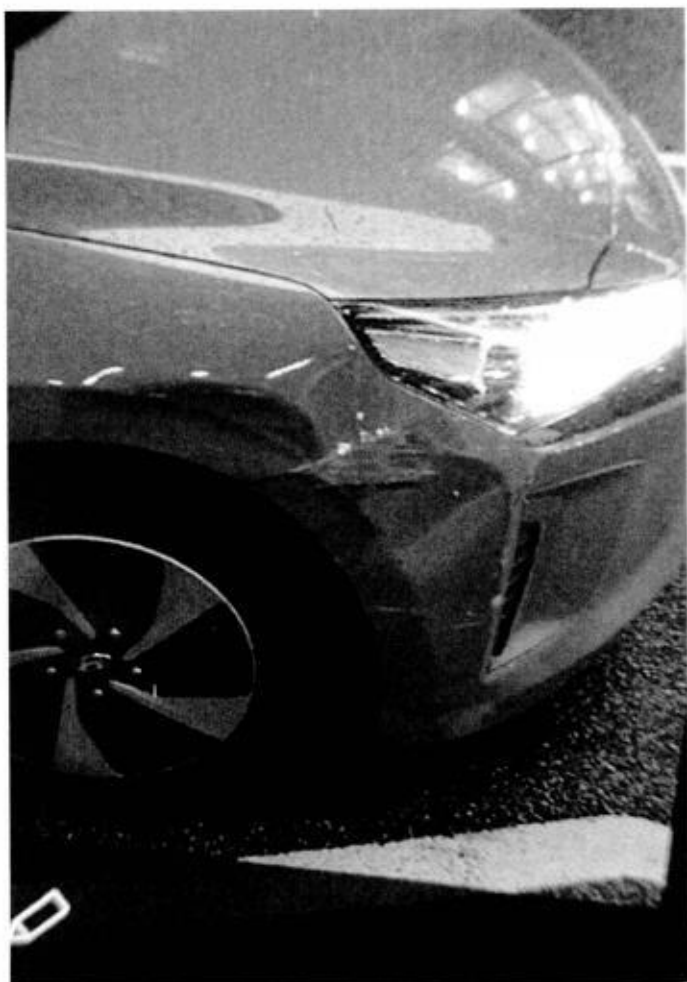
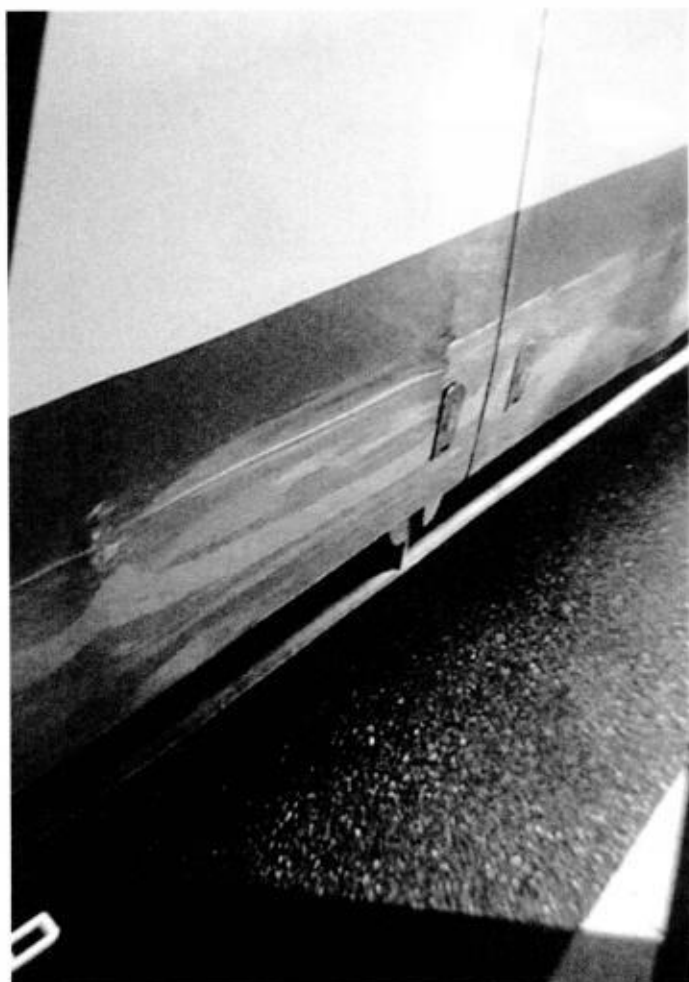
THE VEHICLE SUSTAINED DAMAGES AT THE O/S FRONT PORTION. DAMAGES SEE DETAILS.
---------------------------------------------------------------------------------

Qty	Description of Parts	Condition	Estimate By Workshop (\$)	Our Adjusted (\$)
<b>REPLACEMENT OF PARTS</b>				
1	FRONT BUMPER COVER	CUT	418.30	418.30
1	FRONT BUMPER BRACKET TOP (RH)	SERVICEABLE	35.00	-
1	FRONT BUMPER BRACKET (RH)	SERVICEABLE	28.00	-
10	FRONT BUMPER CLIPS	NECESSARY	22.00	22.00
1	HEADLAMP (RH)	GRAZED	1,198.80	1,198.80
1	DAY LIGHT, RH	SERVICEABLE	642.50	-
1	FRONT FENDER (RH)	BUCKLED	490.70	490.70
1	FRONT FENDER SHIELD (RH)	SERVICEABLE	114.70	-
1	FRONT FENDER RETAINER	SERVICEABLE	41.40	-
1	EMBLEM-BLUE DRIVE (RH)	NECESSARY	26.60	26.60
1	FRONT WHEEL HUB CAP (RH)	SERVICEABLE	346.40	-
	LESS 20% DISCOUNT		-672.88	-431.28
			2,691.52	1,725.12
<b>LABOUR</b>				
	PANEL BEATING.		700.00	320.00
	SPRAY PAINTING CHARGE.		500.00	400.00
	WIRING CHARGE.		50.00	30.00
	TUFF KOTE.		50.00	20.00
	FRT WHEEL ALIGNMENT.	NOT NECESSARY	120.00	-
			1,420.00	770.00
<b>GRAND TOTAL</b>			<b>4,111.52</b>	<b>2,495.12</b>
<b>RECOMMENDED COST OF LUMP SUM REPAIRS (TO ITS PRE-ACCIDENT CONDITION) (CONFIRMED)</b>				<b>2,000.00</b>
