## VEHICLE INSPECTION REPORT

Report No. : PAS/TP/0261218

Vehicle Registration No. : SDN6064E  
Make & Model : Toyota Corolla Altis 1.6  
Date of Registration : 15/10/2009  
Colour : Met. Silver

## VEHICLE DAMAGE INSPECTION REPORT

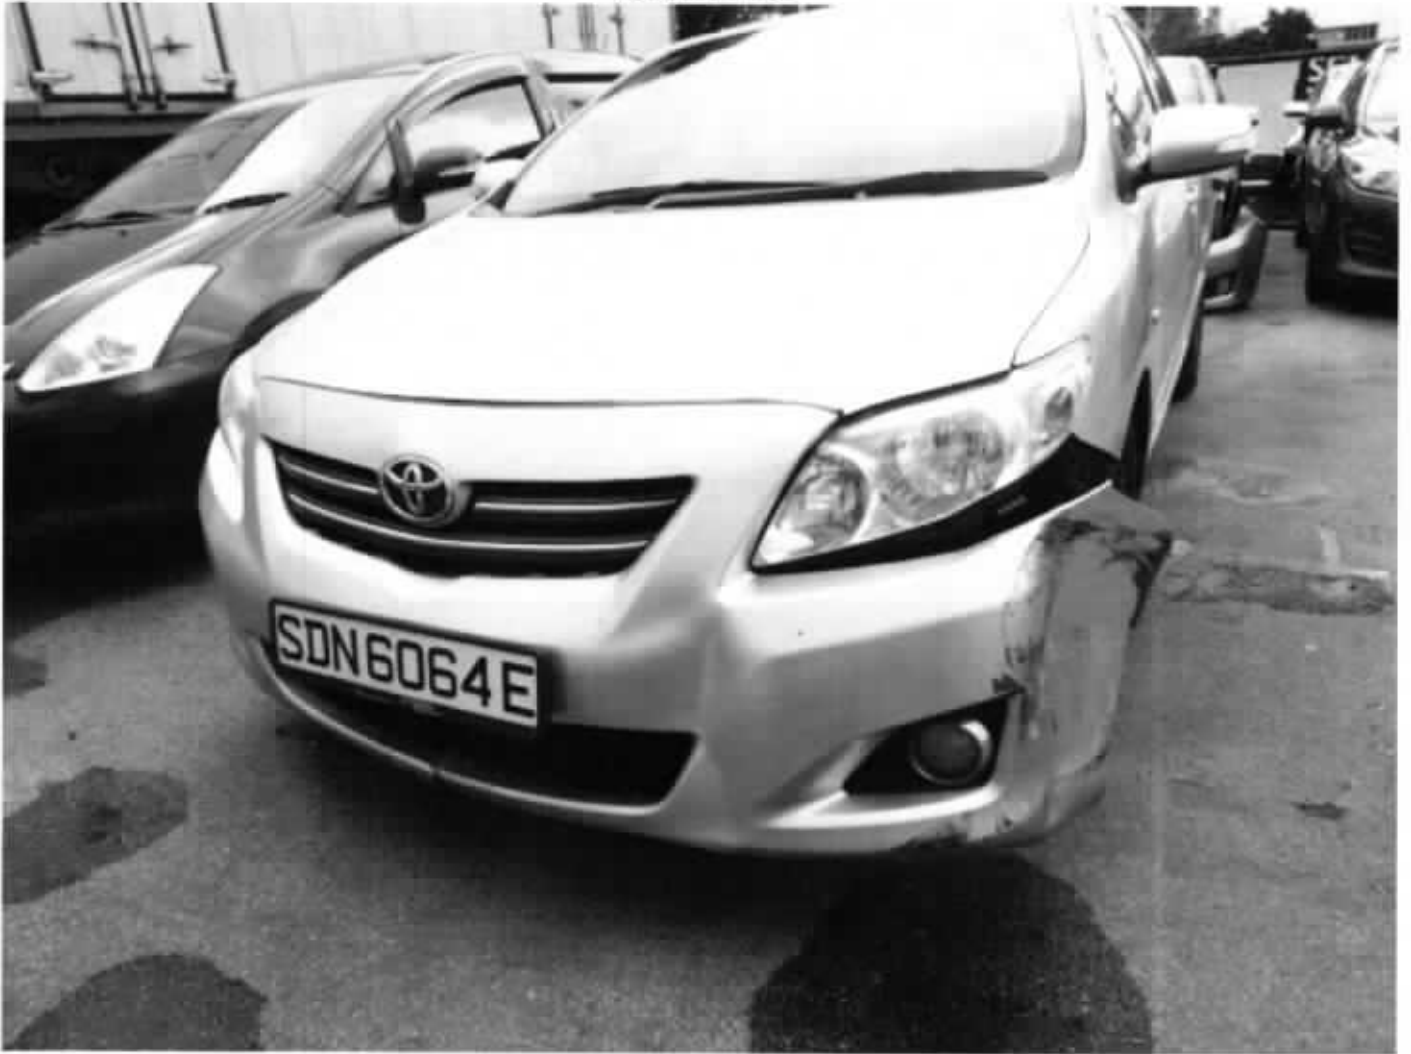
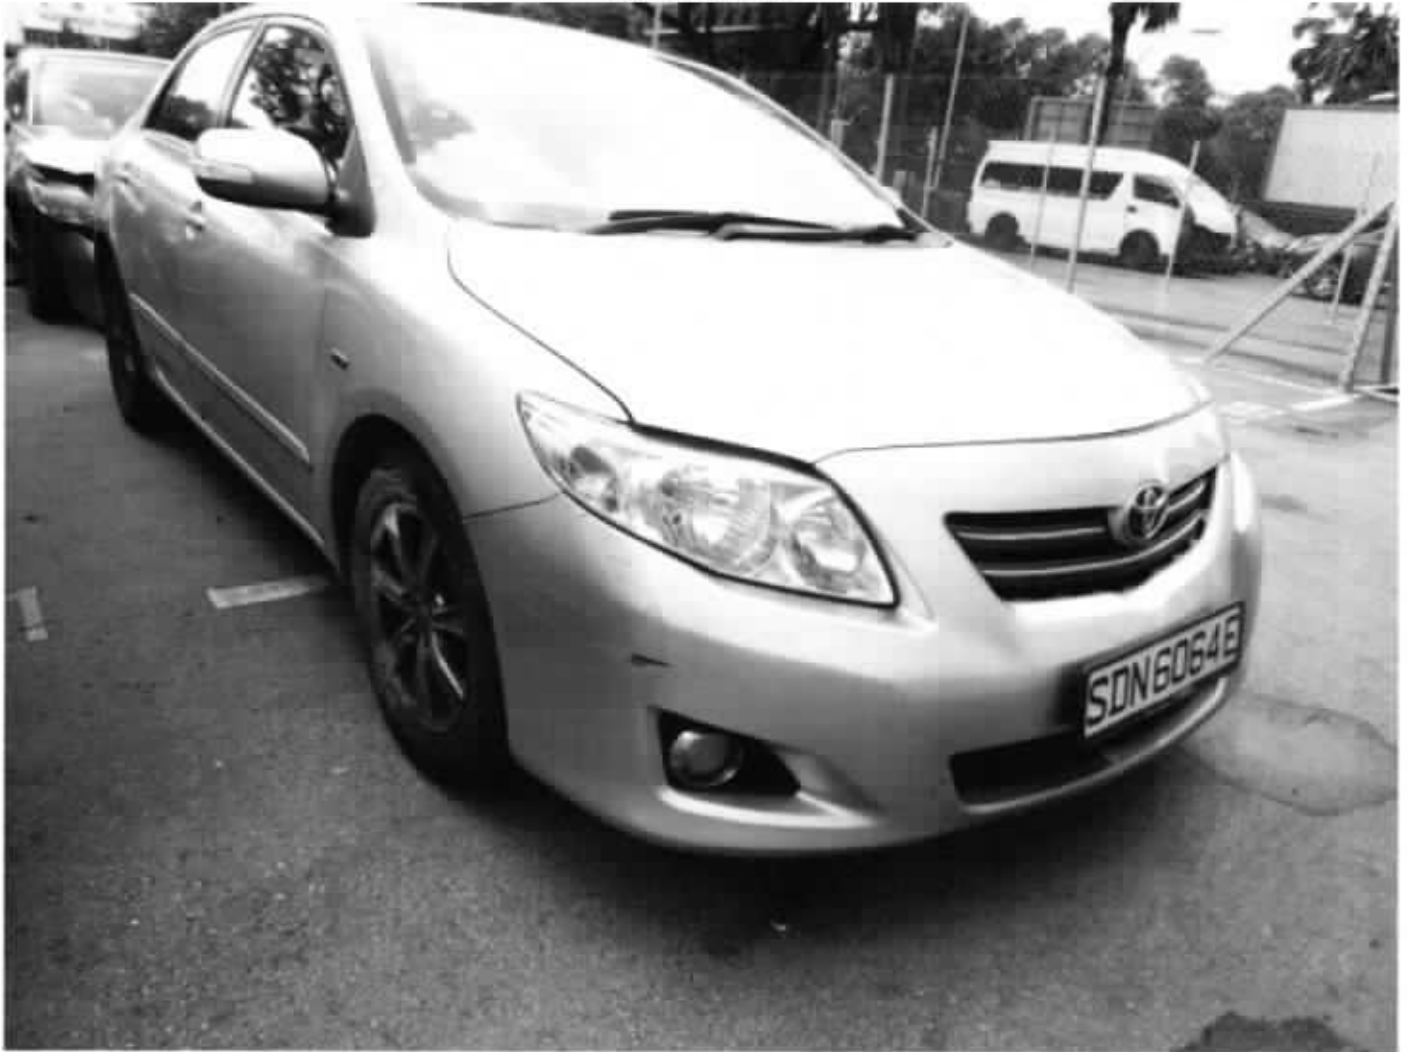
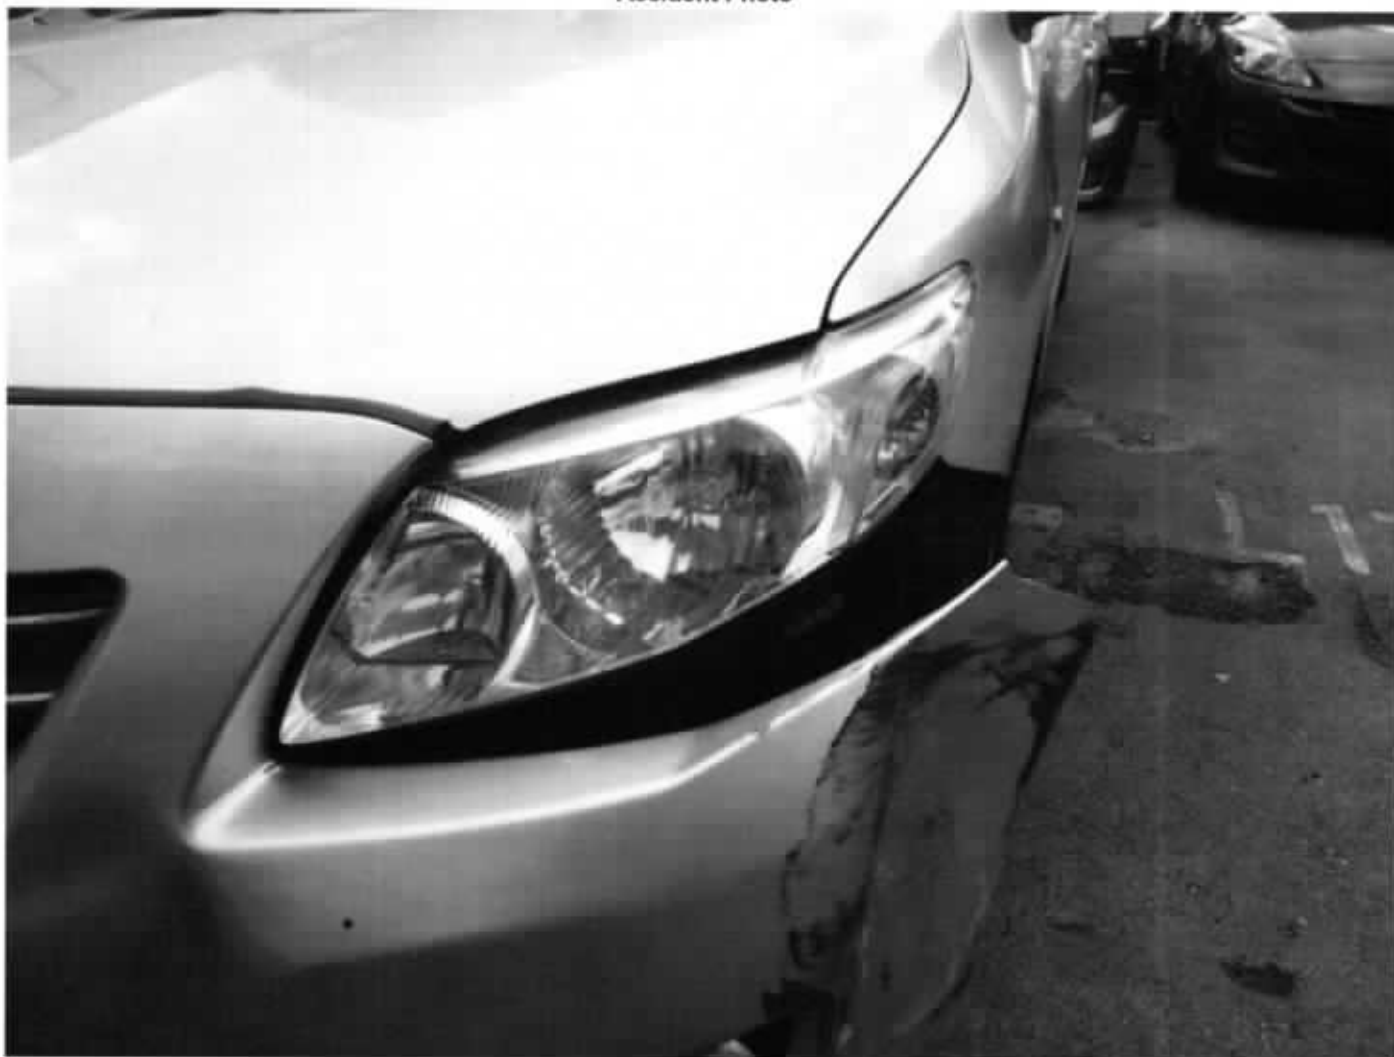
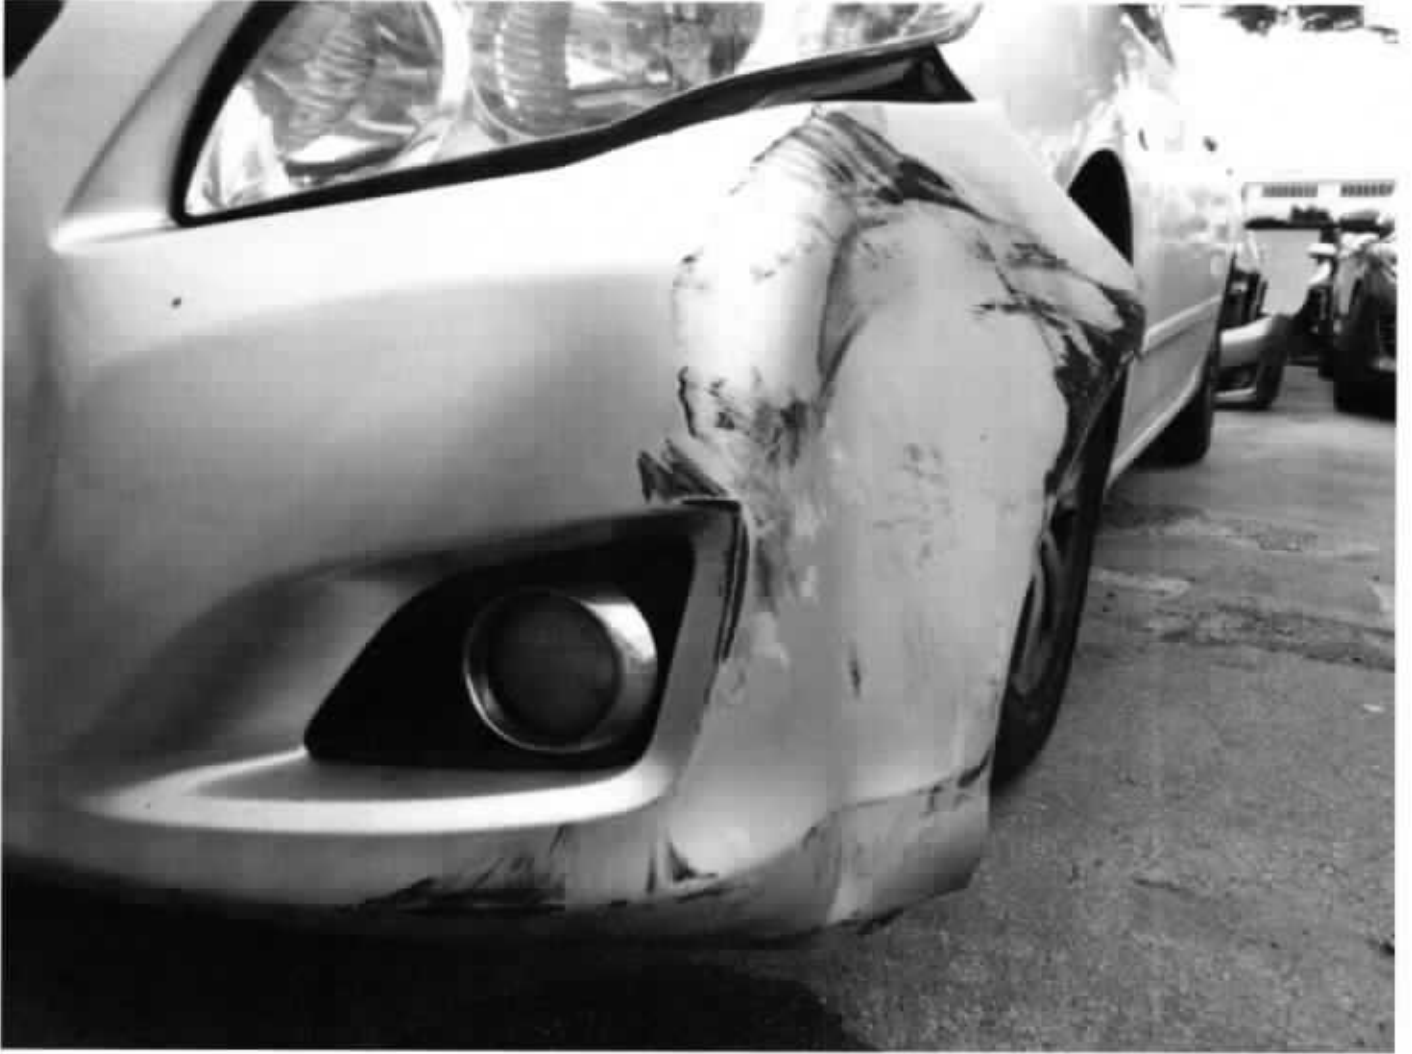
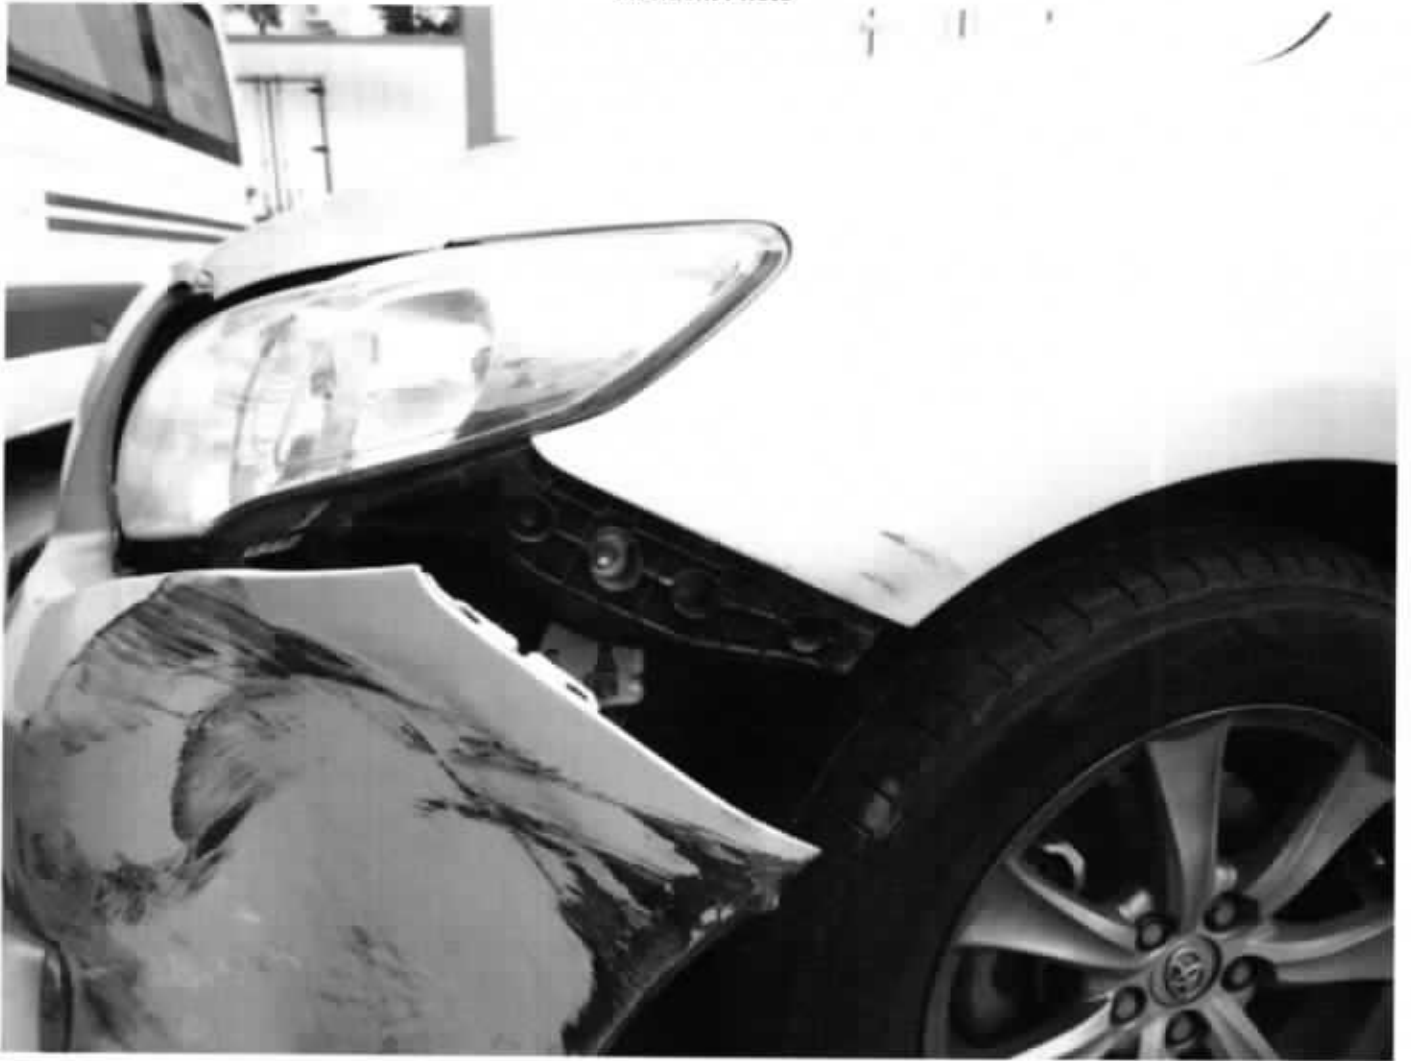
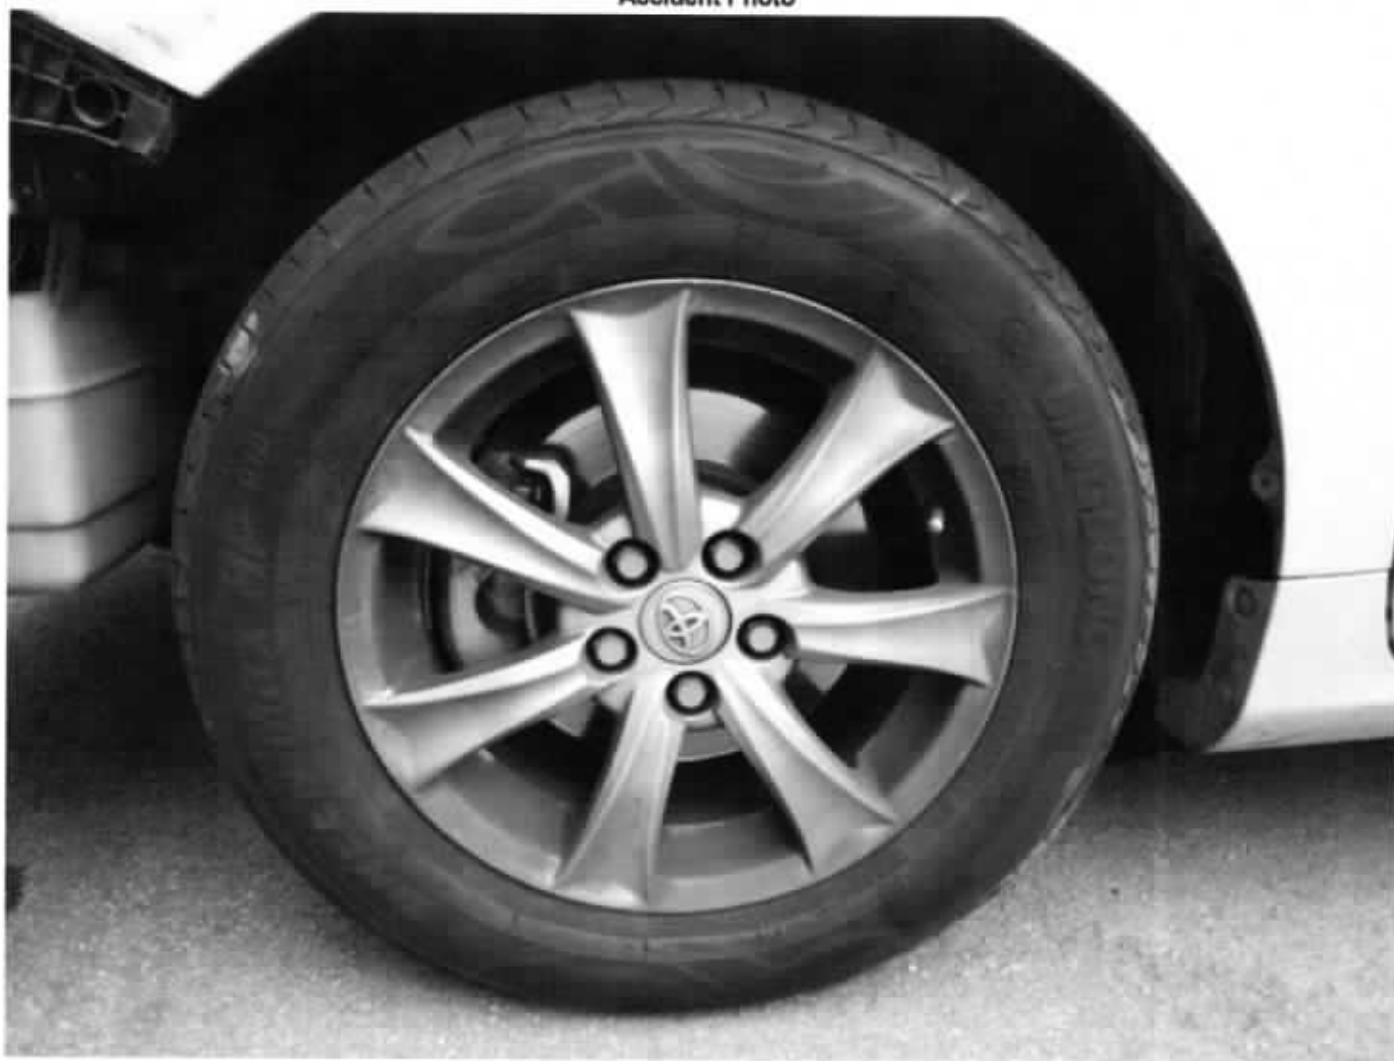
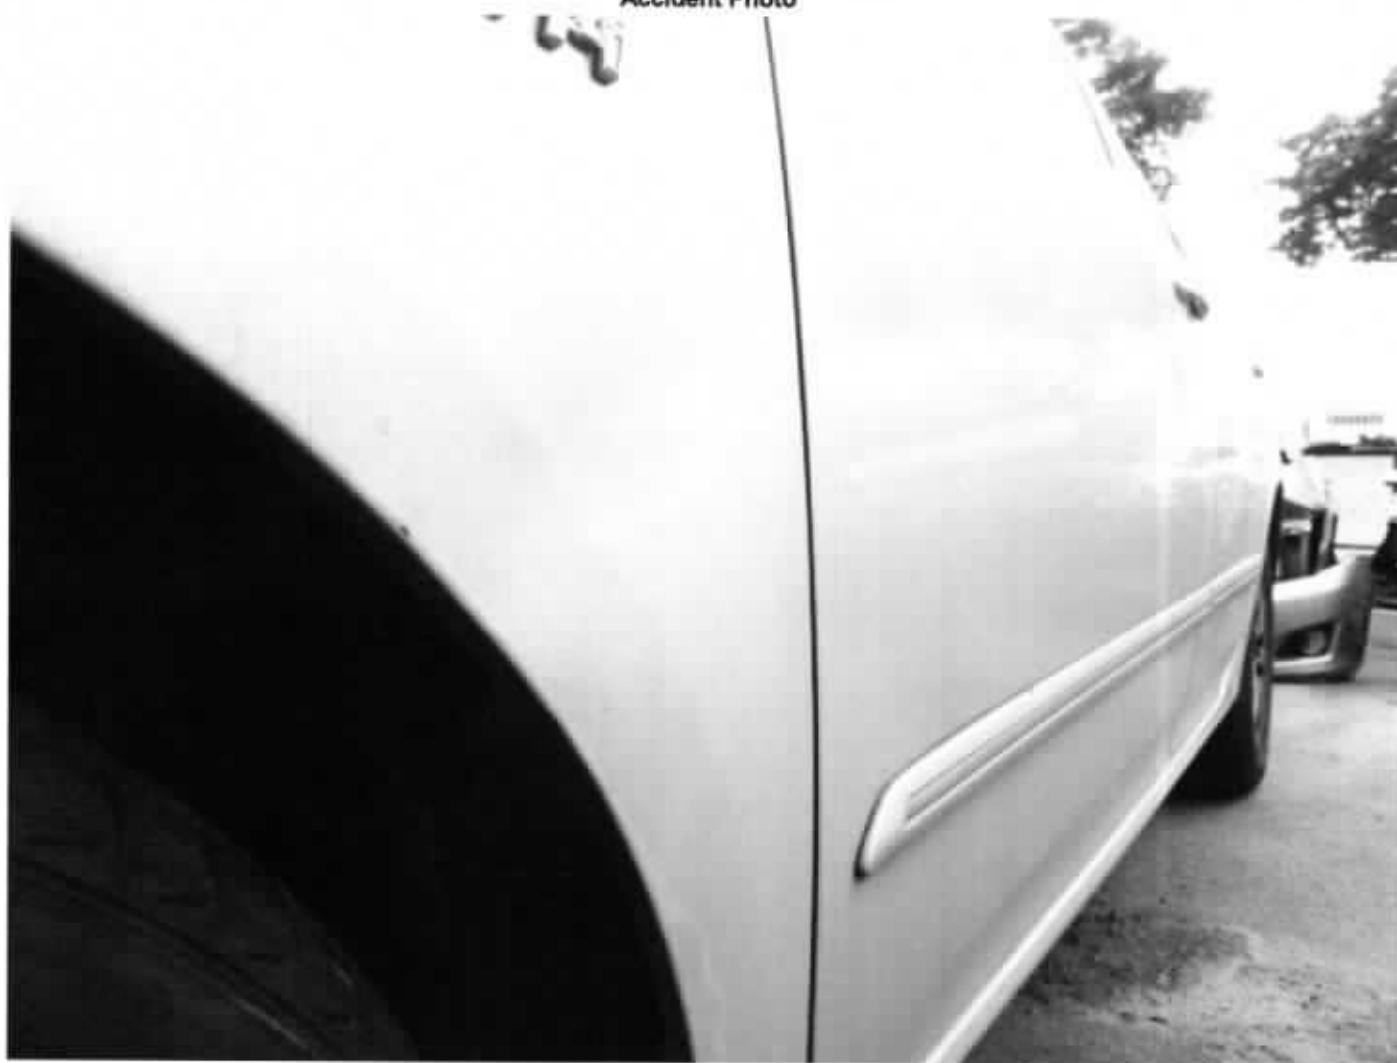
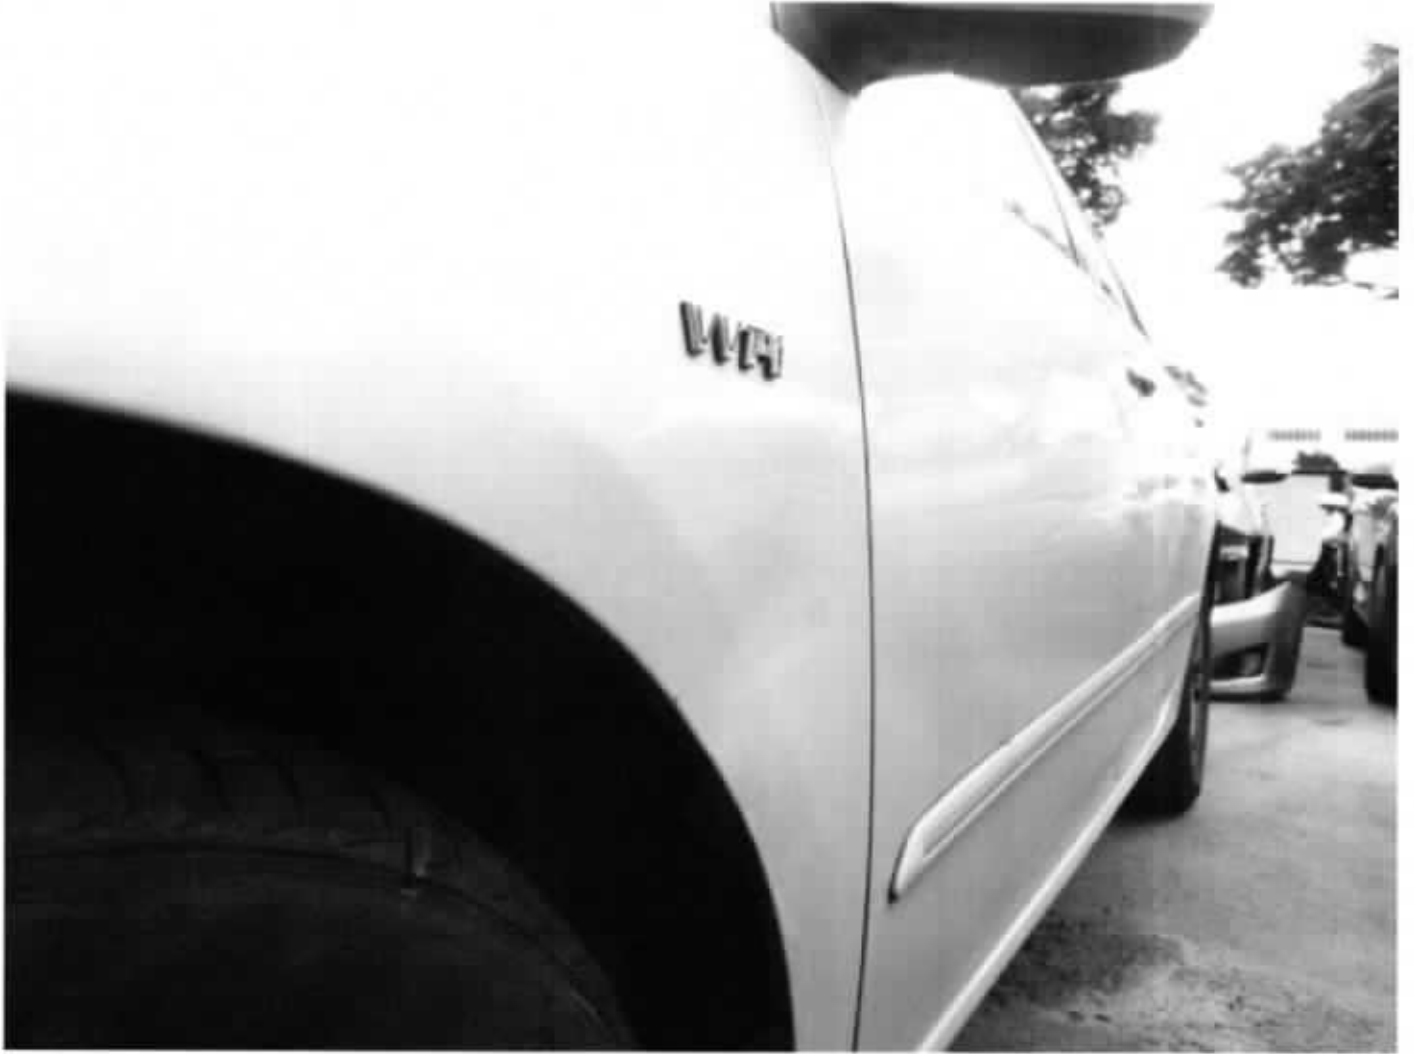
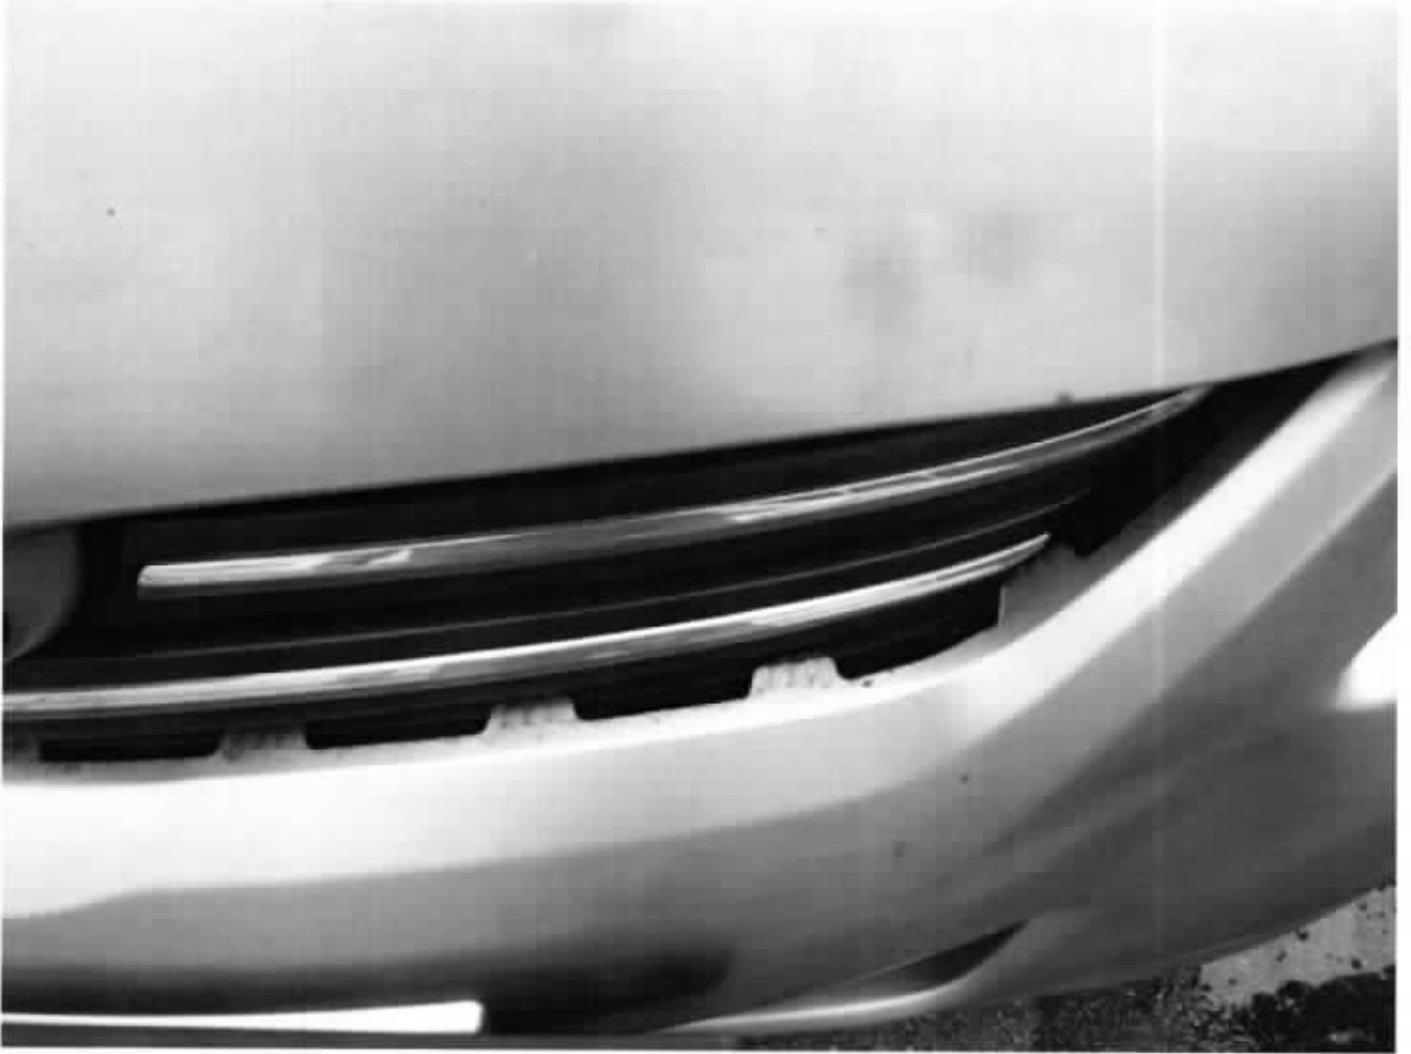
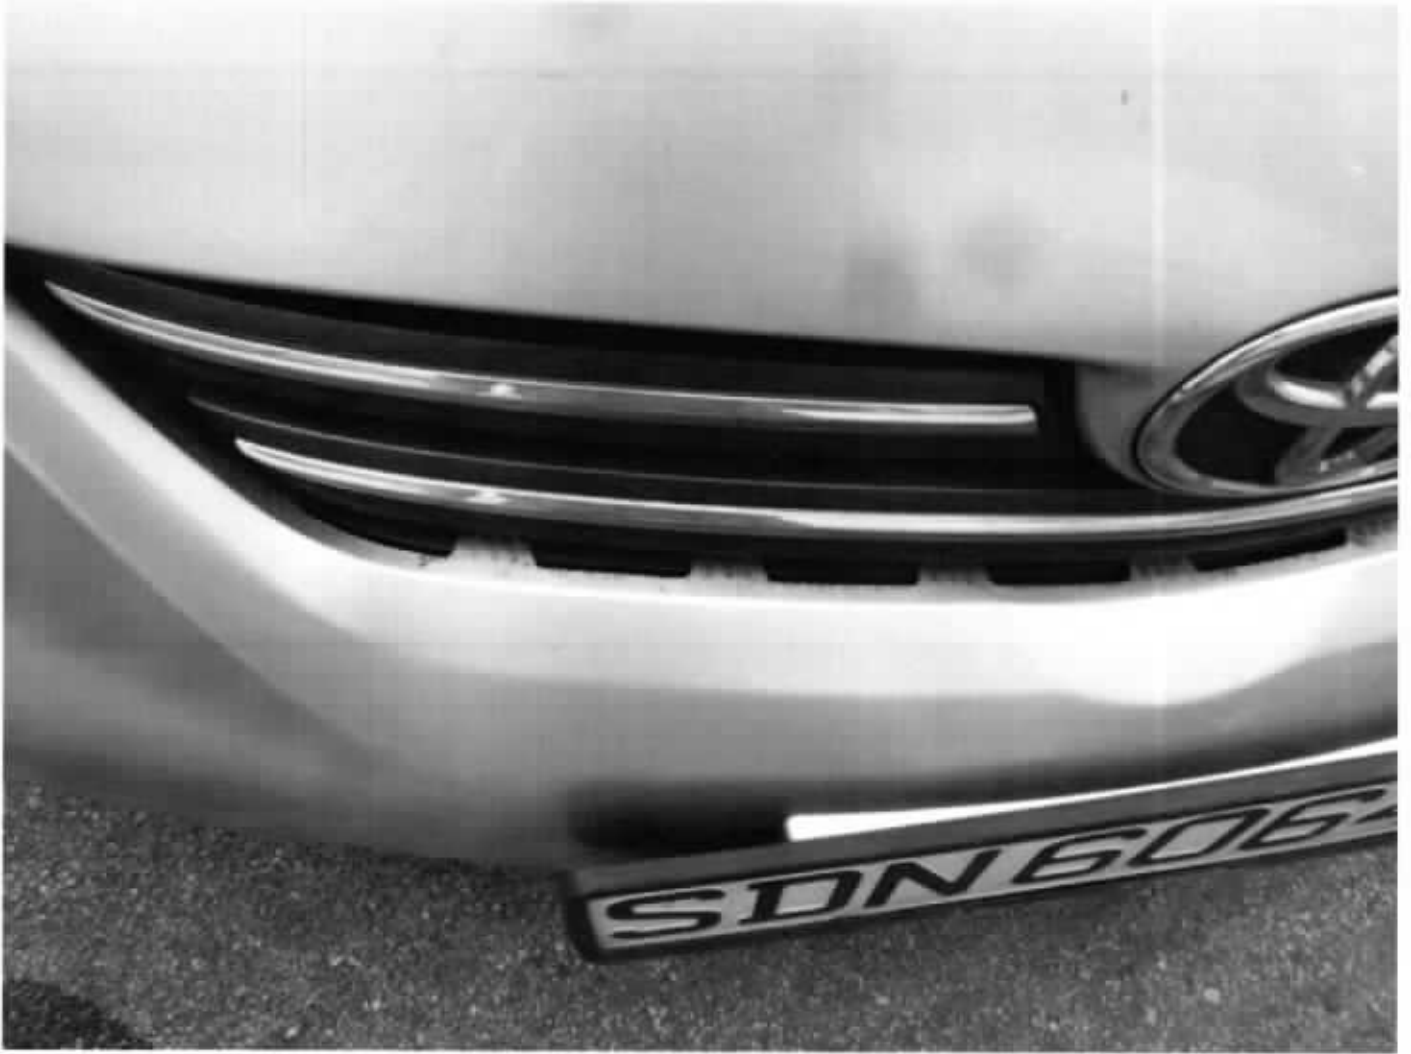
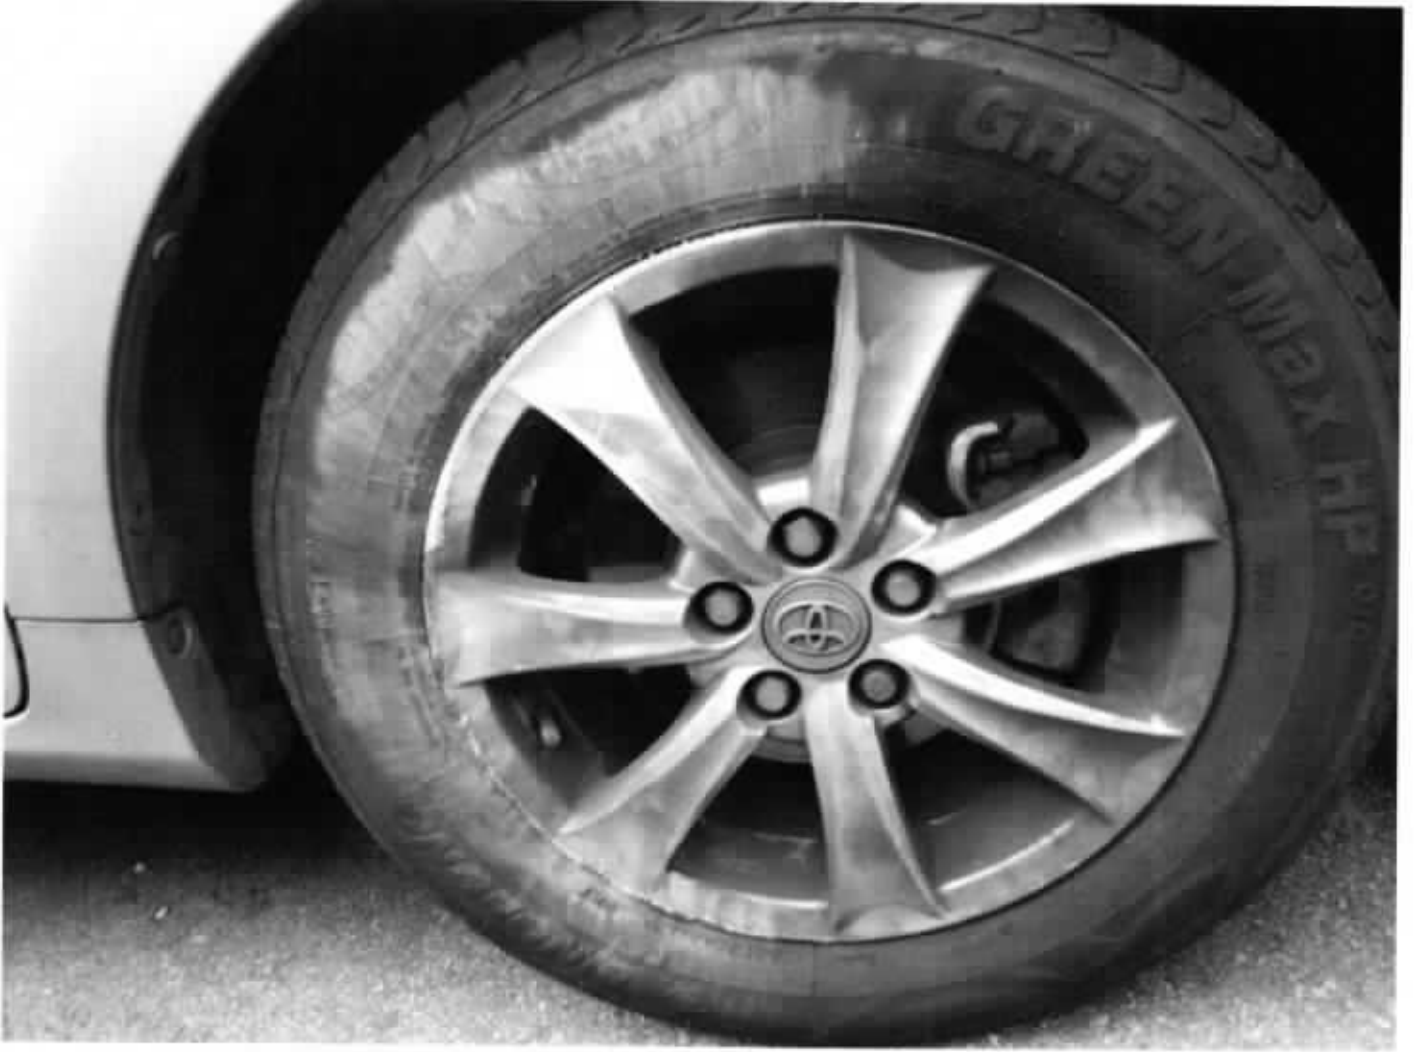
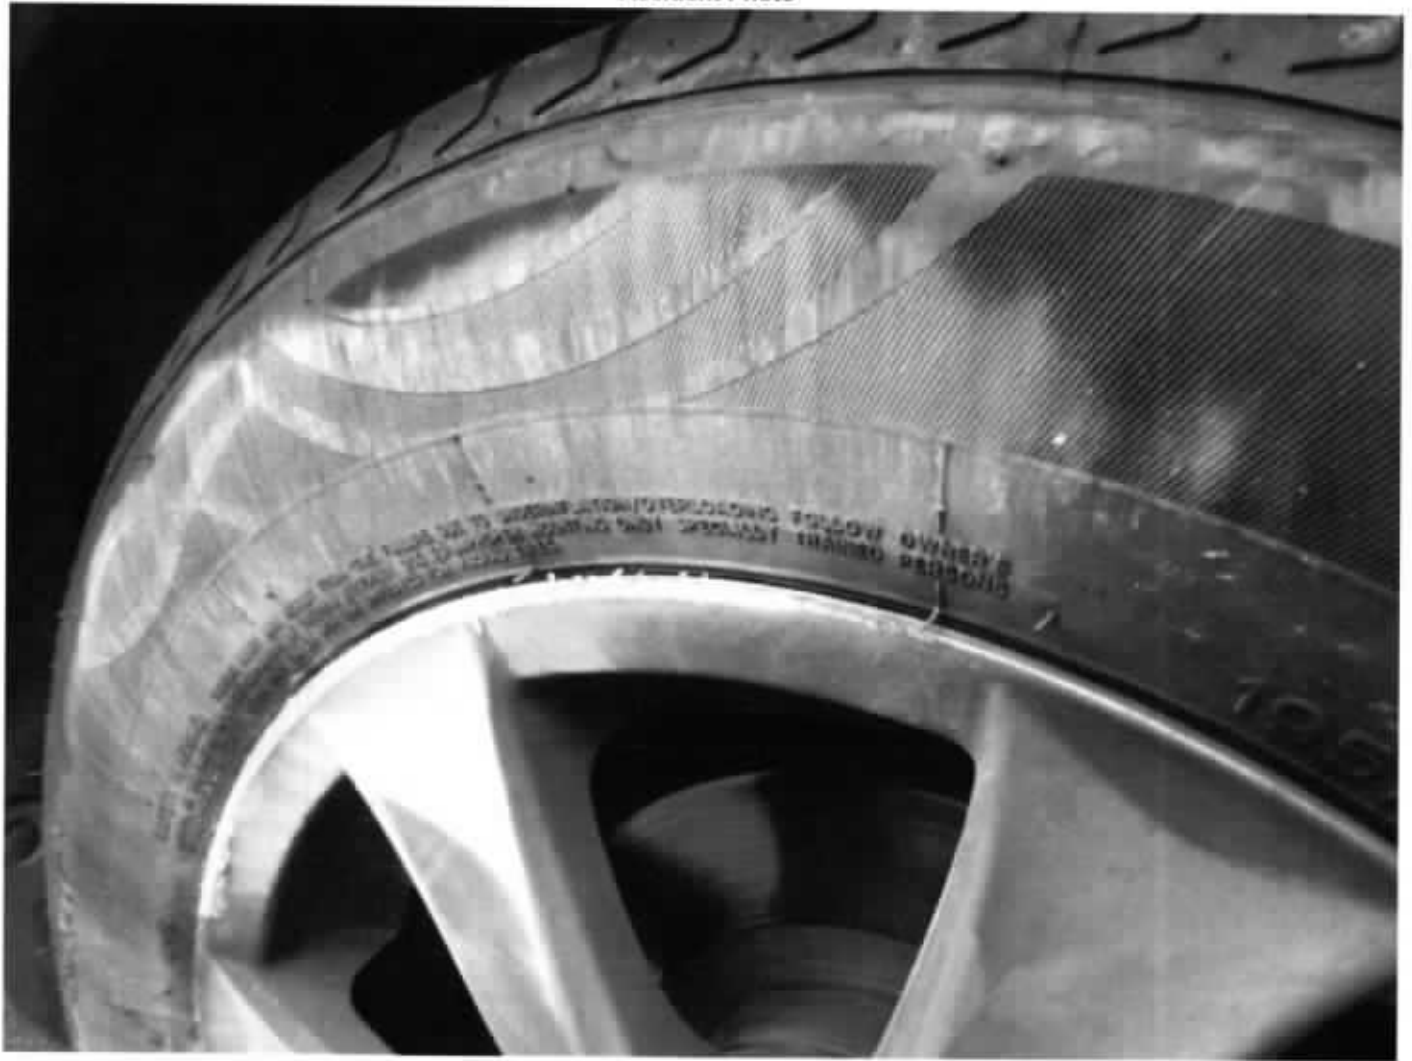
Accident Photo

At the LHF portion. (The RHF roadwheel was also affected)

The bonnet, front support panel, front bumper, LHF fender, LHF fender inner panel, RHF alloy rim, RHF knuckle arm, RHF lower arm, RHF shock absorber, etc.

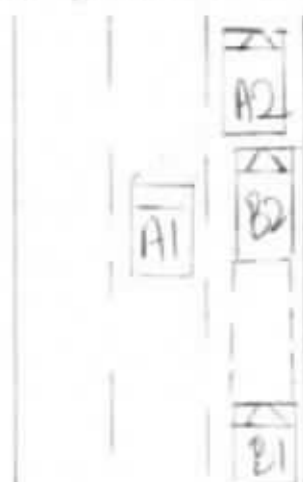
A) SDG 992K

B) SDN 6064 E

Along Honard Road, at the traffic intersection turning into Belmont Road, I was on the centre lane, filtering into the outer lane. Gave the right signal and attended across. Out of a sudden, there was a hit onto my car's right back bumper.
