PRE-REPAIR INSPECTION REQUEST – FBF5092X vs SKN9902J on 02.10.2019

NOTICE TO INSURER TO CONDUCT PRE-REPAIR SURVEY
CLAIMANT: CHONG YIN FONG
TRAFFIC ACCIDENT ON 2 OCTOBER 2019 AT 21:10 HRS ALONG 271 TANJONG KATONG
ROAD OUTSIDE CALTEX INVOLVING VEHICLES NO. FBF5092X & SKN9902J

VEHICLE DAMAGE INSPECTION REPORT

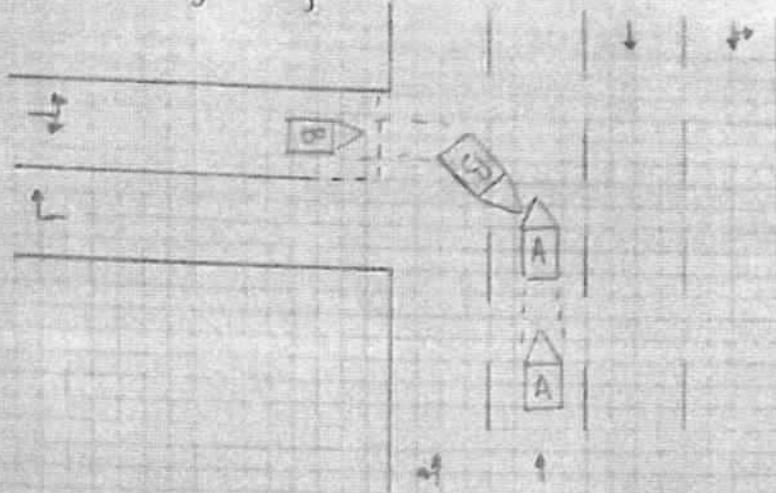
SKETCH PLAN 271 Tanjong Katong Road

On the above stated date and time, I was traveling along 271 Tanjong Katong Road. I was traveling straight when suddenly vehicle B came out from the side road and collided on to my vehicle front left portion, and due to the impact my bike fell on the right.

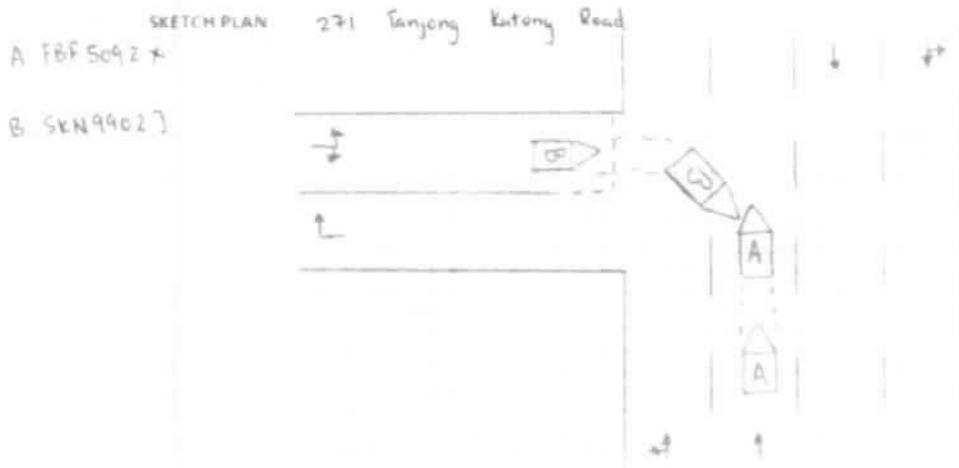
Sketch Plan #2

On the above stated date and time, I was traveling along 271 Tanjong Katong Road. I was traveling straight when suddenly vehicle B came out from the side road and collided on to my vehicle front left portion, and due to the impact my bike fell on the right.
