Report No: 0398 -19-PA

ACCIDENT VEHICLE SURVEY REPORT

Vehicle Reg No.:	SMN5385D	Odometer:	86492km
Make & Model:	Toyota Prius Hybrid 1.8L A	Colour:	Silver
Chassis number:	ZVW300451482	Date of accident:	30/08/2019
Year of Regn.:	17/08/2015	Date inspected:	30/08/2019
	Prime Auto Claims Service Pte Ltd		
	6 Benoi Place		
	Singapore 629927

Impact on the rear RH portion.
Please see details as described in the Annex for parts and labour.

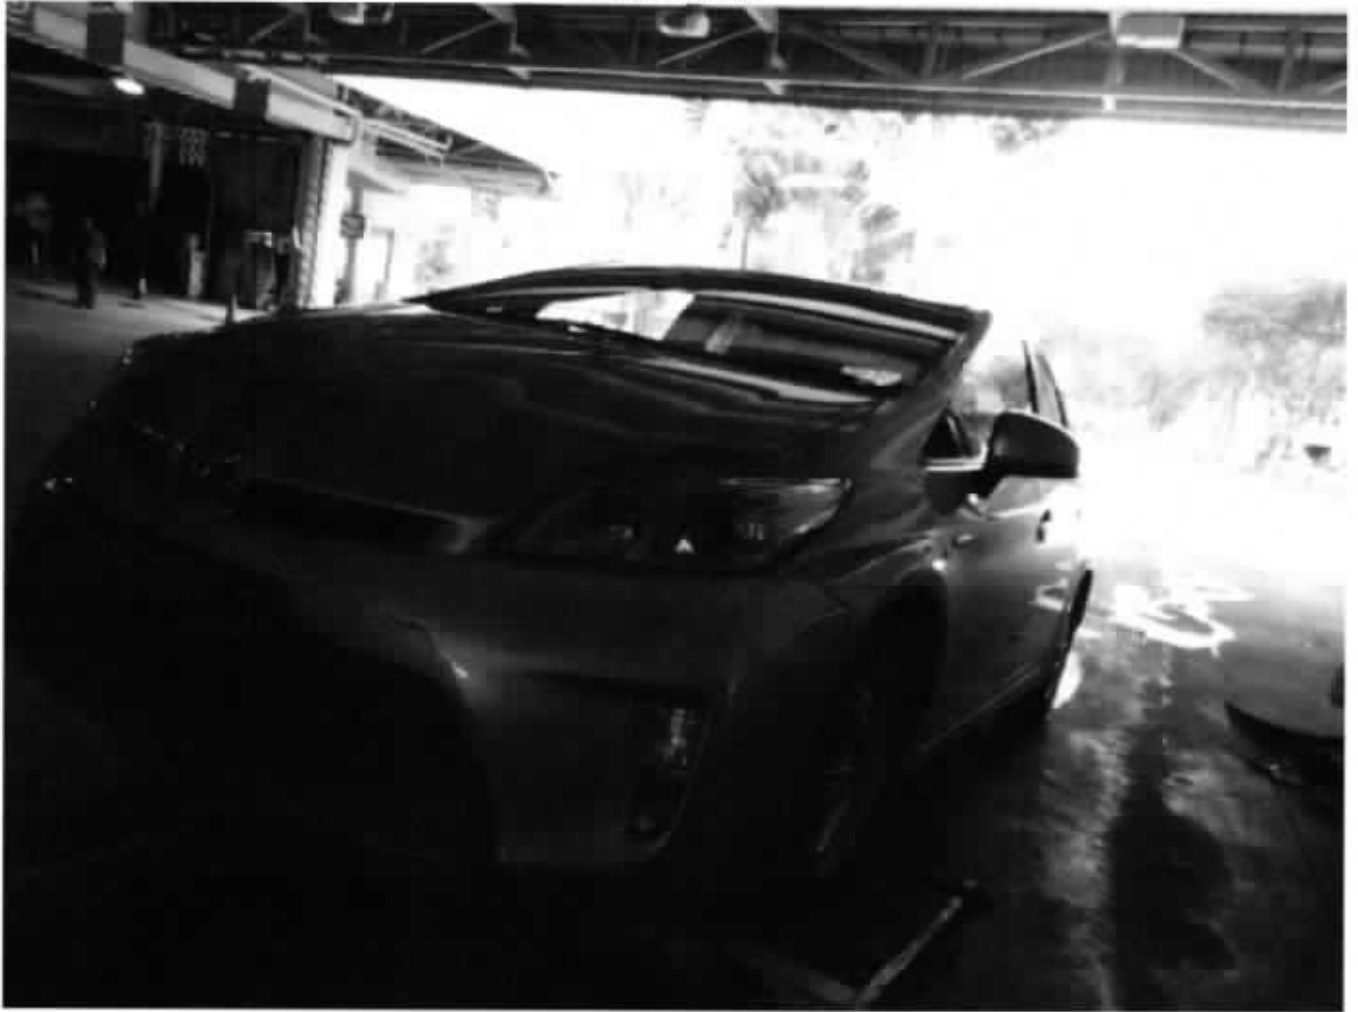
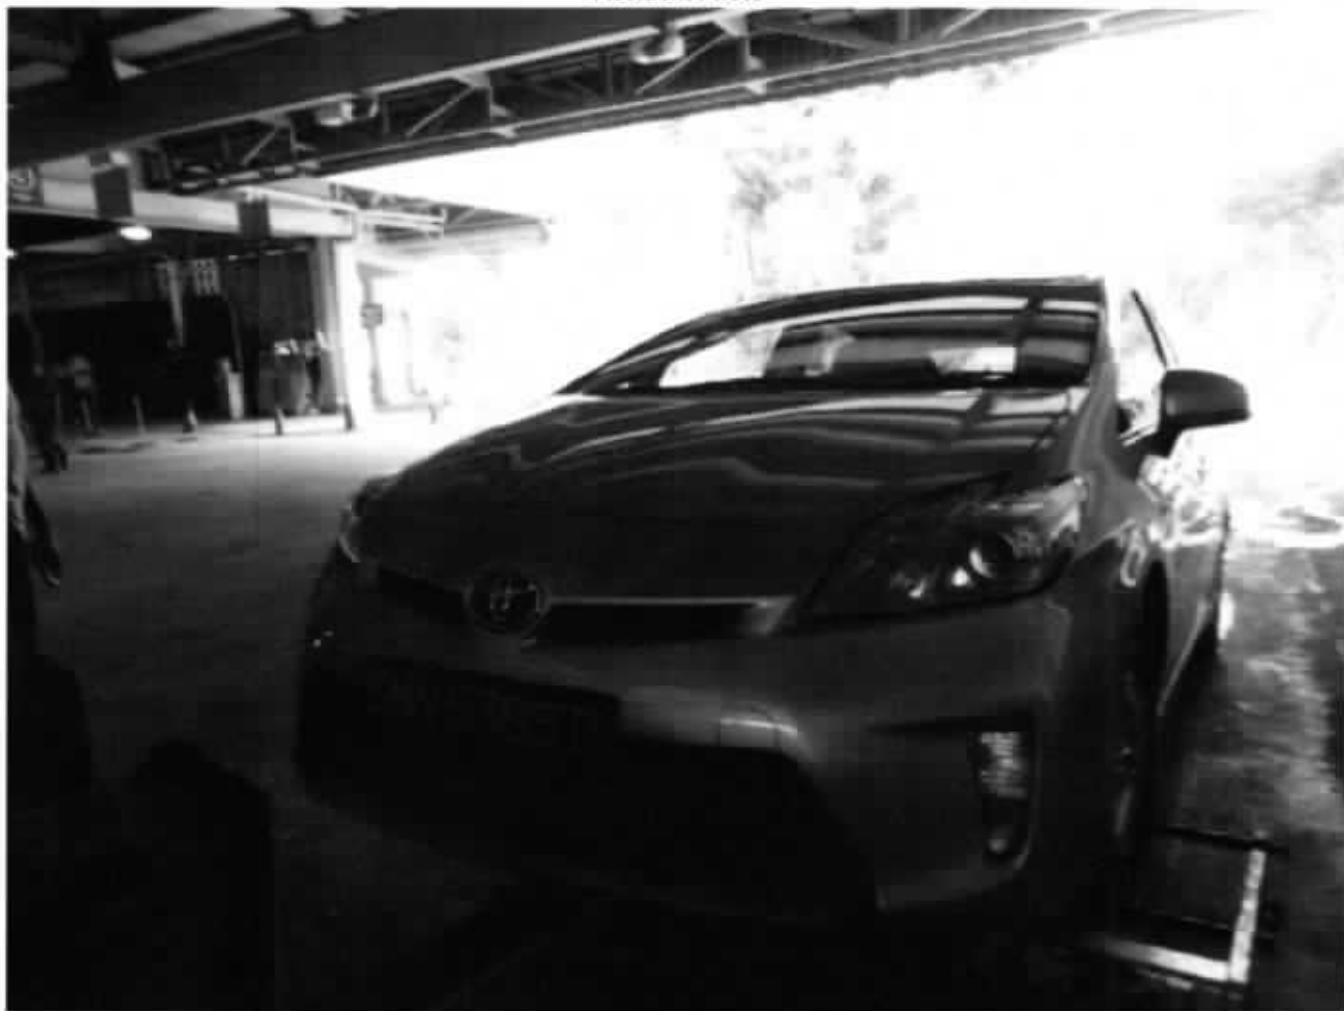
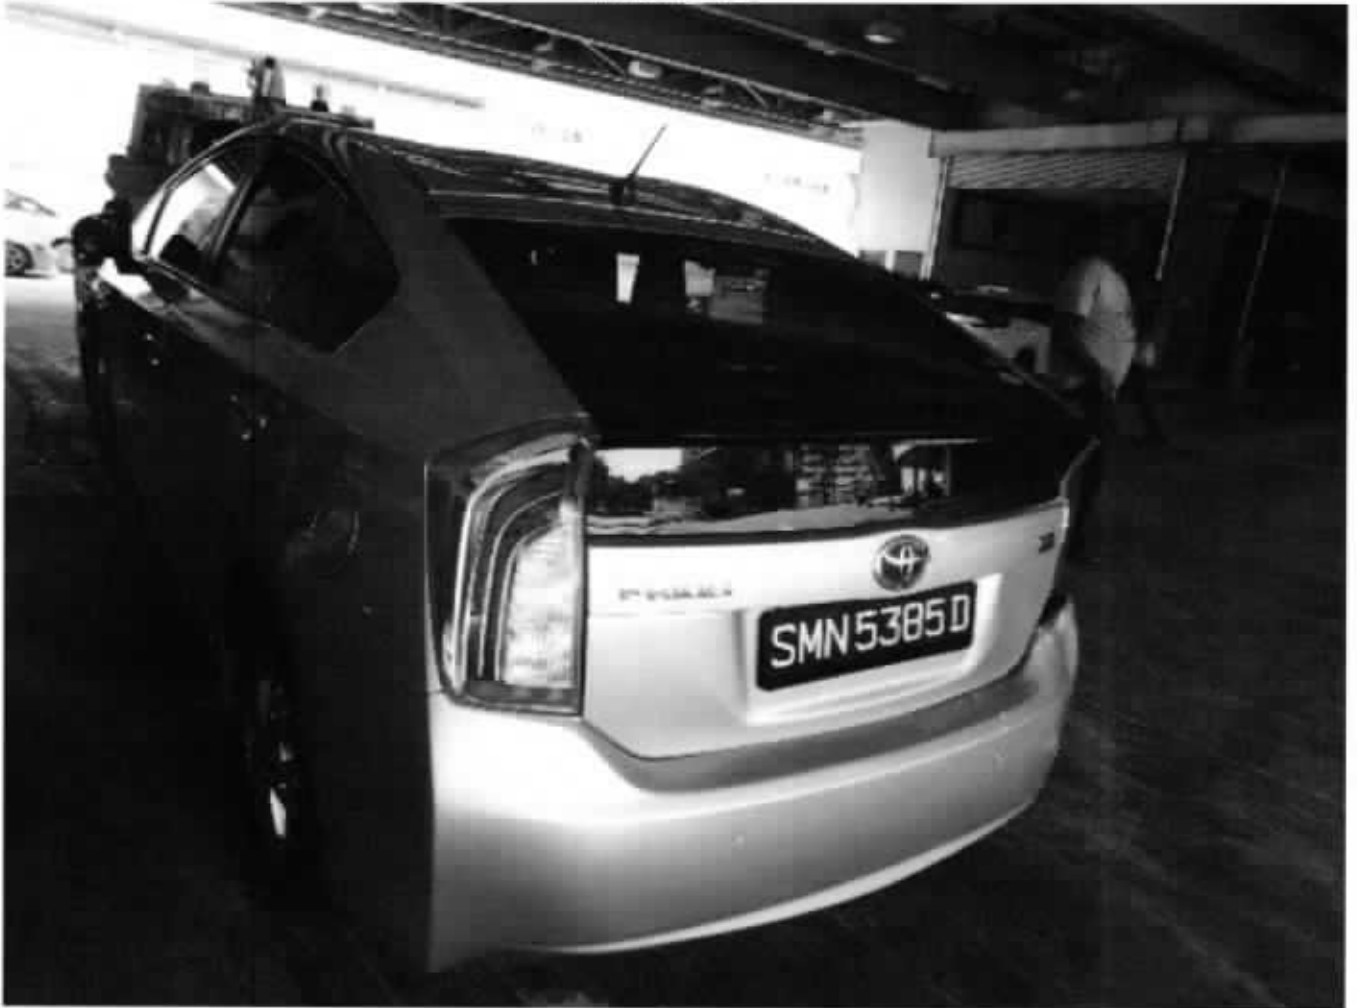
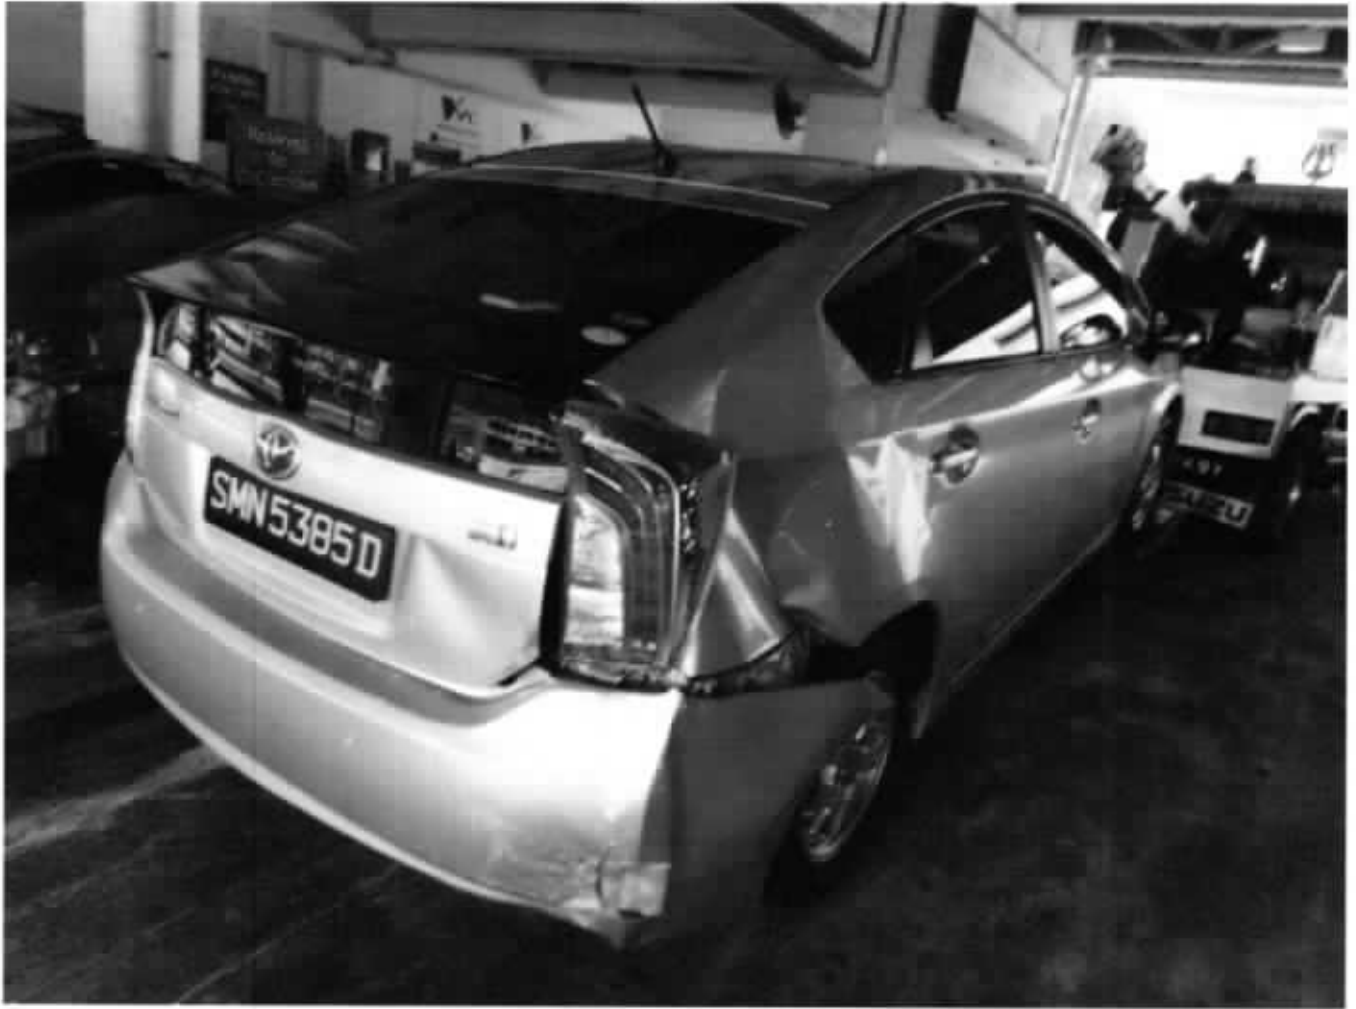
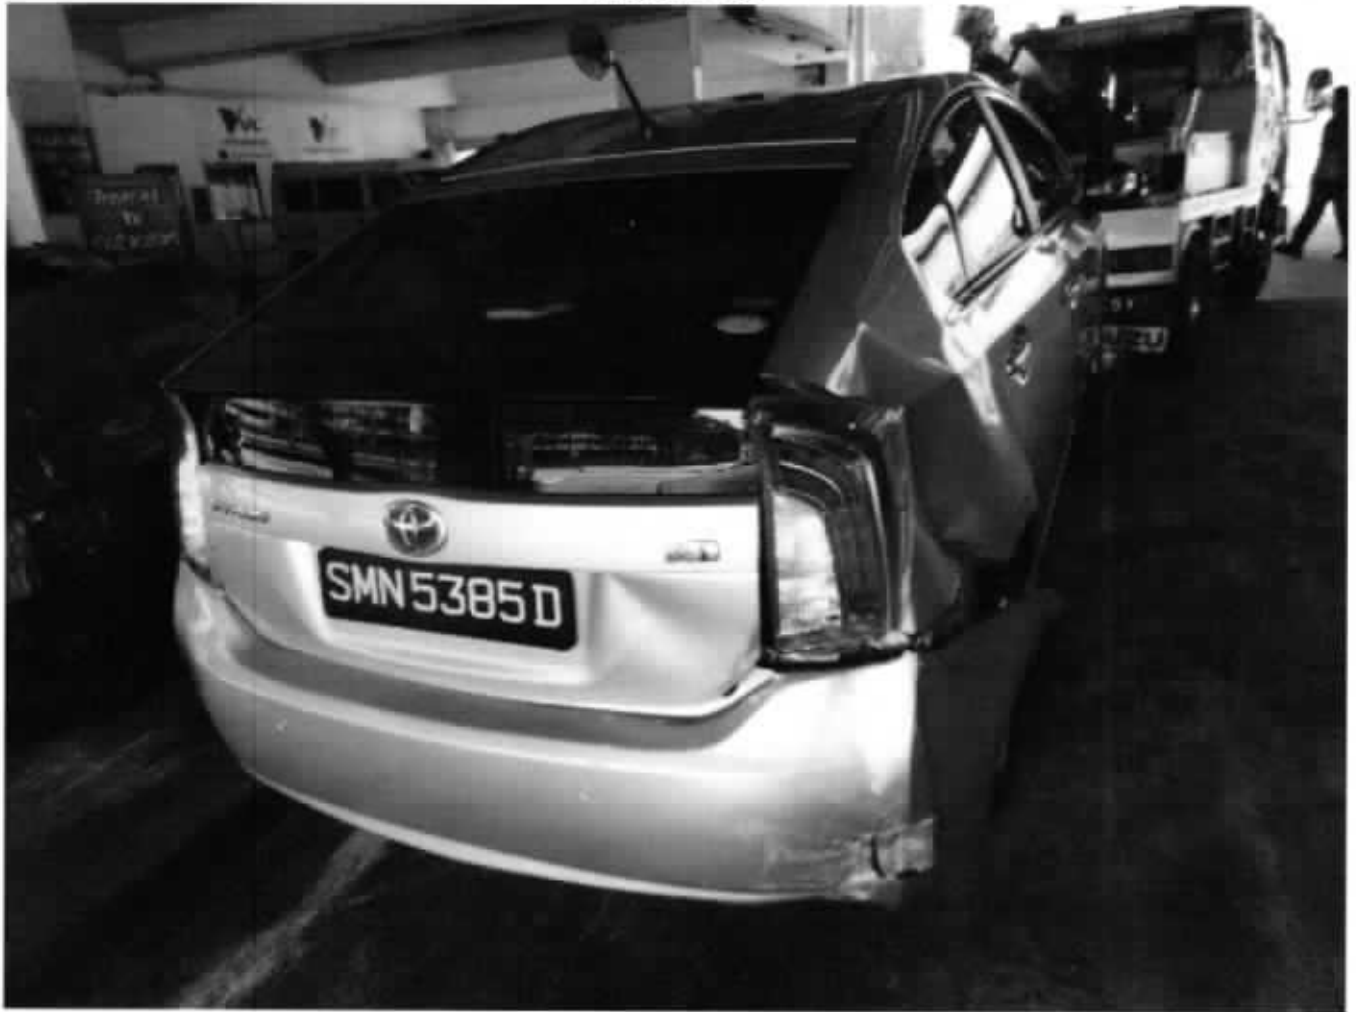
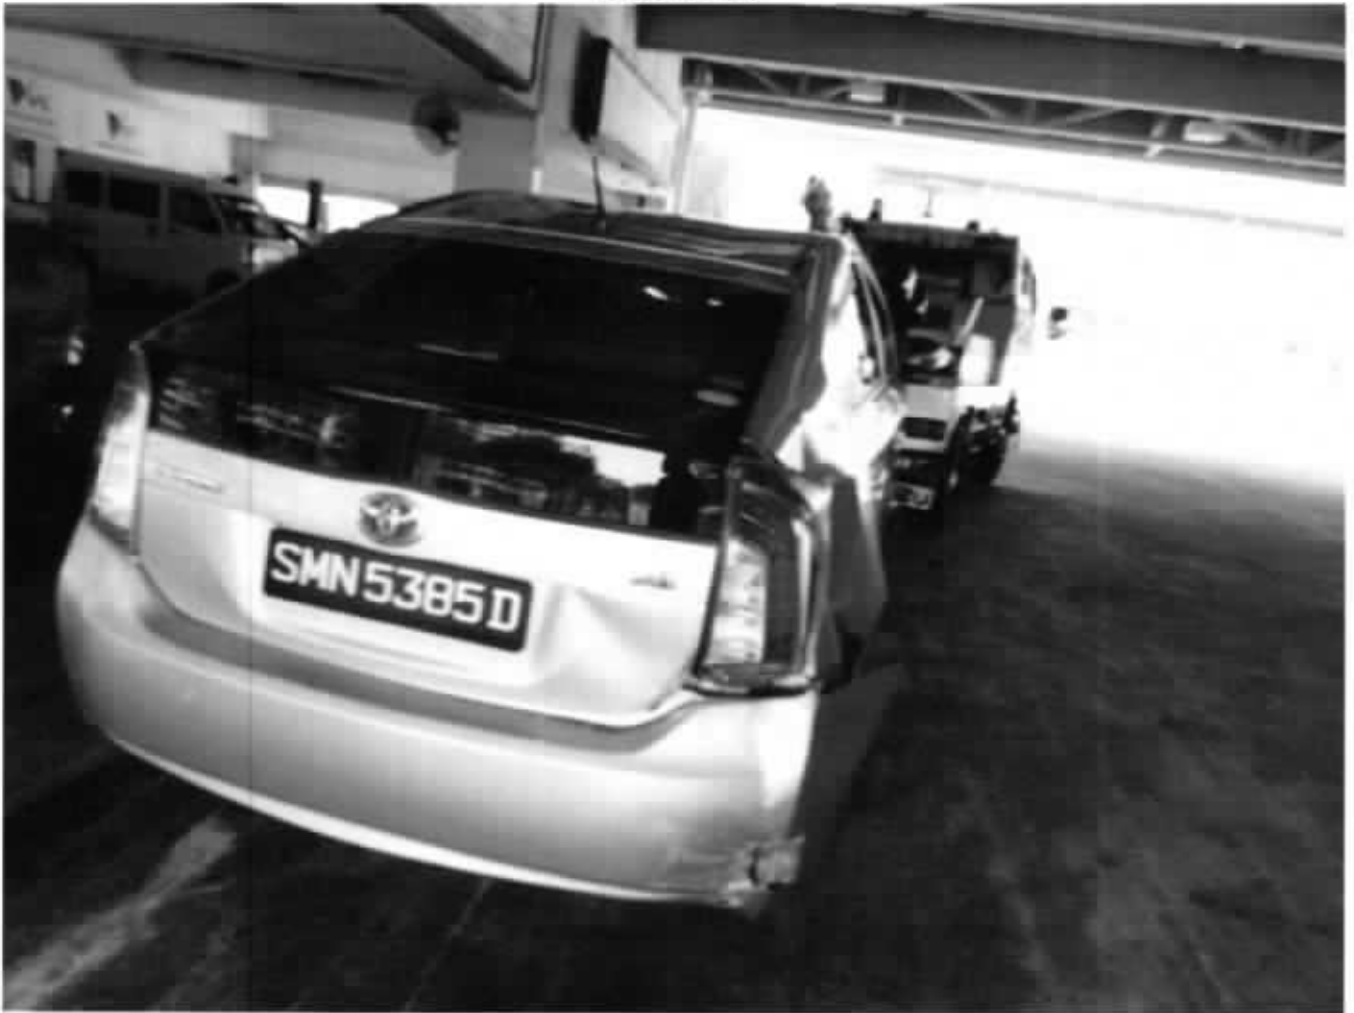
Vehicle Registration Number	SMN5385D
Vehicle Make/Model/Colour	TOYOTA PRIUS SILVER
Details Of Properties	REAR RIGHT PART OF THE CAR DAMAGED
Vehicle Category	PRIVATE CAR
Name of Driver	NG ANG SENG
NRIC/Passport Number	S7335367Z
Contact Number	96225190
Address	
Postcode	
Insurance Company Name	
Nature Of Damage

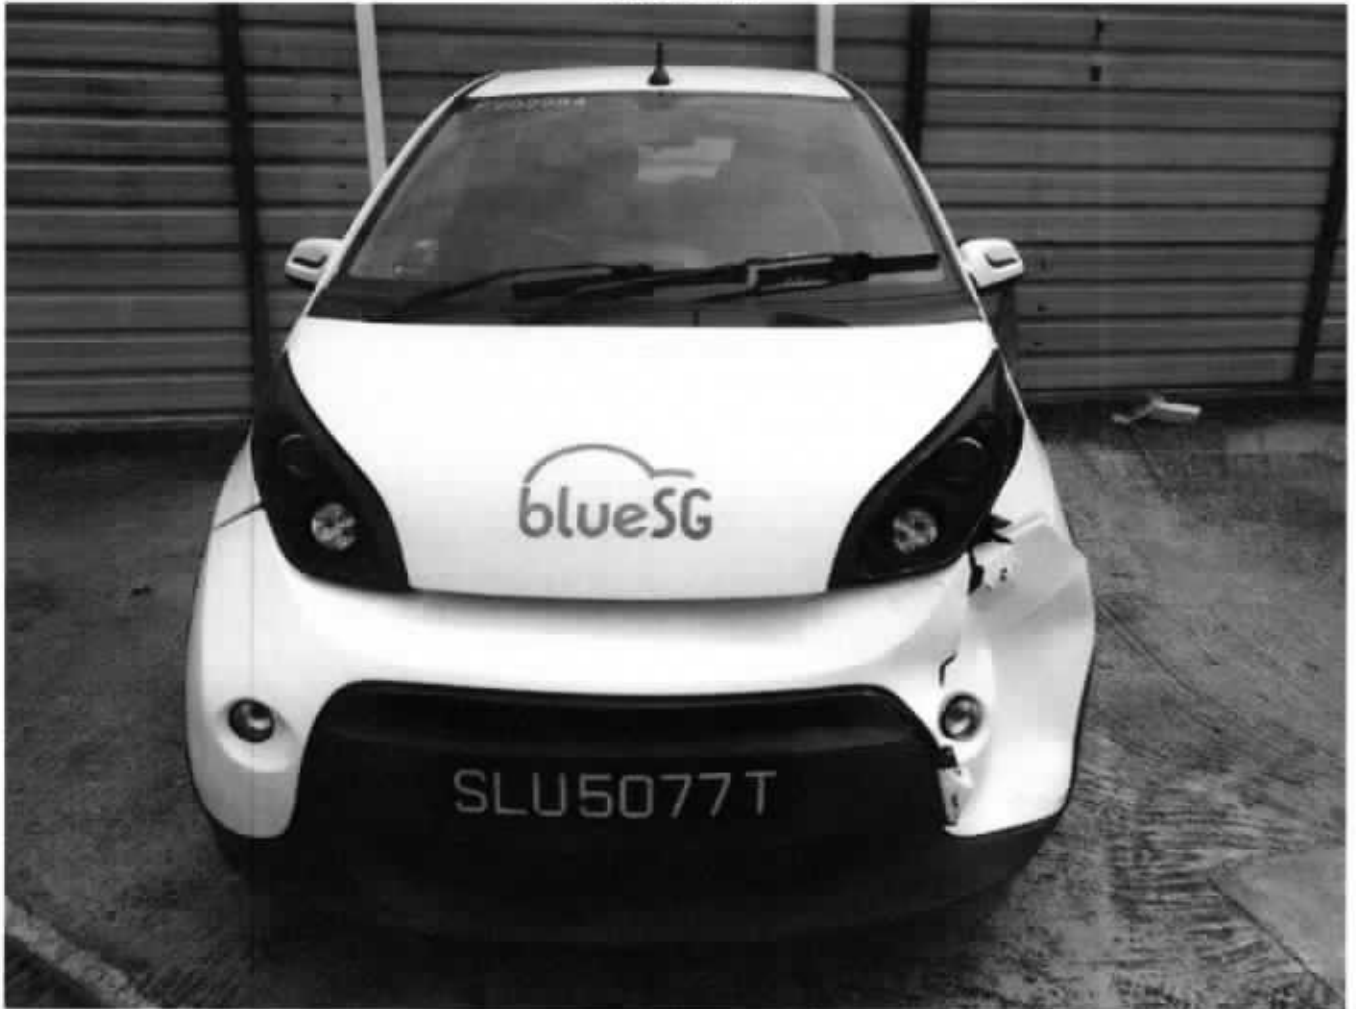
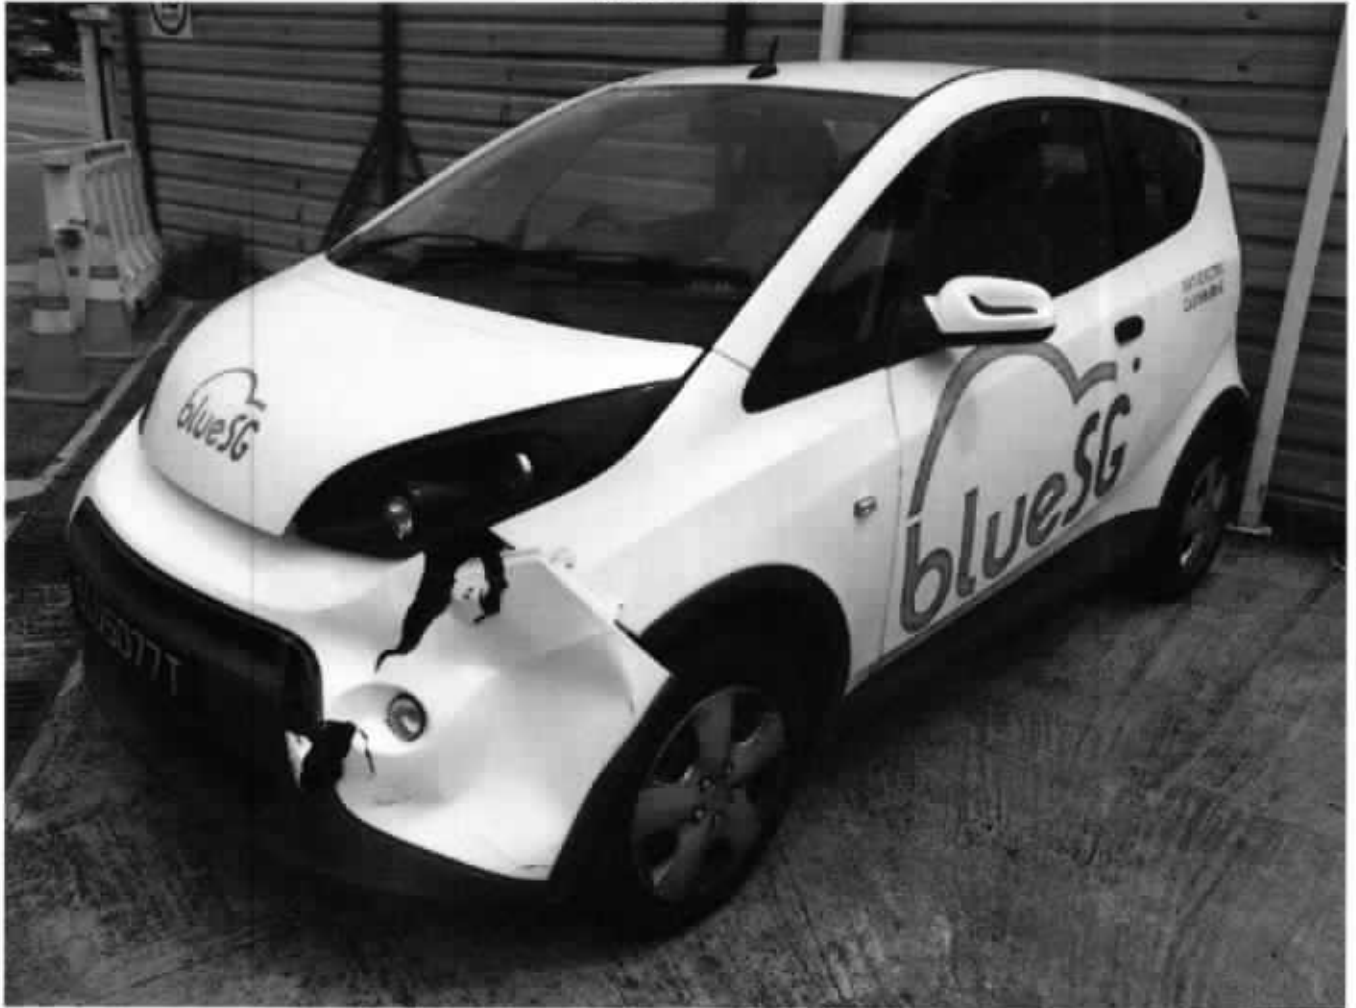
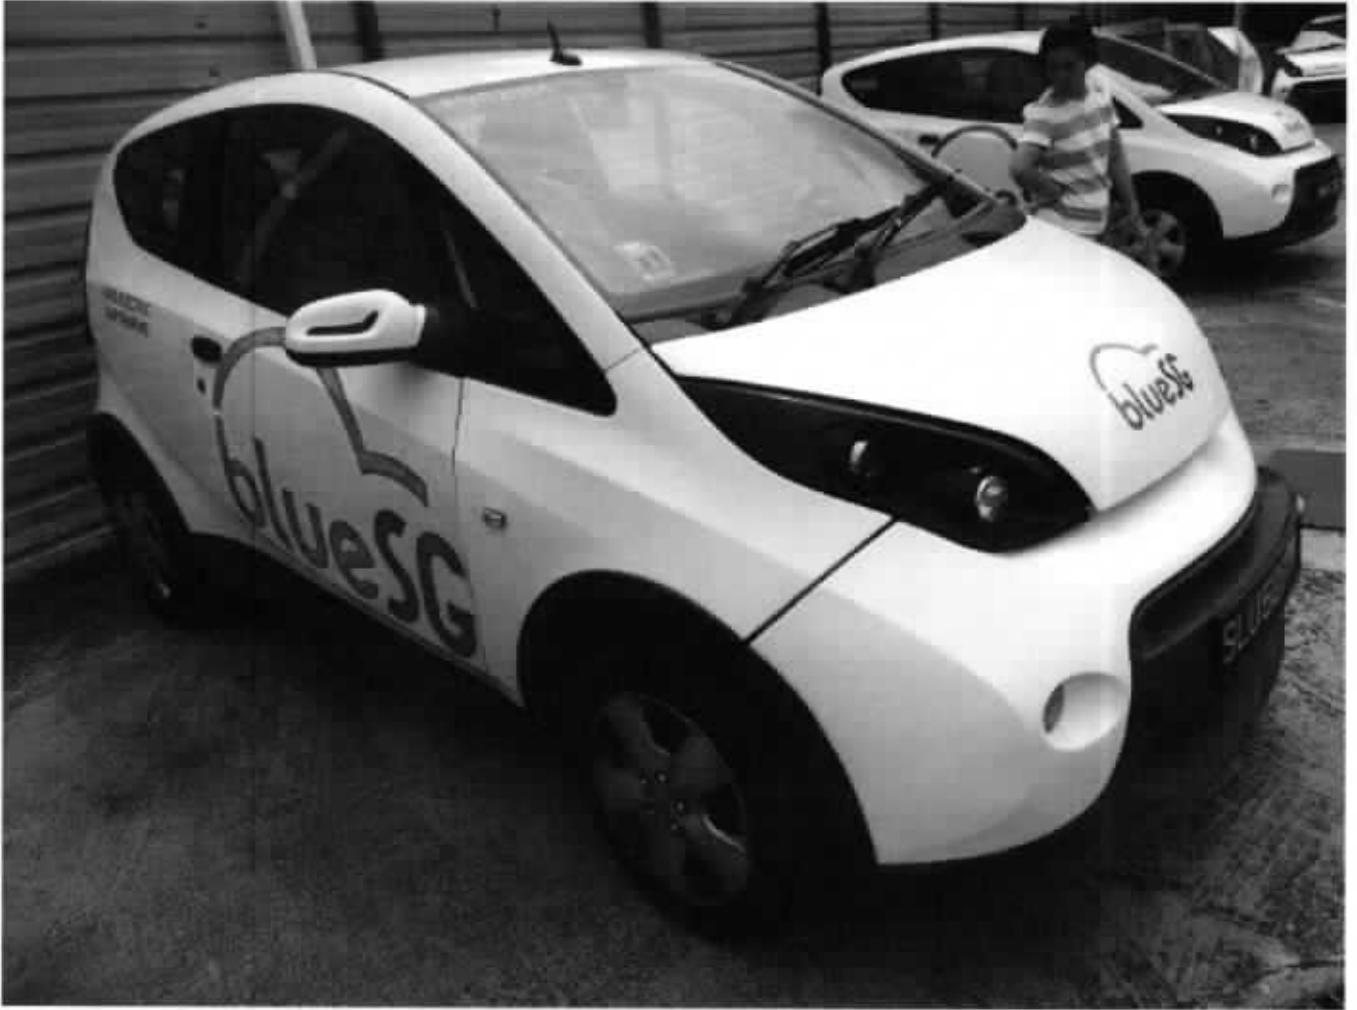
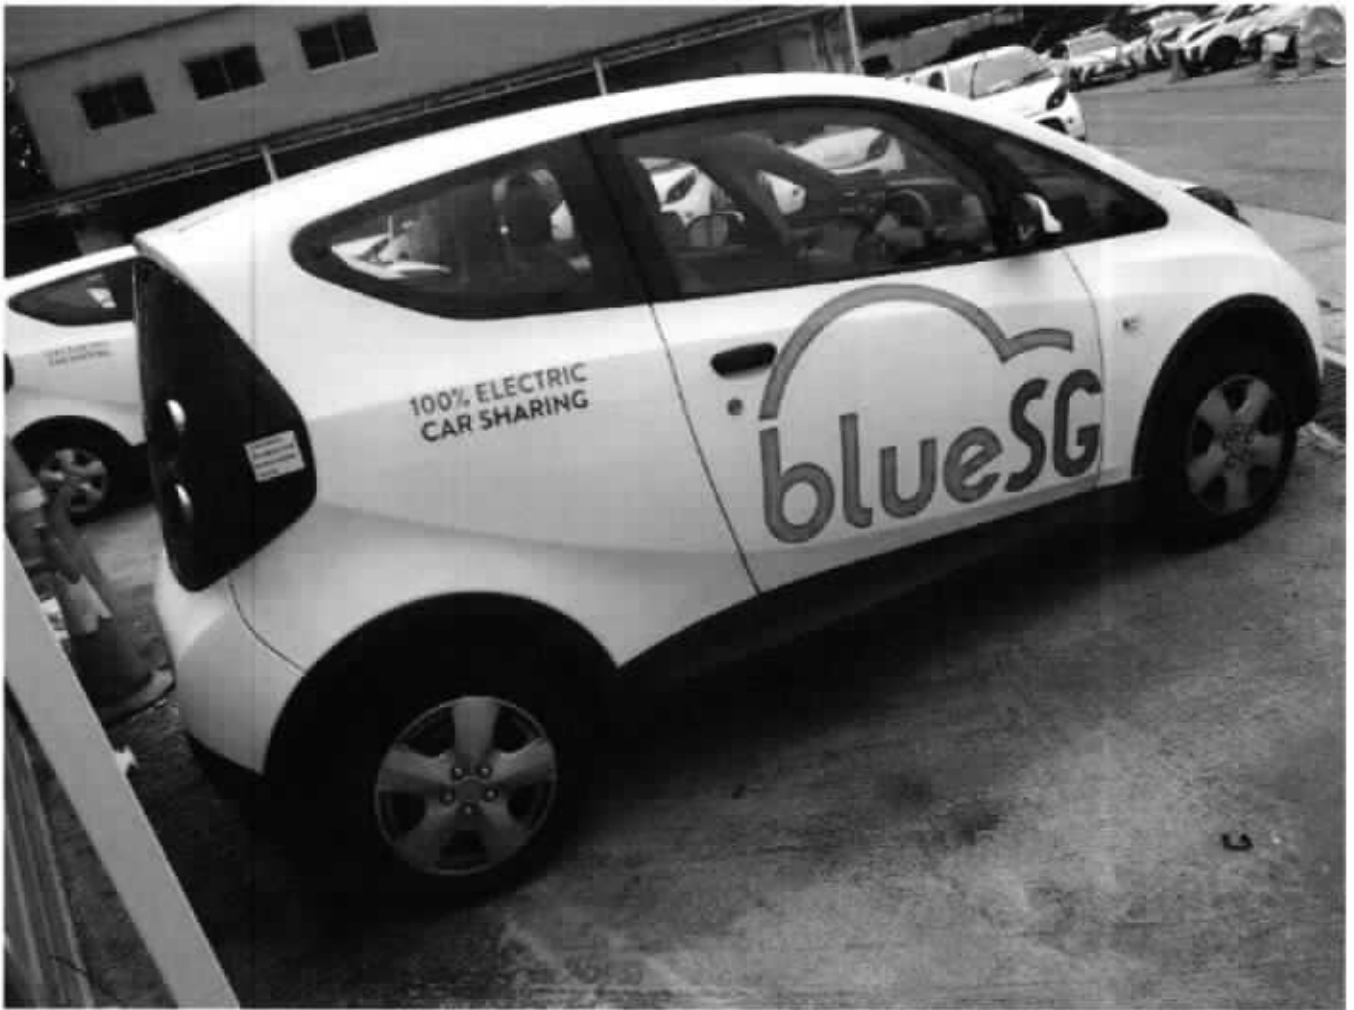
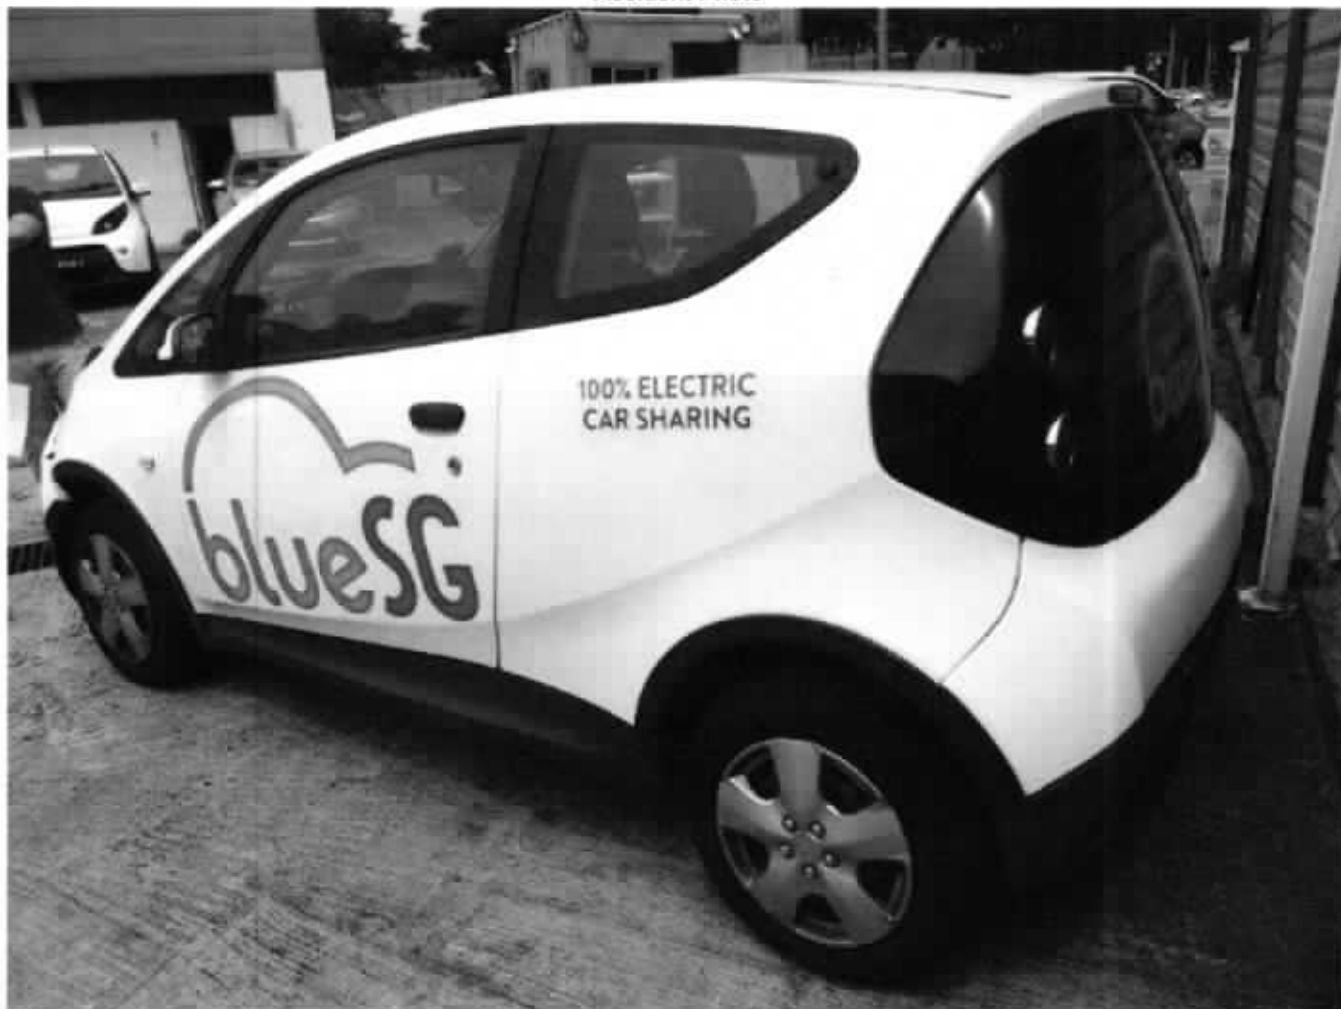
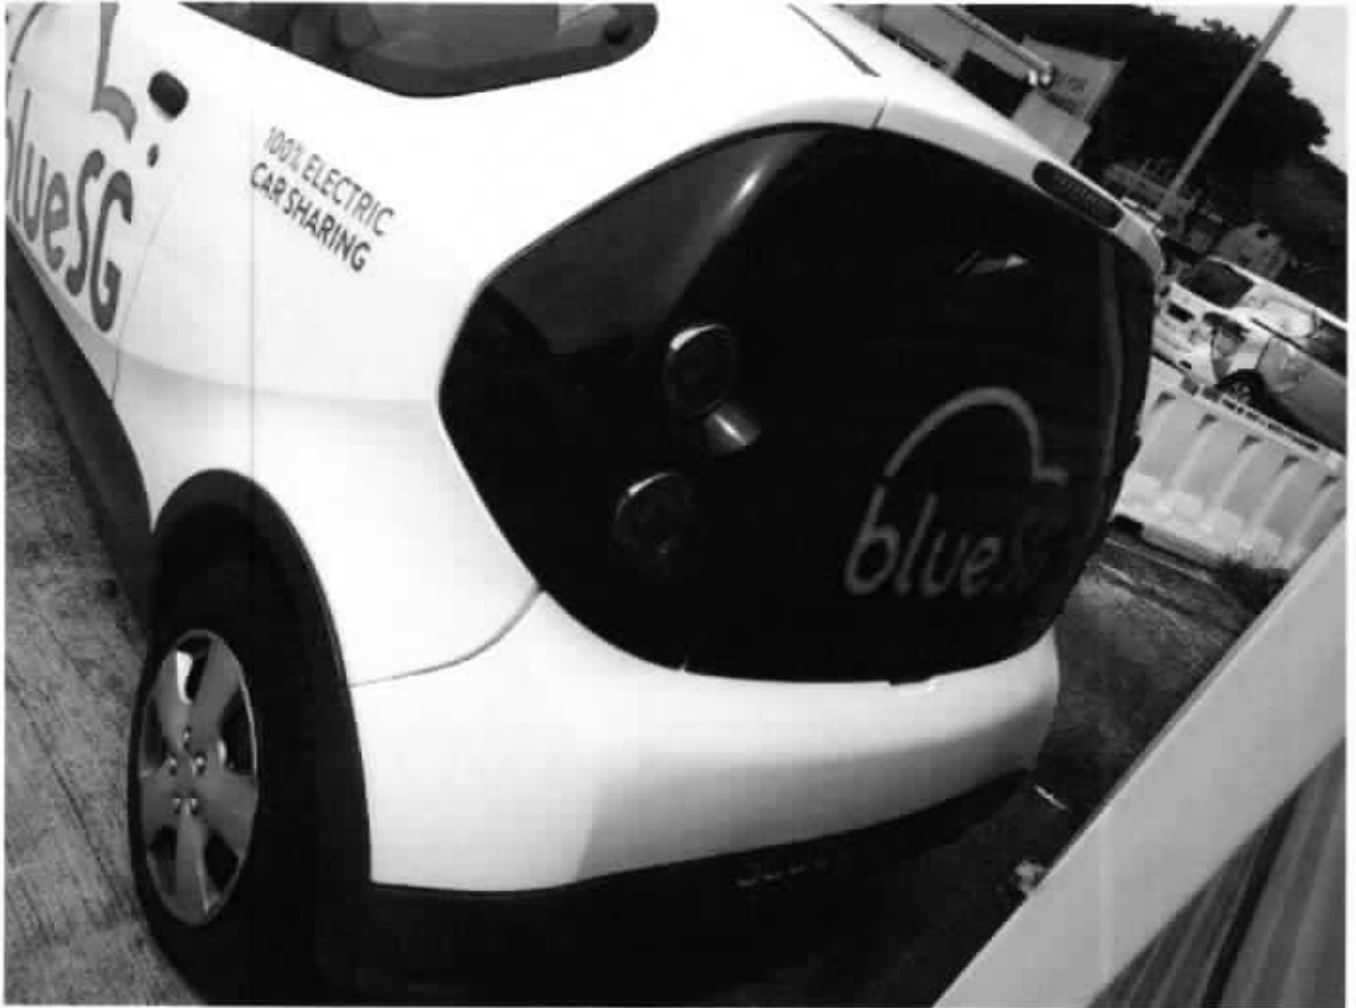
The rear right of 8MN 5385D was damaged.

The front left of Blue 36 SLU5047T was damaged.

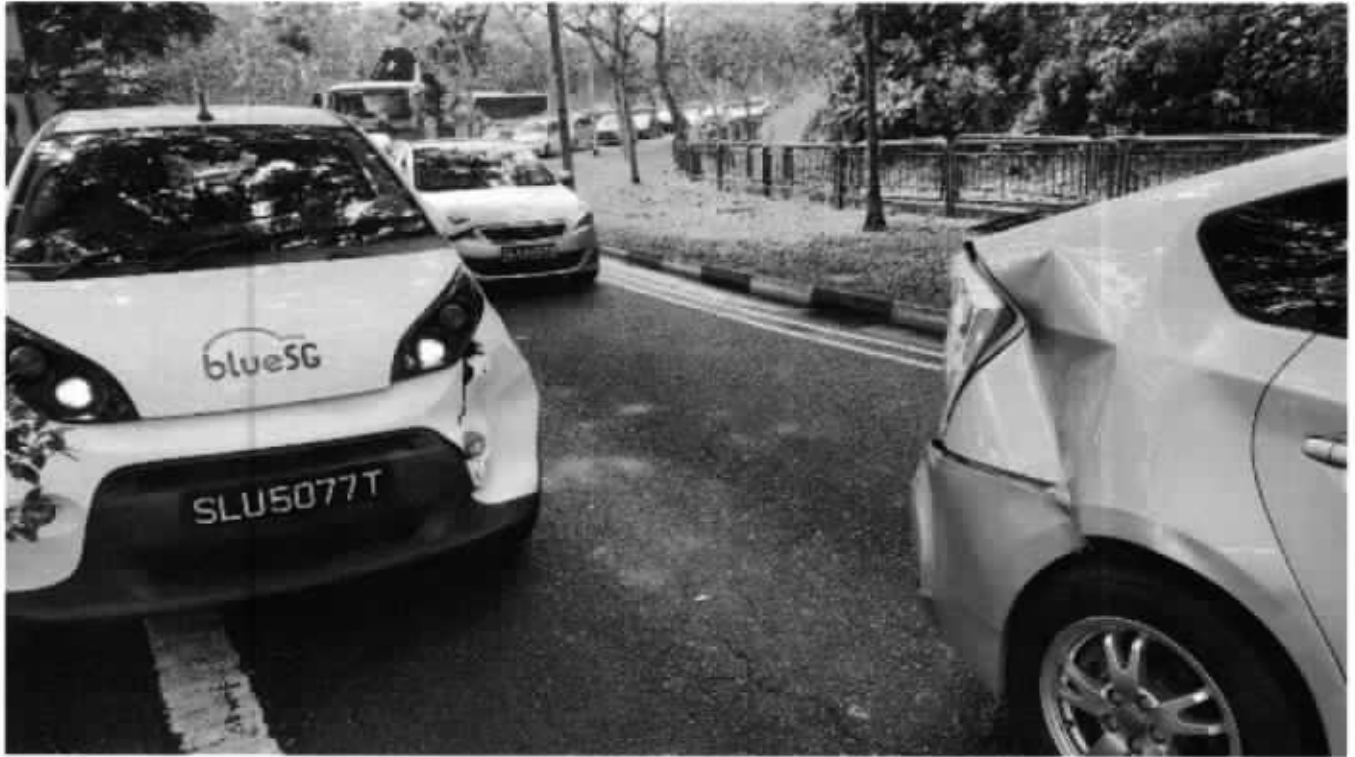
Schematic of accident site on 30/08/2019 1030am.
between MN5385D and BlueGr BLU5077T
