To Inspect Vehicle No: SML 6182 B

Claim No: SNM19D204539C02

Veh No: SML 6182B VI Regn: 29/05/2019  
 Type:  M.Car / M.Cycle / Bus / Van / Lorry / Taxi / Prime Mover /  
 Truck / Trailer or \_\_\_\_\_  
 Make: H. AD AVANTE (GAS) CC 1591  
 Colour: Gray AC: Insured / Std / NI / NA  
 Sp. Reading: 4339 km T/Radio: Insured / Std / NI / NA  
 Eng No: \_\_\_\_\_  
 C/Nr: KMH084 / CMK4910019  
 Gen. Cond:  Good / Fair / Poor / Burnt  
 Steering:  Inorder / Jammed / Leaked / Burnt or \_\_\_\_\_  
 Brake:  Inorder / Jammed / Leaked / Burnt or \_\_\_\_\_  
 Modi: Nil  S/Rim / STD A/Rim or \_\_\_\_\_  
 Tyre Size: F: 205/55/R16  
 R: 205/55/R16  
 BS / DUN / EXNOVA / GY / FS / LIZA / MIC / OHTSU / PIR / SUMI /  
 TOYO / YOKO or Kumho → (at and for same)  
 Front: \_\_\_\_\_ Rear: \_\_\_\_\_  
 R/Bal: 7 mm R/Bal: 7 mm  
 L/Bal: 7 mm L/Bal: 7 mm  
 D.O.A: 21/9/17 D.O.I: 11/10/19  
 Survey held at: Ngiam Motor  
 Des. of Damages: Frnt / Rear /  O/S / N/S / UIC / Rooftop or \_\_\_\_\_

### VEHICLE DAMAGE INSPECTION REPORT

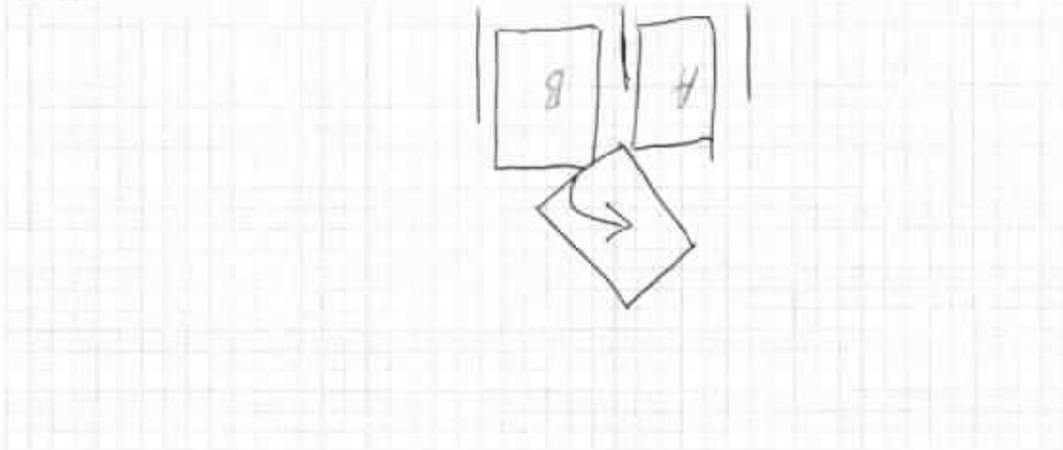
SKETCH PLAN

My car was parked next to 3rd party car.  
 He drove out and turned too early, his under carriage scraped the front right side of my car.
