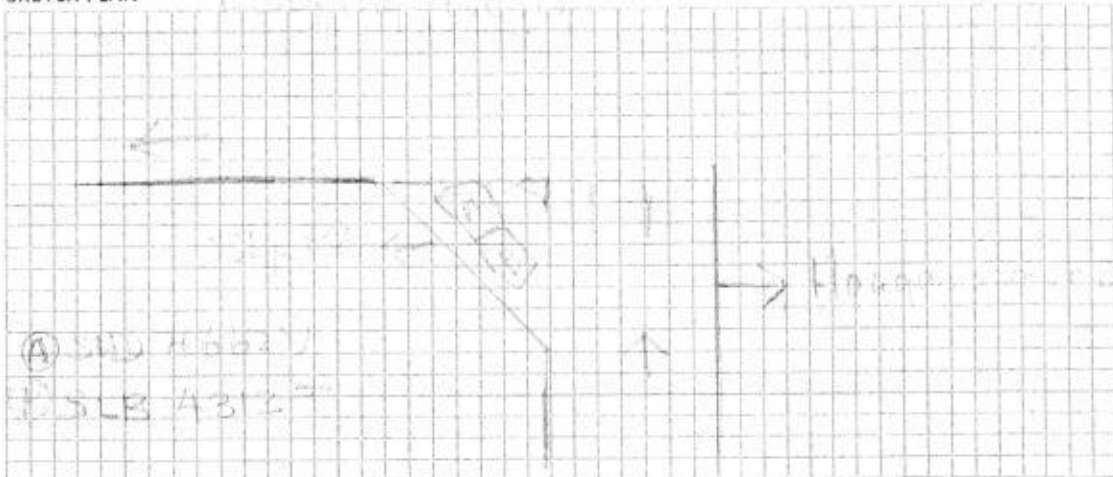
SKETCH PLAN

On 9/10/2019 at about 2340 hrs, I vehicle A was driving my taxi along Hangang ave 8 (Ship Road) toward Hangang ave 10* while I stop to give way to my right side. A few second later vehicle B came from behind bang onto vehicle A rear portion. no one were injured at that time.

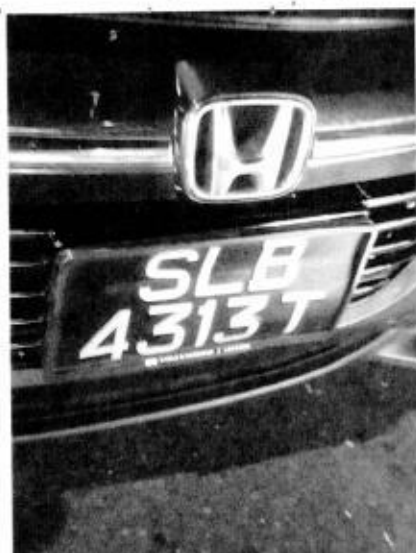
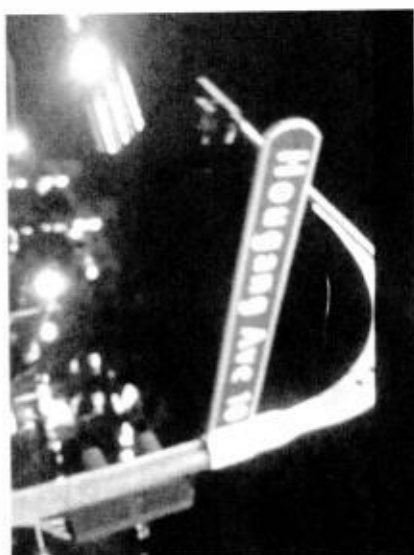
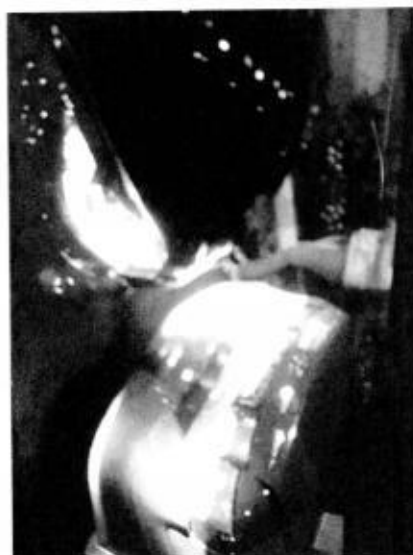
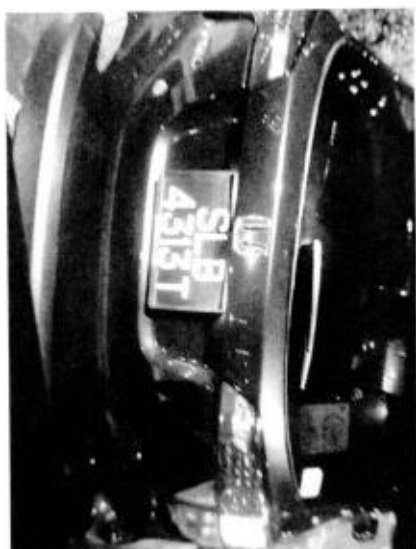
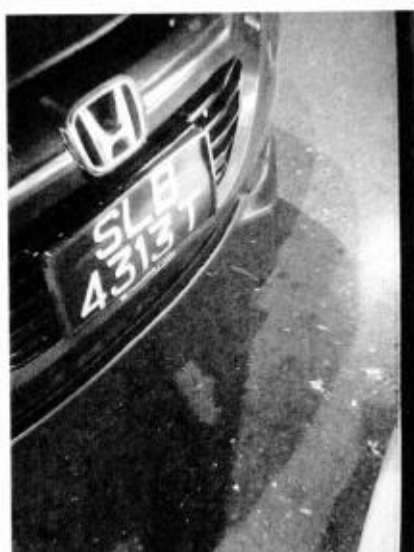
The U/C / Chassis frame / Body Structure affected due to collision.

THE VEHICLE SUSTAINED DAMAGES AT THE REAR PORTION. DAMAGES SEE DETAILS.
--

Qty	Description of Parts	Condition	Estimate By Workshop (\$)	Our Adjusted (\$)
<u>REPLACEMENT OF PARTS</u>				
1	BOOT LID	BUCKLED	1,349.50	1,349.50
1	BOOT LID LOCK UPPER	JAMMED	132.10	132.10
1	BOOT LID LOCK LOWER	TO REPAIR SEE LABOUR	30.30	-
1	BOOT LID SONATA PLATE	NECESSARY	43.60	43.60
1	BOOT LID HYUNDAI PLATE	NECESSARY	24.20	24.20
1	BOOT LID "H" EMBLEM	NECESSARY	26.10	26.10
1	BOOT LID CRDI PLATE	NECESSARY	22.70	22.70
2	BOOT LID LAMP (LH/RH) @\$230.20	O/S CRACKED / N/S SERVICEABLE	460.40	230.20
1	REAR BUMPER	DEFORMED	578.40	578.40
1	REAR BUMPER REINFORCEMENT	CRACKED	483.30	483.30
10	REAR BUMPER CLIP	NECESSARY	22.00	22.00
2	REAR BUMPER BRACKET (LH/RH) @\$49.00	SERVICEABLE	98.00	-
1	REAR BUMPER SPONGE	SERVICEABLE	137.40	-
1	REAR BUMPER UNDER COVER	SERVICEABLE	185.80	-
2	REAR BUMPER PROTECTOR (LH/RH) @\$38.00	TO REPAIR SEE LABOUR	76.00	-
2	TAIL LAMP (LH/RH) @\$344.00	O/S CRACKED / N/S SERVICEABLE	688.00	344.00

1	REAR PANEL	TO REPAIR SEE LABOUR	391.80	-
1	REAR PANEL GARNISH	SERVICEABLE	95.80	-
	LESS 20% DISCOUNT		-969.08	-651.22
			3,876.32	2,604.88
<u>NETT ITEMS</u>				
1	BOOT LID COMFORT LOGO & TEL NO STICKER (N)	NECESSARY	30.00	30.00
1	REAR BUMPER REVERSE SENSOR (N)	SHORTED	135.70	135.70
	LESS 10% DISCOUNT		-	-16.57

Qty	Description of Parts	Condition	Estimate By Workshop (\$)	Our Adjusted (\$)
1	<u>SPECIAL NETT ITEMS</u>	NECESSARY		
	REAR BUMPER RUBBER MAT (SN)		50.00	50.00
			50.00	50.00
	<u>LABOUR</u>			
	PANEL BEATING.INCLUSIVE OF THE REPAIR OF BOOT LID LOCK LOWER,REAR BUMPER PROTECTOR (LH/RH) AND REAR PANEL.		800.00	360.00
	SPRAY PAINTING CHARGE.		600.00	400.00
	WIRING CHARGE.		50.00	20.00
	TUFF KOTE.		50.00	20.00
	REMOVE/REFIX REVERSE SENSOR.		120.00	30.00
			1,620.00	830.00
GRAND TOTAL			5,712.02	3,634.01
RECOMMENDED COST OF LUMP SUM REPAIRS (TO ITS PRE-ACCIDENT CONDITION) (CONFIRMED)				2,900.00
