# ASSIGNMENT

#05-01 NTUC TRADE UNION HOUSESINGAPORE 189556			
		Date: 29-10-2019	
		Code: INC4	
<b>1. Policy Particulars :- THIRD PARTY CLAIM</b>			
Insured Veh.	SJN 3299T	Veh. Inspected	SHA 7707Z
Policy No.	5095906901-01	Coverage (\$)	0.00
Claim No.	MT/1066221-002	Excess (\$)	0.00
Assign From		Assign Date	09/10/2019
<b>2. Vehicle Particulars &amp; Condition</b>			
Make & Model	HYUNDAI I40	c.c	1685
Engine No.	HIDDEN	Year of Reg.	2015
Chassis No.	KMHLB41UMFU069416	Colour	BLUE
Odometer	730277	Steering	IN ORDER
Brakes	IN ORDER	Modification	STANDARD ALLOY RIM
General	FAIR		
<b>3. Conditions of Tyres</b>			
	Size	Make	Balance
R/H Front Tyre	205/60 R16	HANKOOK	6 mm
L/H Front Tyre	205/60 R16	HANKOOK	6 mm
R/H Rear Tyre	205/60 R16	HANKOOK	5 mm
L/H Rear Tyre	205/60 R16	HANKOOK	5 mm
<b>4. Description of Damages</b>			
THE VEHICLE SUSTAINED DAMAGES AT THE REAR PORTION.

**ADJUSTMENT ON REPAIR COST FOR VEHICLE NO. SHA 7707Z**

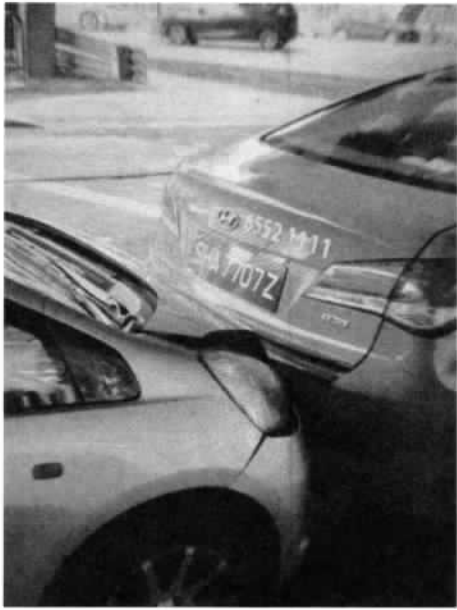
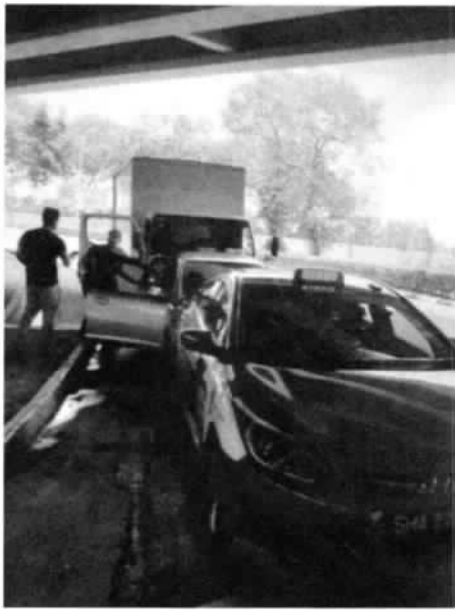
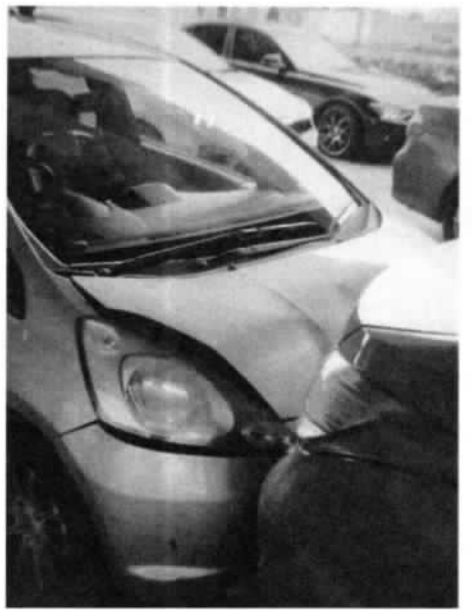
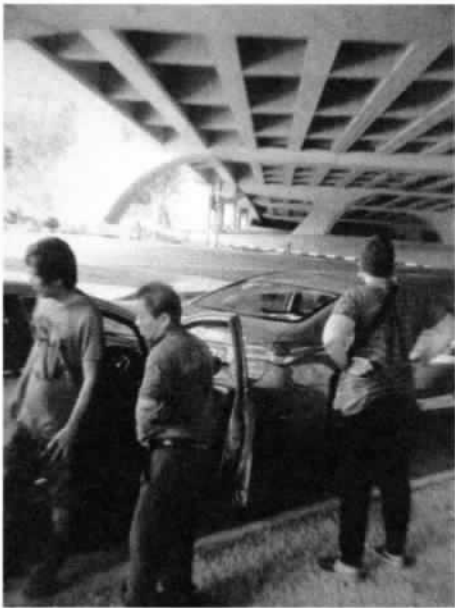
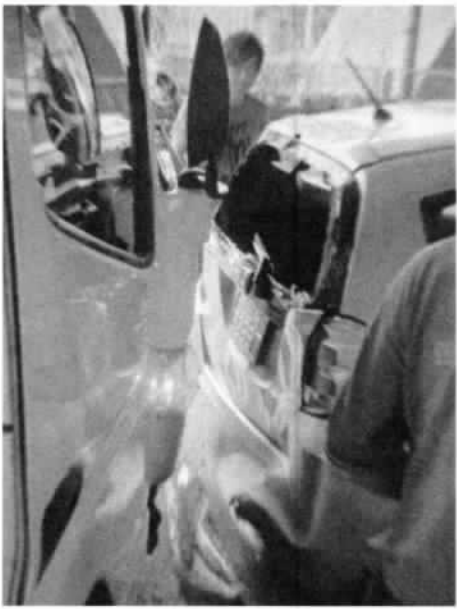
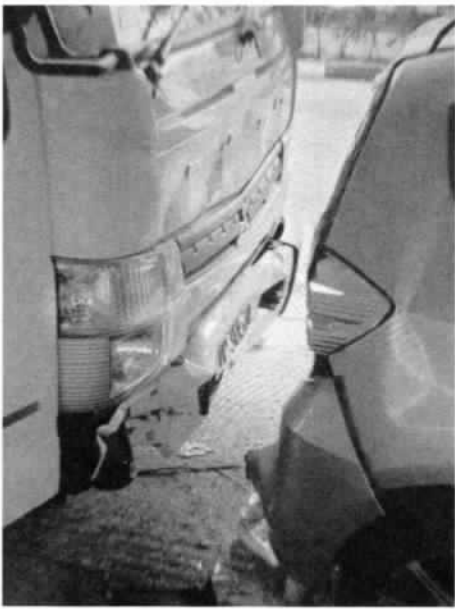
DAMAGES SEE DETAILS.			
<b>5. General Information</b>			
Accident Date	08/10/2019	Inspection Date	09/10/2019
Survey held at	COMFORTDELGRO ENGINEERING PTE LTD 59 LOYANG DRIVE SINGAPORE 508969		
<b>5a. Remarks</b>			
A)THE INSPECTION WAS CONDUCTED ON A"WITHOUT PREJUDICE" BASIS. B)IN ACCORDANCE TO YOUR INSTRUCTIONS, WE HAVE NOT AUTHORISED REPAIRS.			
<b>5b. Estimate Days of Repair</b>			
ESTIMATED NORMAL PERIOD FOR REPAIR:		2 Working Days

Qty	Description of Parts	Condition	Estimate By Workshop (\$)	Our Adjusted (\$)
<b><u>REPLACEMENT OF PARTS</u></b>				
1	REAR BUMPER	CRACKED	553.00	553.00
10	REAR BUMPER CLIP	NECESSARY	22.00	22.00
2	REAR BUMPER BRACKET @\$35.60	SERVICEABLE	71.20	-
1	REAR BUMPER UNDER COVER	DEFORMED	228.00	228.00
1	REAR BUMPER REFLECTOR LAMP (RH)	SERVICEABLE	30.60	-
	LESS 20% DISCOUNT		-180.96	-160.60

730.00	510.00
<b>GRAND TOTAL</b>			<b>1,639.54</b>	<b>1,202.40</b>
<b>RECOMMENDED COST OF LUMP SUM REPAIRS (TO ITS PRE-ACCIDENT CONDITION) (CONFIRMED)</b>				<b>950.00</b>
