TP Claims against NTUC Income: Follow-Through Survey

1. Policy Particulars :- THIRD PARTY CLAIM

THE VEHICLE SUSTAINED DAMAGES AT THE N/S FRONT PORTION. DAMAGES SEE DETAILS.

ADJUSTMENT ON REPAIR COST FOR VEHICLE NO. SHA 8343H

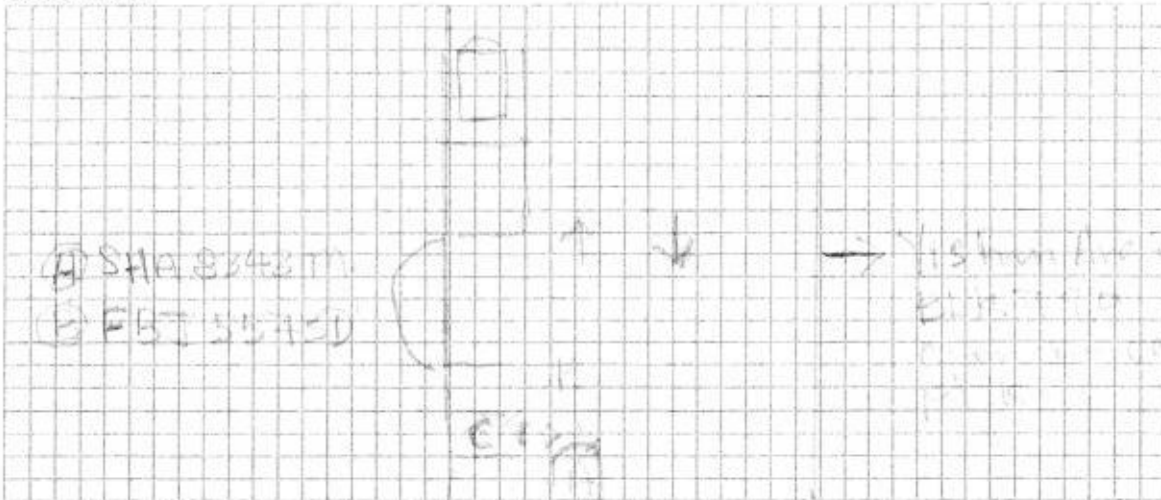
SKETCH PLAN

On 10/10/2019 at about 0840 hrs, I vehicle A was driving my taxi along Yishun Ave 2 BLK 780 open air car park. After I pick up 3 passengers at HDB car park when I make a left turn I was in the straighten position, vehicle B was push out from a motorcycle lot and I collided onto vehicle B. No one was injured at that time.

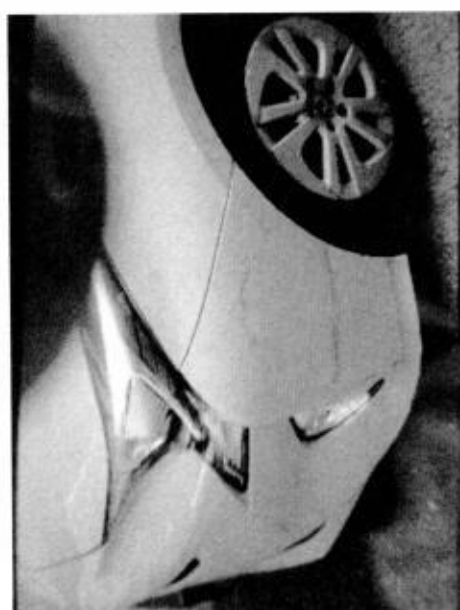
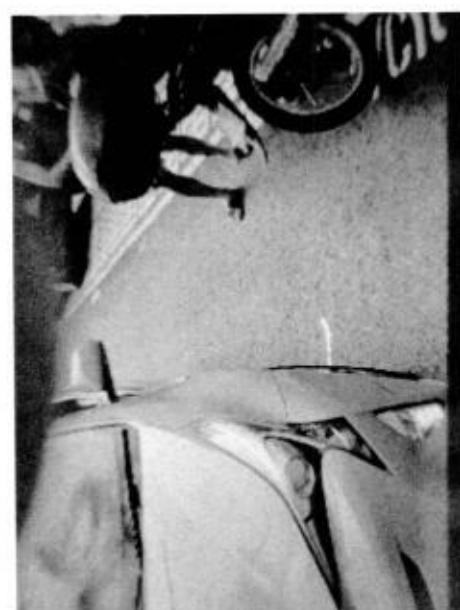
Qty	Description of Parts	Condition	Estimate By Workshop (\$)	Our Adjusted (\$)
REPLACEMENT OF PARTS				
1	LAMP ASSY, FOG, LH	GRAZED	920.00	920.00
1	FRONT BUMPER COVER	CRACKED	499.90	499.90
10	FRONT BUMPER CLIPS	NECESSARY	22.00	22.00
2	FRONT BUMPER SIDE RETAINER @\$77.00	SERVICEABLE	154.00	-
1	FRONT WHEEL HUB CAP (LH)	GRAZED	177.70	177.70
	LESS 25% DISCOUNT		-443.40	-404.90
			1,330.20	1,214.70
LABOUR				
	PANEL BEATING.		350.00	320.00
	SPRAY PAINTING CHARGE.		500.00	200.00
	WIRING CHARGE.		50.00	20.00
	FRT WHEEL ALIGNMENT.	NOT NECESSARY	120.00	-
			1,020.00	540.00
GRAND TOTAL			2,350.20	1,754.70
RECOMMENDED COST OF LUMP SUM REPAIRS (TO ITS PRE-ACCIDENT CONDITION) (CONFIRMED)				1,400.00
